# The Application of Qualification Testing, Field Testing, and Accelerated Testing for Estimating Long-Term Durability of Composite Materials for Caltrans Applications

25 February 2005

G. L. STECKEL and G. F. HAWKINS  
Space Materials Laboratory  
Laboratory Operations

STATE OF CALIFORNIA  
DEPARTMENT OF TRANSPORTATION  
Sacramento, CA 94273

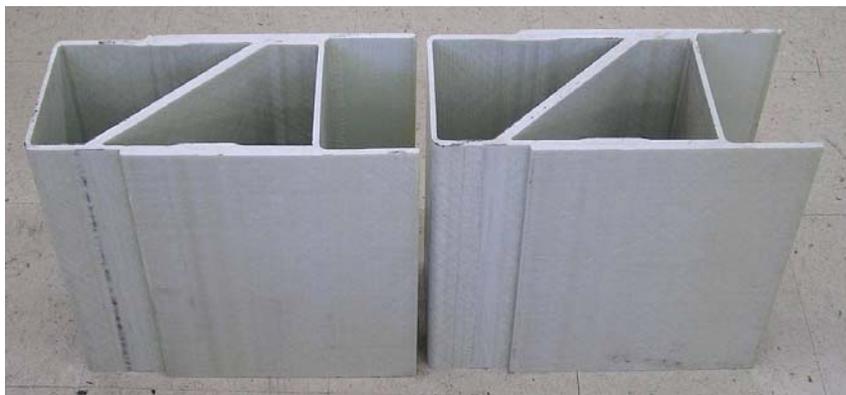
The bridge deck materials were fabricated by Martin Marietta Composites, Incorporated (MMC), Raleigh, North Carolina. The deck, MMC's Duraspan<sup>TM</sup> 766 modular design, is constructed from interlocking dual-cell sections of pultruded E-glass/Isophthalic polyester composite. Short pieces of a pair of typical pultruded sections are shown in Figure 1.1. The deck sections are reinforced with

Figure 1.1. Photograph of MMC pultruded bridge deck sections.

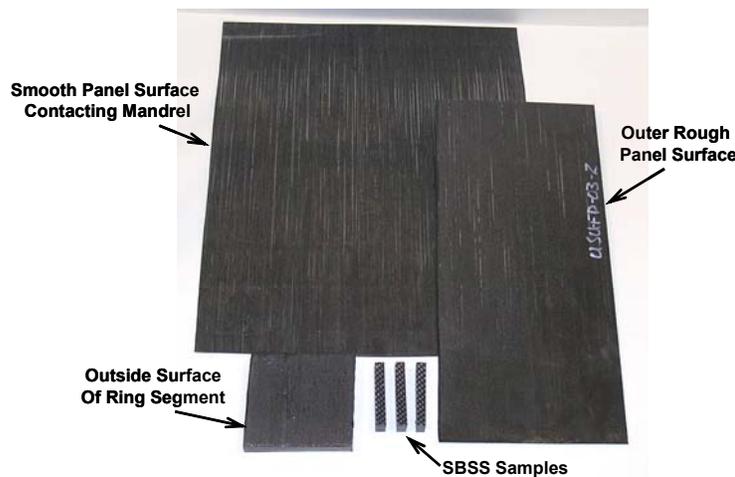
Photographs of typical flat panels and ring segments are shown in Figure 1.2. The panel surface that was in contact with the mandrel was very smooth and had a lined appearance showing the fiber direction of the inner ply. This is demonstrated by the larger panel in the figure. The outer surface, shown by the smaller panel in the photograph, had a very rough, resin-rich surface from a fabric peel-ply that was removed after the panels were cured. The ring segments also had a rough surface on the outside diameter from a peel-ply. The ring segments had a very smooth inner surface as demonstrated by three short-beam shear strength (SBSS) samples shown in the figure. The SBSS samples also show the fabric layer that was applied on the inner surface of the shells.

Figure 1.2. Photograph of ATK flat panels and ring segments.

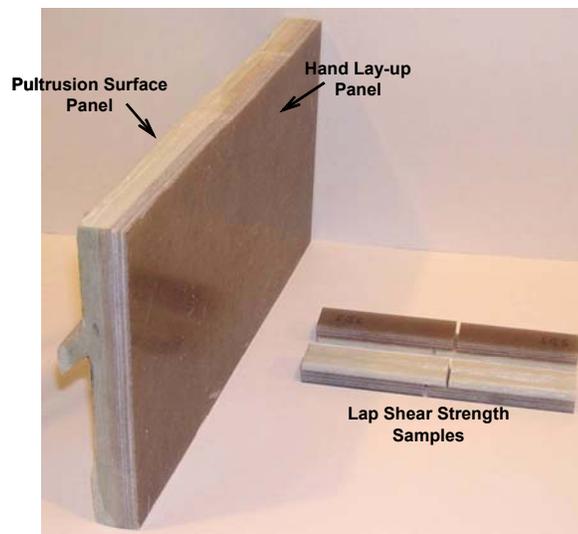
A photograph of an as-received bonded assembly and two lap shear strength samples is shown in Figure 1.3. Each bonded assembly was cut into two 7.5-in.-long pieces, and all four edges were sealed. The resulting pieces for durability exposures were labeled 1A, 1B, 1C, 1D, 2A, 2B, 2C, 2D, 3A, 3B, 3C, 3D, 4A, 4B, 4C, 4D, 5A, 5B, 5C, and 5D. The pieces were identified by the pultruded sections (numbered 1 through 5) from which they originated. For example, Pieces 1A and 1B were cut from one bonded assembly that was fabricated using a surface panel from Pultruded Section No. 1 and Pieces 1C and 1D were cut from the other surface panel from Pultruded Section No. 1. Lap shear strength samples were machined from the bonded assemblies following the environmental exposures. Details of the LSS samples are given in Subsection 1.2.4.

Figure 1.3. Photograph of MMC bonded assembly and LSS samples.

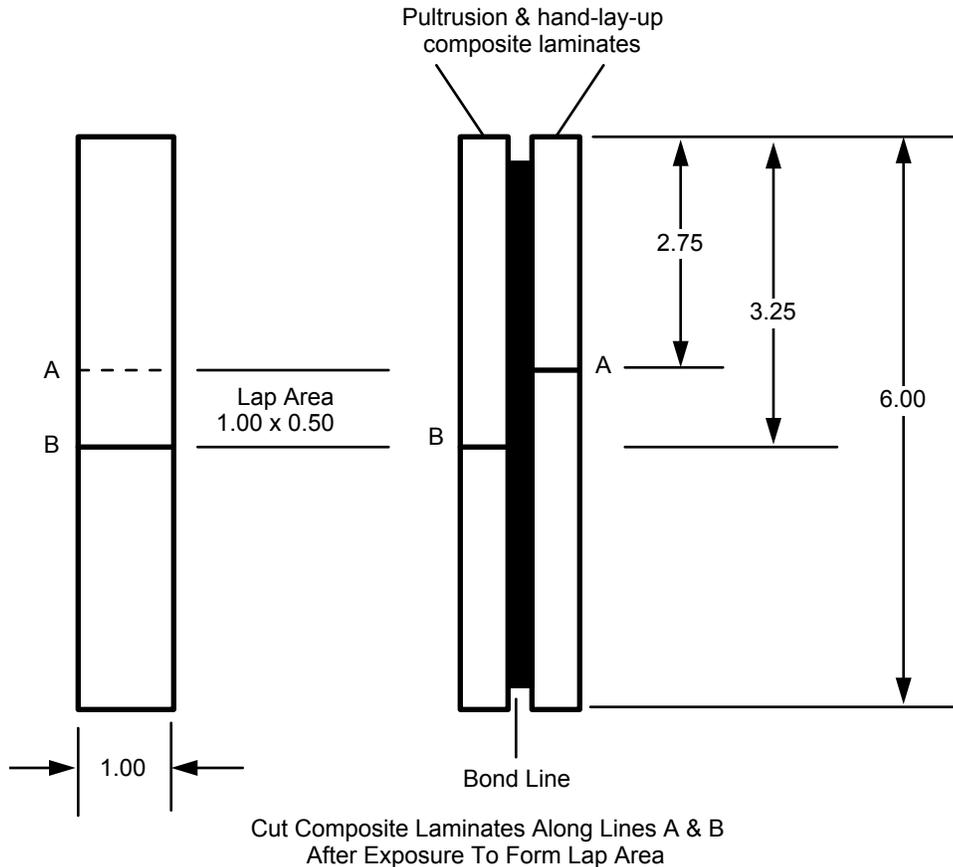
For the preparation of single lap shear samples, the Martin Marietta Composites bonded assemblies were cut parallel to the pultrusion direction with the diamond cut-off wheel into five 6 x 1.0 in. (15 x 2.5 cm) strips. The pultruded panel and hand lay-up panels were cut along locations A and B as shown in Figure 1.4 to form the lap shear area. Thus, the lap shear samples had a 0.5 in. (1.3 cm) long single-lap configuration. Two lap shear samples were shown above in Figure 1.3. The lap shear testing was performed in an Instron Universal Testing Machine at a crosshead rate of 0.1 in./min (0.25 cm/min).

Figure 1.4. Drawing for preparation of single lap shear samples from bonded composite panel assemblies.

For the preparation of single-lap shear samples, the Myers Technologies, Inc. bonded assemblies are cut parallel to the fiber direction with the diamond cut-off wheel into five 6 x 1.0 in. (15 x 2.5 cm) strips. The two composite adherends are cut along locations A and B as shown in Figure 1.4 (Subsection 1.2.4) to form the lap shear area. Thus, the lap shear samples have a 0.5-in. (1.3-cm) long single-lap configuration. It is pointed out in ASTM D 4896,<sup>21</sup> "Standard Guide for Use of Adhesive-Bonded Single Lap-Joint Specimen Test Results," that the true shear stress of an adhesive joint can not be easily determined using single-lap specimens. The major problem is that the bending moment inherent in single-lap specimens induces tensile stresses normal to the plane of the bond line at the ends of the overlap and a nonuniform shear stress distribution in the adhesive. Thus, the measured shear stress at failure is lower than the true shear strength of the joint. This is not an issue for the thick composite adherends used for MMC-bonded assemblies, but is for the thin composite adherends in

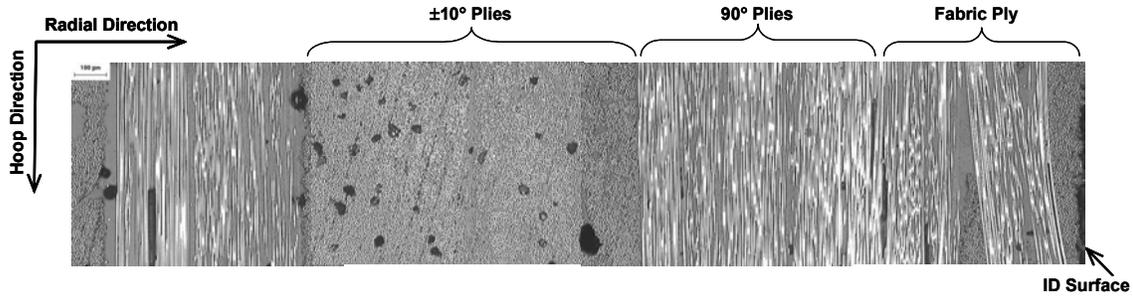
A cross section normal to the axial direction is shown in Figure 1.5 for Ring Segment No. 1-4, which was exposed to 20 freeze/thaw cycles. The micrograph, which shows the inner 8 layers of the 24-ply lay-up, is representative of the microstructure for all ring segments that were cross sectioned. Excellent infiltration of the EPON™ 826/EPI-CURE™ 9551 epoxy resin into the AS4D carbon-fiber tows and a uniform fiber-matrix distribution were achieved. Optical microscopy showed that the ring segments had relatively low porosity that was clearly within the specified requirement of  $\leq 5$  vol%.<sup>1</sup>

Figure 1.5. Micrograph of cross section normal to axial direction of carbon/epoxy ring segment exposed to freeze/thaw exposure.

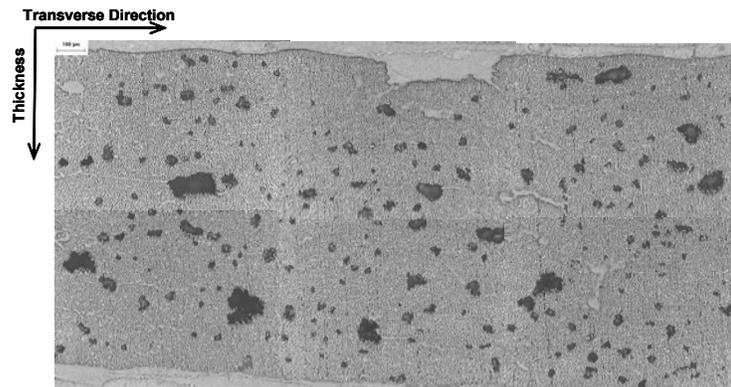
Figure 1.6. Micrograph of cross section normal to fiber direction of carbon/epoxy Panel No. A03-1M after 10,000 h alkali exposure.

Figures 1.6 and 1.7 show cross sections normal to the fiber direction for flat panels exposed to the alkali solution and UV/condensation weathering test, respectively. It is evident from these figures that the flat panels had significantly higher porosity than the ring segments. In addition, the fiber-matrix distribution was not as uniform for the flat panels. These characteristics are not unusual for filament-wound flat panels. Tow tension is not transferred to wound composites as efficiently for flat mandrels as for cylindrical mandrels, so less compaction is achieved. Reduced compaction leads to higher porosity and reduced uniformity. It was apparent from the optical micrographs that there were significant variations in fiber content among the different panels and between different locations on any given panel.

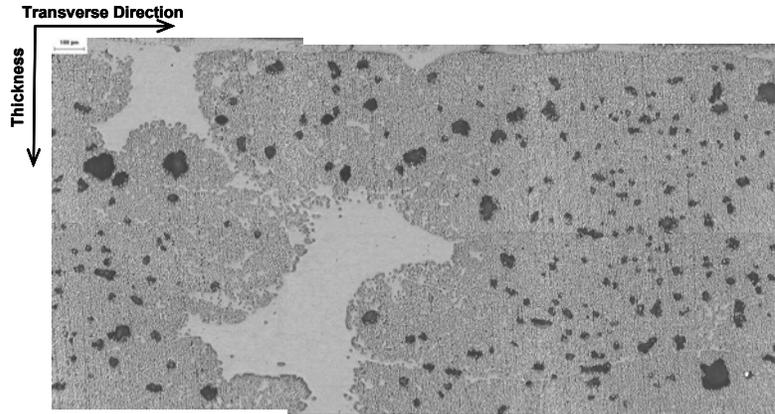
Figure 1.7. Micrograph of cross section normal to fiber direction of carbon/epoxy Panel No. A03-2M after weathering exposure.

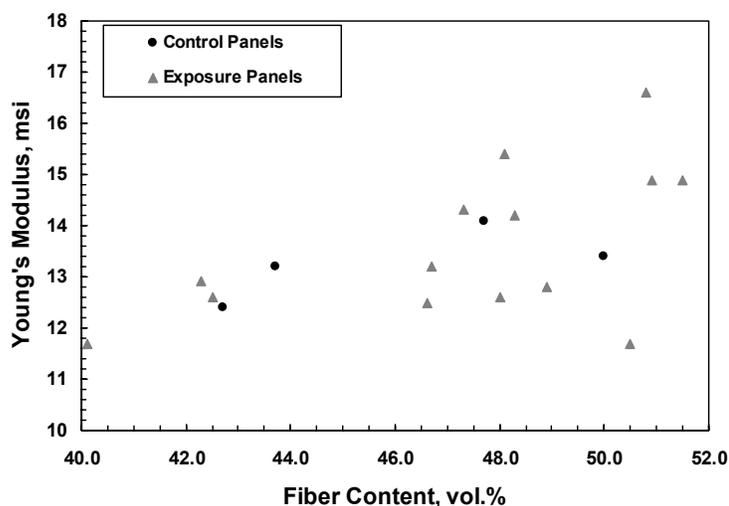
Figure 1.8. Young's modulus of carbon/epoxy panels as function of panel fiber content.

Due to the poor correlation between panel thickness and fiber content, it was decided to plot the Young's modulus data as a function of the fiber content (Figure 1.8) and as a function of the tensile sample thickness (Figure 1.9). The plot that most closely followed a linear relationship would then be used for normalizing the modulus and tensile strength data. Although Young's modulus generally increased as the fiber content increased, there was considerable scatter in the data. The modulus

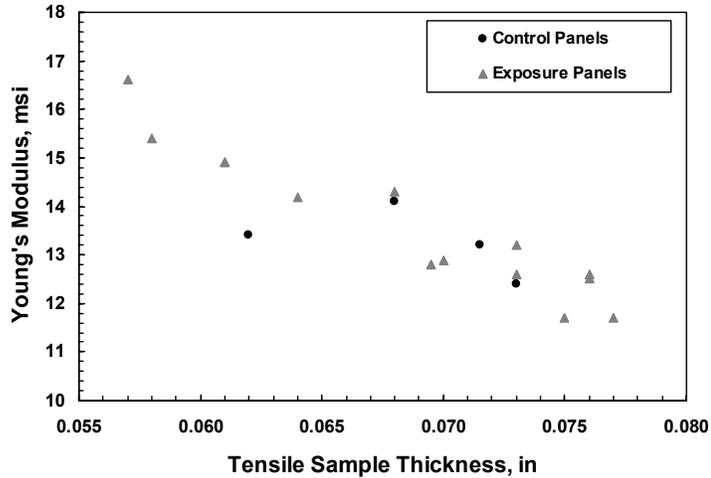
Figure 1.9. Young's modulus of carbon/epoxy panels as function of panel thickness.

showed a much stronger correlation with the tensile sample thickness. In retrospect, these results are not surprising since the thickness measurements were made on the same samples as the modulus measurements, while the fiber content measurements were made on samples from different locations on the panels. It is apparent that in many cases the measured fiber content was not representative of the tensile samples. It was concluded that the sample thickness should be used to normalize the tensile data. All tensile data were normalized to the average thickness of the 18 panels, which was 0.070 in. (1.78 mm).

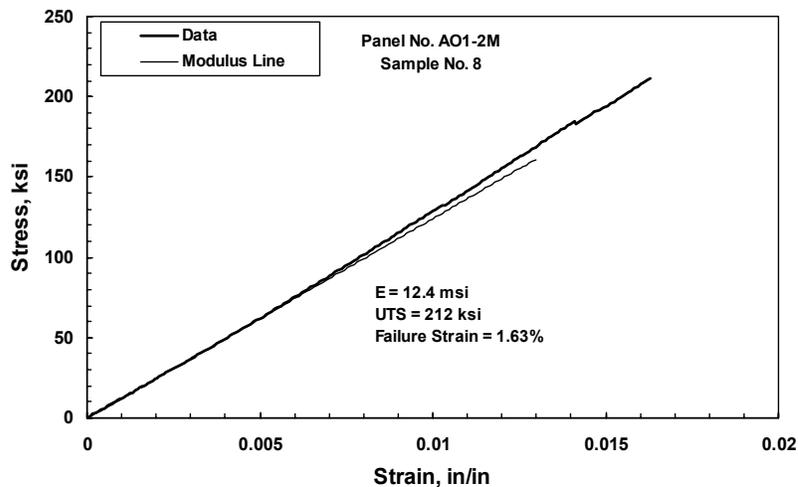
A typical stress-strain curve for the AS4D/EPON™ 826/EPI-CURE™ 9551 system is shown in Figure 1.10. The unidirectional composites have essentially linear curves up to the failure stress. The tensile data for the four control panels are presented in Table 1.5. This table includes the measured modulus and strength values along with normalized values. The Young's modulus and tensile strength for each sample were normalized to a thickness of 0.070 in. (1.78 mm). The average modulus and

Figure 1.10. Stress-strain curve for carbon/epoxy Control Sample No. A01-2M8.

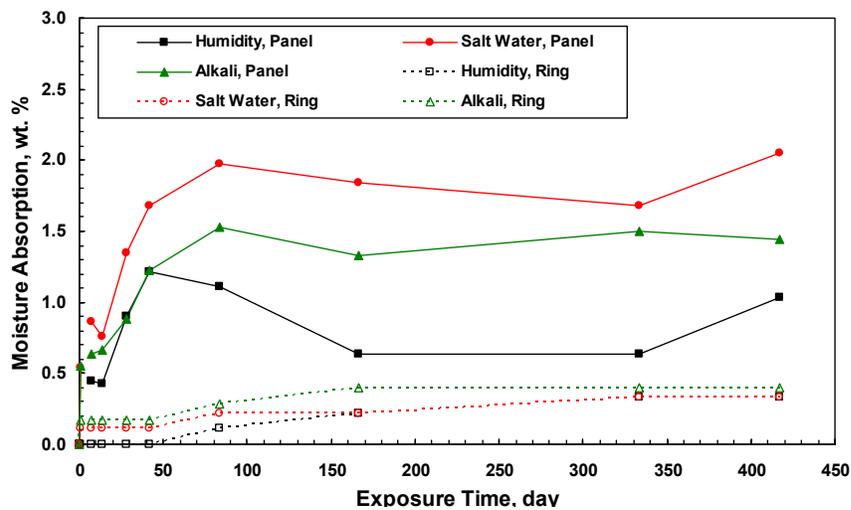
Table 1.7 shows that the carbon/epoxy system had positive weight changes, attributed to moisture absorption, after the humidity, salt water, alkali, and freeze/thaw exposures. Moisture absorption is plotted as a function of exposure time for the 10,000-h panels and ring segments in Figure 1.11. The moisture absorption curves show that approximately 50% of the total moisture absorption occurred in the first 25 days for the flat panels and in the first 80 days for the much thicker ring segments. Equilibrium was reached in approximately 80 days for the flat panels and was approached in approximately 170 days for the ring segments. However, as the data in Table 1.7 indicates, the moisture content of the ring segments was still increasing at the end of the 10,000-h exposure period. In prin-

Figure 1.11. Moisture absorption curves for 10,000-h carbon/epoxy panels and ring segments.

ciple, the ring segments should eventually reach the same equilibrium moisture content as the flat panels. However, the higher porosity of the panels may have caused them to absorb additional moisture.

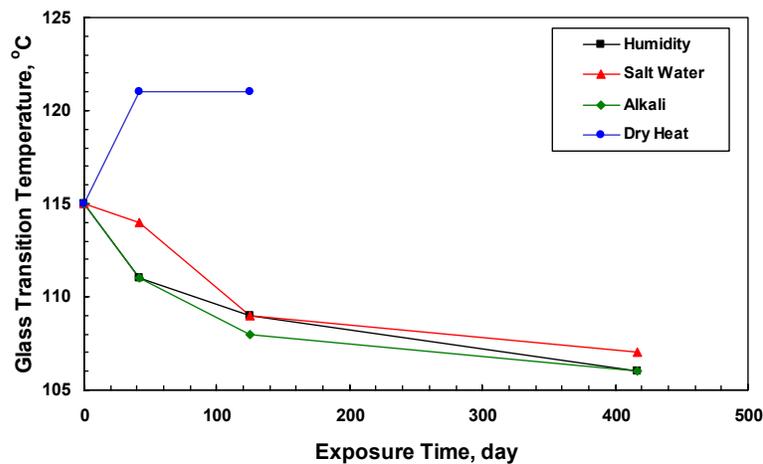
Plots of  $T_g$  versus exposure time are shown in Figure 1.12 for the humidity, salt water, alkali, and dry heat exposures. In general,  $T_g$  was increased by elevated temperature exposure, probably due to moisture dry-out, and was decreased by moisture exposure due to plasticization of the epoxy. The  $T_g$ s for samples exposed to moisture decreased by around 5°C after 1,000-h exposures and by 10°C after 10,000-h exposures. The graph shows that most of the reduction occurred during the first 3,000 h (125 days), which corresponds to the time period over which most moisture was absorbed. Although the humidity exposure was at 38°C (100°F) versus 23°C (72°F) for the salt water and alkali exposures,  $T_g$  decreased at the same rate in the humidity chamber as in the salt water and alkali solu-

Figure 1-12. Glass-transition temperature versus exposure time for carbon/epoxy panels.

tions.  $T_g$  increased by approximately 5°C after 1,000 h in dry heat at 60°C (140°F), but showed no additional increase after 3,000 h. This is probably due to the fact that complete dry-out occurred during the first 1,000 h, as indicated by the mass loss data. Similar  $T_g$  changes were measured for the dry heat and weathering exposures.

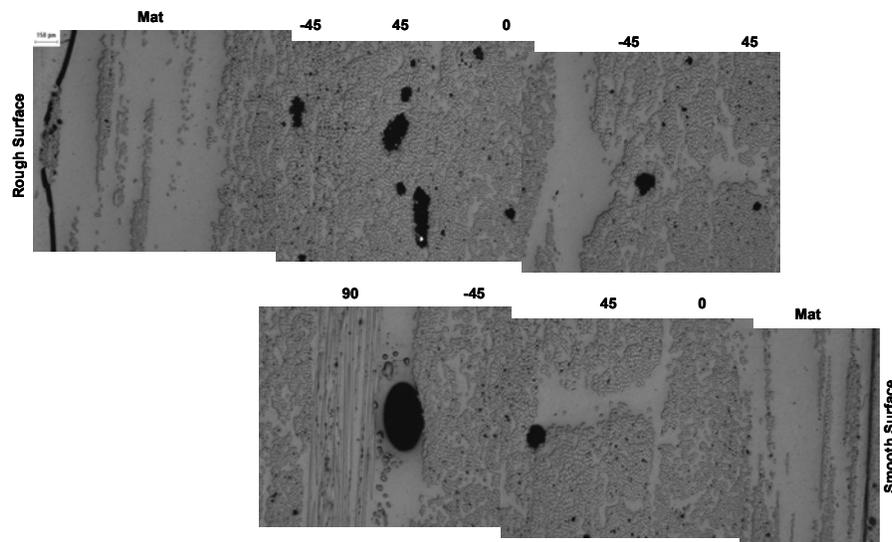
A cross section normal to the 0° direction is shown in Figure 1.13 for a control panel. The micrograph, which shows the full thickness of the 11-ply lay-up, is representative of the microstructure for all hand-lay-up panels that were cross sectioned. The smooth surface corresponds to the surface that would face outward on the bridge deck. Excellent infiltration of the DERAKANE 411-370 epoxy vinyl ester resin into the E-glass fiber tows and a uniform fiber-matrix distribution were achieved. Although the panels had isolated areas with relatively large voids, the overall void content was low.

Figure 1.13. Micrograph of cross section normal to 0° direction of E-glass/epoxy vinyl ester control panel.

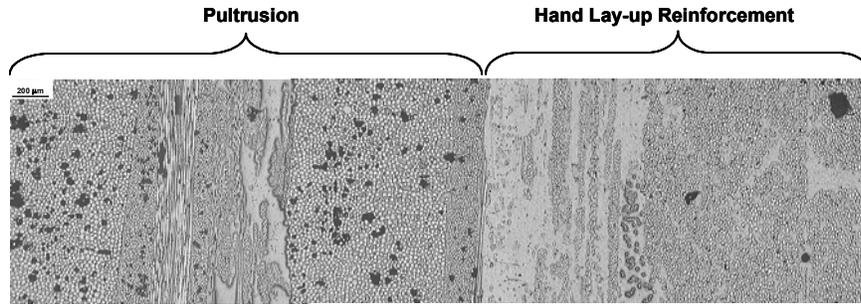
Figure 1.14 shows a cross section normal to the 0° direction for the bonded assembly that was exposed to 20 freeze/thaw cycles. The micrograph extends from the E-glass/polyester pultruded section, across the bond line, and into the E-glass/epoxy vinyl ester hand-lay-up composite. It is apparent from this figure, and was also demonstrated by microscopy of other bonded assemblies, that the pultruded section had higher porosity than the hand lay-up composite. This cross section and the other cross sections demonstrated complete bonding between the pultrusion and hand lay-up composites. Optical microscopy gave no indications of any microcracking, delaminations, fiber-matrix separation or any other damage from the environmental exposures of the hand lay-up panels and bonded assemblies.

Figure 1.14. Micrograph of cross section normal to 0° direction of bonded assembly exposed to freeze/thaw exposure.

The baseline LSS data from the pultrusion/hand-lay-up bonded assemblies are presented in Table 1.11. In addition to the LSS, the table includes the sample dimensions, failure load, and failure mode of each sample. The average LSS was  $2030 \pm 410$  psi. Most of the samples failed within the pultrusion by interlaminar shear or by shear within the fiber mat layer immediately below the bond line. Only one sample had a pure adhesive failure between the two composite materials. All samples from Panel No. MMBA-1D had a mixed failure mode of adhesive failure + pultrusion mat shear. Therefore, it is concluded that the bond strength between the pultrusion and hand-lay-up composites is generally stronger than the interlaminar shear strength of the pultrusion. The fact that the pultrusion is the weakest material in the LSS test may be a result of the higher porosity for the pultrusion, as noted in the optical micrographs (Figure 1.14).

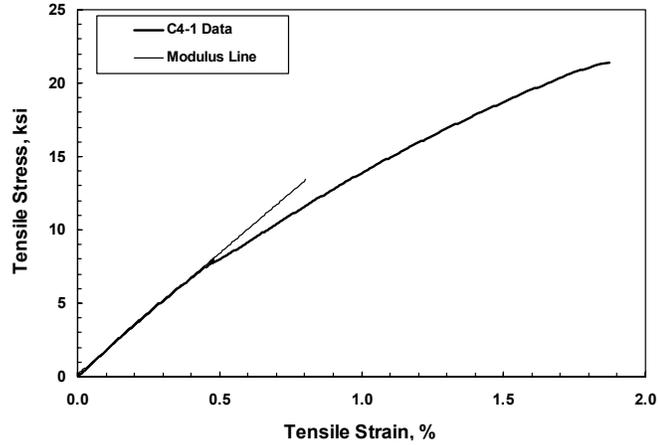
A typical stress-strain curve for the hand-lay-up panels is shown in Figure 1.15. The stress-strain curve is linear up to approximately 0.5%, but deviates from linearity at higher strain. This type of behavior is expected due to the high percentage of  $\pm 45^\circ$  fibers in the lay-up. Failure occurs by tensile overload of the fibers in the  $0^\circ$  layers and matrix failure for the  $\pm 45^\circ$  and  $90^\circ$  plies. Typical tensile sample fracture surfaces are shown in Figure 1.16. The masking tape on the samples was used to prevent slippage of the extensometer used for strain measurements. The location of the tape shows that fracture occurred within the gage section.

Figure 1.15. Stress-strain curve for E-glass/epoxy vinyl ester Control Sample No. C4-1.

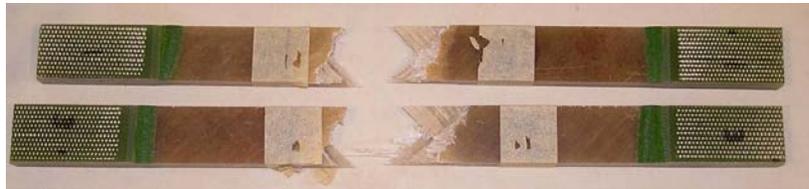
Figure 1.16. Photograph of fractured tensile samples from E-glass/epoxy vinyl ester control panels.

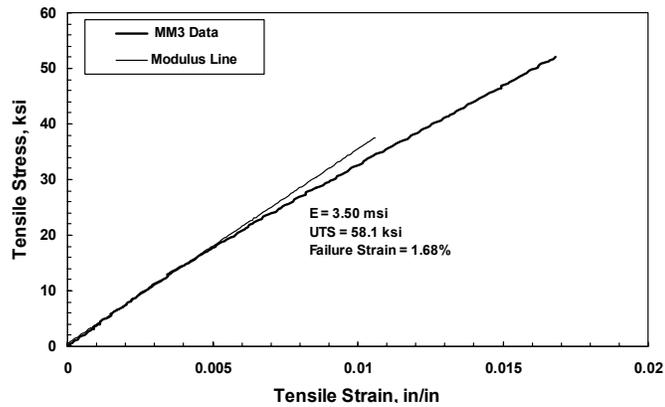
Figure 1.17. Stress-strain curve for web section of Duraspan™ 766 pultrusion.

Although durability testing was not performed on the Duraspan<sup>TM</sup> 766 E-glass/Isophthalic polyester pultruded sections, tensile tests were performed on one panel extracted from a pultrusion. The panel was cut from the web wall and was tested in the pultrusion direction, which corresponds to the  $0^\circ$  direction for the hand lay-up when applied to the deck. The tensile properties of the Duraspan<sup>TM</sup> 766 web section are summarized in Table 1.10, and a typical stress-strain curve is shown in Figure 1.17. The web laminate has 66% of the plies at  $\pm 45^\circ$  and 34% at  $0^\circ$ .<sup>2</sup> The pultrusion web section is expected to have higher tensile properties than the hand-lay-up panels since the  $90^\circ$  plies in the hand

lay-up are replaced by  $\pm 45^\circ$  plies. It may also have lower resin content due to compaction from the pultrusion process. The average Young's modulus and tensile strength of the pultrusion web section are 3.53 msi and 58.2 ksi, which are 2.2 and 2.9 times the respective values for the hand-lay-up control panels. It is interesting to note that the measured modulus and strength of the web section are significantly higher than values predicted by laminate analyses. MMC has reported a predicted modulus of 2.52 msi and a predicted tensile strength of 32 ksi.<sup>2</sup>

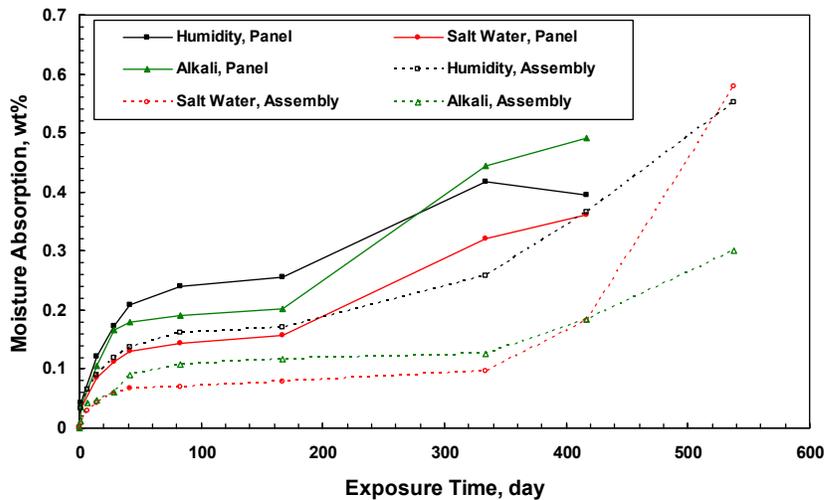
Figure 1.18. Moisture absorption curves for fiberglass panels and bonded assemblies.

Moisture absorption is plotted as a function of exposure time for the 10,000-h panels and for the 12,910-h bonded assemblies in Figure 1.18. The curves show that the initial moisture absorption rates were higher for the panels than for the bonded assemblies, which were over twice the thickness of the panels. The relative rates for the different environments were consistent for the panels and bonded assemblies. In both cases, the highest rates were in the humidity chamber due to the higher temperature, and the lowest rates were in salt water. Initially, the curves followed normal Fick's Law diffusion behavior with rapid initial moisture absorption followed by diminishing absorption rates as the equilibrium moisture content was approached. However, the moisture absorption rates subsequently increased at exposure times between 167 and 333 days for the panels and between 333 and 417 days for the bonded assemblies. This type of behavior has been reported in the literature and was attributed to moisture saturation of the composite matrix followed by additional absorption within voids or other defects.<sup>17</sup> The curves suggest that the panels may have reached the equilibrium moisture content at around 0.4–0.5%. Moisture content was still increasing at the end of the exposure periods for the thicker bonded assemblies. It is interesting to note that the bonded assemblies in the salt water and humidity exposures absorbed more moisture than the flat panels. This may indicate that the equilibrium moisture content for the Isophthalic polyester matrix of the pultrusion is higher than that for the epoxy vinyl ester matrix of the reinforcement panels. It may also be a consequence of the higher porosity within the pultrusion. Moisture can collect within voids, giving higher than normal moisture absorption.

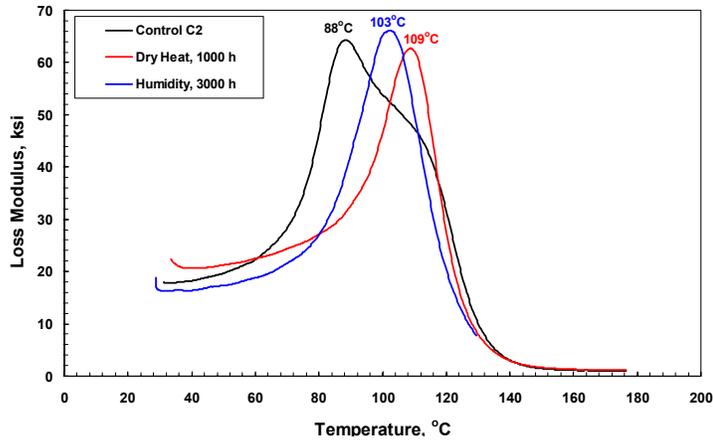
Figure 1.19. Loss modulus versus temperature for E-glass/epoxy vinyl ester control and exposure panels.

The  $T_g$  data for the four control panels were very consistent, showing a variation of only  $1^\circ\text{C}$  ( $2^\circ\text{F}$ ) between  $87$  and  $88^\circ\text{C}$  ( $189$  and  $190^\circ\text{F}$ ). This indicates that the matrix is very stable at laboratory temperature since the first control panel was tested along with the 1,000-h exposure panels on July 9, 2002, while the last control panel was tested along with the 10,000-h exposures on August 6, 2003. The panels exposed to diesel fuel, salt water, or the alkali solution at  $23^\circ\text{C}$  ( $73^\circ\text{F}$ ) had no significant change in  $T_g$ . All of the exposures that involved elevated temperatures, the humidity chamber at  $38^\circ\text{C}$  ( $100^\circ\text{F}$ ), dry heat at  $60^\circ\text{C}$  ( $140^\circ\text{F}$ ), and the alternating humidity at  $40^\circ\text{C}$  ( $104^\circ\text{F}$ ), plus UV at  $60^\circ\text{C}$  ( $140^\circ\text{F}$ ) exposure caused increases in  $T_g$ . These results suggest that the epoxy vinyl ester resin was not fully cured at room temperature, and the elevated temperatures further advanced the cure state. This is further demonstrated by a comparison of the loss modulus versus temperature plots in Figure 1.19. The loss modulus curve for Control Sample No. 2 was nonsymmetrical with a peak at  $88^\circ\text{C}$  ( $190^\circ\text{F}$ ) and a shoulder at approximately  $110^\circ\text{C}$  ( $230^\circ\text{F}$ ). The curves for the samples exposed to the humidity chamber for 3,000 h and dry heat for 1,000 h are more symmetrical with narrow peaks that are shifted to higher temperatures. These curve changes are all indicative of cure advancement from the elevated temperature exposures.

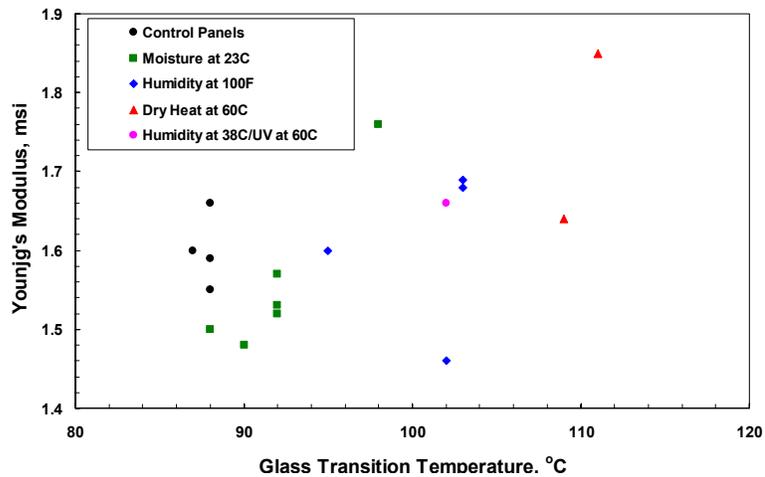
Figure 1.20. Young's modulus versus  $T_g$  for E-glass/epoxy vinyl ester control and exposure panels.

A plot of Young's modulus as a function of  $T_g$  is shown in Figure 1.20 for the E-glass/epoxy vinyl ester panels. The plot shows a general tendency for the composite modulus to increase as the cure state of the matrix advanced and  $T_g$  increased. The salt water and alkali solution exposures at  $23^\circ\text{C}$

(73°F) caused a decrease in modulus due to matrix plasticization even though there was either no change or just a slight increase in  $T_g$ . The panel exposed to salt water for 3,000 h deviated from this behavior in that it had a significantly higher modulus and  $T_g$  than the control panels. It is probable that this panel was inadvertently exposed to heat, probably sunlight, at some time. This most likely occurred during fabrication, shipping, or storage prior to the salt water exposure.

The panel exposed to the humidity chamber for 10,000 h was the only panel that deviated significantly from the correlation between Young's modulus and  $T_g$ . This observation further supports the supposition that the E-glass fibers were attached by the 10,000-h humidity exposure. Thus, the modulus change for this panel was due to a different mechanism than that for the other panels.

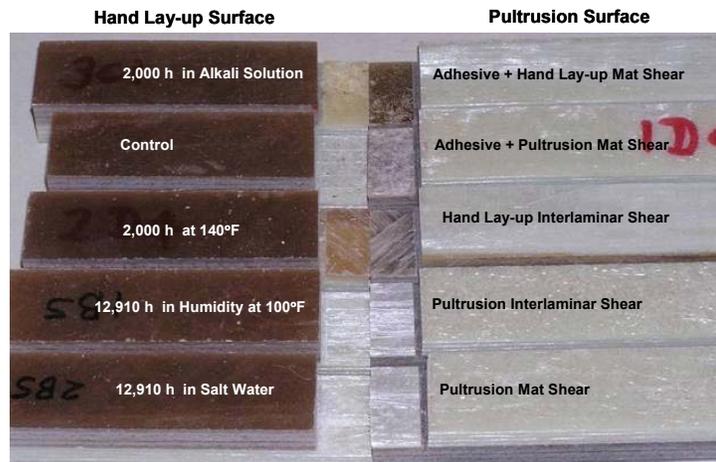
Figure 1.21. Examples of failure modes exhibited by bonded assembly LSS samples.

The LSS data for the bonded assemblies subjected to the environmental exposures are tabulated in Table 1.13. The average LSS and standard deviation for the five tests for each exposure condition are given. The most frequent failure mode for the five tests for each exposure condition is also included in the table. A photograph showing examples of the different failure modes is shown in Figure 1.21. Detailed data for the individual LSS tests are given in Appendix 2.

Like the control bonded assemblies, most of the exposure bonded assemblies failed by interlaminar shear within the pultrusion. The bonded assemblies subjected to 2,000-h exposures to salt water, alkali solution, and dry heat all failed at the bond line and within the pultrusion mat layer. However, there was no reduction in LSS, and the samples subjected to longer exposures in these environments all failed within the pultrusion. Thus, there is no evidence that any of the exposures weakened the bond between the pultrusion and hand lay-up.

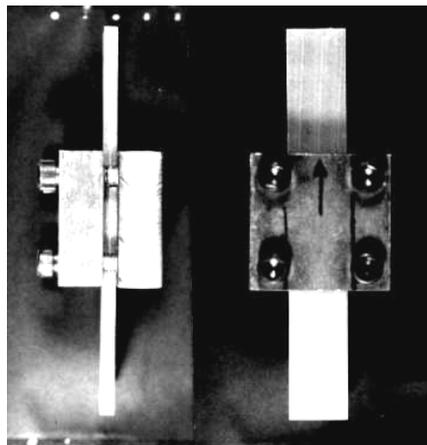
Figure 2.1. Anti-bending fixture for single-lap shear testing.

the Myers Technologies, Inc. bonded assemblies. Therefore, the steel fixture shown in Figure 2.1 is used to reduce bending of the composite adherends. The overlap area of the sample is centered within the 2-in. (5.1-cm) long fixture so that bending stresses on the adherends are resisted by the steel plates at positions approximately 0.75 in. (1.9 cm) outside the overlap area. During installation, the screws are tightened only to the point at which the clamping force is sufficient to prevent the steel fixture from sliding down the sample under the force of gravity. Thus, high compressive normal stresses on the adhesive bond line are avoided. The fixture eliminates failures due to peeling stresses. The lap shear testing is performed in an Instron Universal Testing Machine at a crosshead rate of 0.1 in/min (0.25 cm/min).

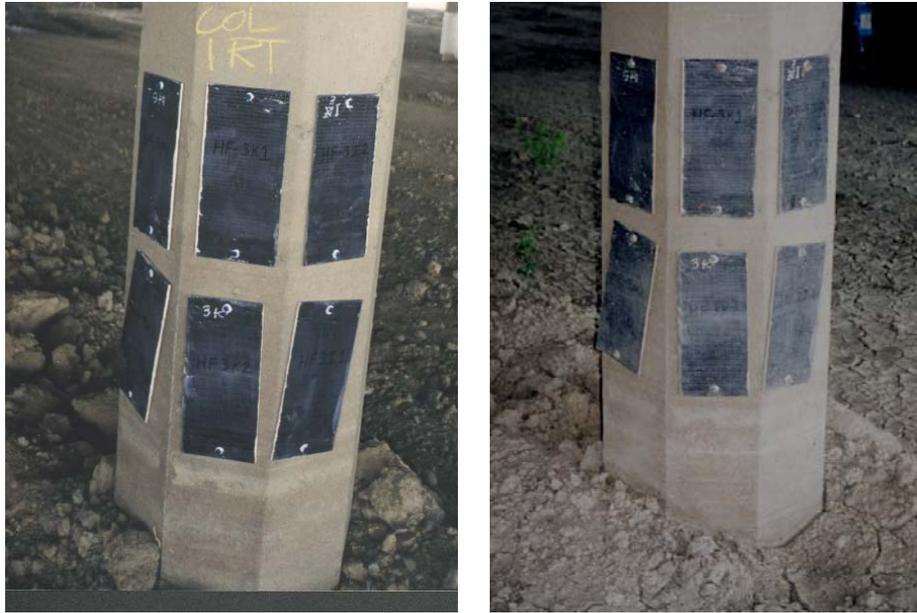
Figure 2.2. Photographs of Fyfe Co. SCH 41/Tyfo<sup>®</sup> S Carbon/Epoxy panels taken at beginning (left) and after 1-yr field exposure

Comparative photographs taken immediately after mounting the panels on the columns in October 1998 and after the first year of exposure in September 1999 are shown in Figures 2.2 and 2.3 for one carbon-fiber-reinforced system and one glass-fiber-reinforced system. The effects of wintertime flooding and subsequent drying are evident by cracking of the soil around the columns in the one-year photographs. The panels were obviously soiled from the one-year exposure. Sample identification numbers were obscured or removed from several panels, particularly the E-glass/polyester panels fabricated by Myers Technologies, Inc. However, there was no evidence of physical damage to any of the composite panels following the first year of exposure. The photographs in Figures 2.2 and 2.3 are representative of composite systems fielded in the experiment. Photographs for all nine systems are documented elsewhere.<sup>19</sup>

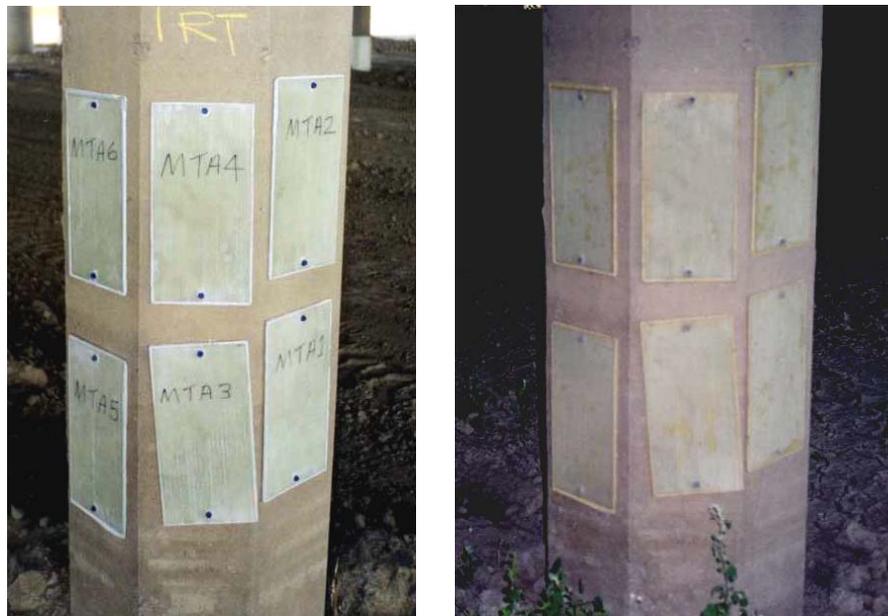
Figure 2.3. Photographs of Myers Technologies, Inc. E-glass/Polyester/MOR-AD-695-28 Adhesive-bonded assemblies taken at beginning (left) and after 1-yr field exposure.

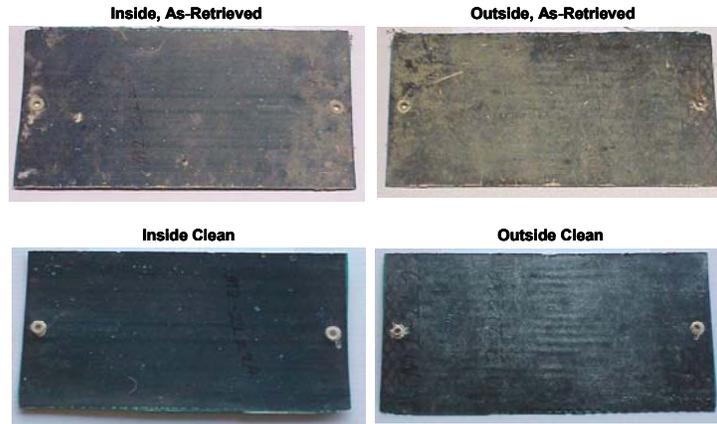
Figure 2.4. Photographs of Mitsubishi Chemical Co. carbon/epoxy Panel No. M2-2L22A after 4-yr field exposure.

The retrieved panels were returned to the laboratory for cleaning, further inspection, and mechanical and physical property measurements. Visual inspection following brush cleaning in tap water gave no indications of any changes in physical appearance for any of the composite systems. Photographs (Figure 2.4) of the as-retrieved and cleaned 4-yr panels for the Mitsubishi Chemical Co. Replark<sup>®</sup>

30/L700S-LS carbon/epoxy system are typical of all exposure panels. Considerable dirt and debris covered the outside and inside (against column) surfaces of the panels from submersion in the murky flood waters. However, cleaning restored the original appearance of all panels.

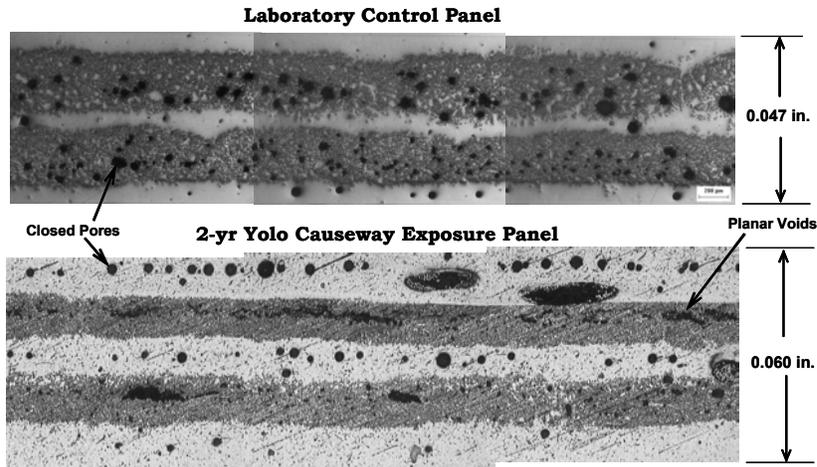
Figure 2.5. Optical micrographs of Master Builders, Inc. laboratory control panel and 2-yr Yolo Causeway exposure panel.

As the data in Table 2.4 demonstrate, the 1.1-year exposure in the alkali solution had no effects on the tensile properties of the carbon-fiber-reinforced systems. And as noted above, none of the laboratory exposures had a significant effect on the tensile properties of these systems. Therefore, no changes in tensile properties were anticipated from the 2-yr or 4-yr Yolo Causeway exposures. The anticipated results were obtained for the Fyfe Co., Mitsubishi Chemical Corp., and Xxsys Technologies, Inc. systems. However, the Master Builders, Inc. system had a 15% reduction in tensile strength and failure strain relative to the control properties for the 2-yr panel and a 10% reduction in these properties for the 4-yr panel. We believe that this is an anomalous effect. The two-ply CF130/MBrace<sup>TM</sup> epoxy panels exposed at Yolo Causeway were 0.059 in. (0.150 cm) thick for the 2-yr exposure and 0.055 in. (0.140 cm) thick for the 4-yr exposure. The 18 panels tested in the laboratory environmental durability program were within the 0.038–0.048 in. (0.097–0.122 cm) thickness range. Optical micrographs presented in Figure 2.5 show that the higher thickness values for the Yolo panels were due to excess epoxy resin between the two layers of carbon fibers. This thick band of epoxy could affect load sharing between the two layers of fibers, thereby reducing tensile strength. In addition, the 2-yr and

4-yr exposure panels had planar voids within epoxy-impregnated fiber plies, while the control panel had only closed pores. These large planar voids caused delaminations during tensile testing and probably reduced the tensile strength. Previous studies have shown that this system is susceptible to reduced tensile strength from delamination failures.<sup>22</sup>

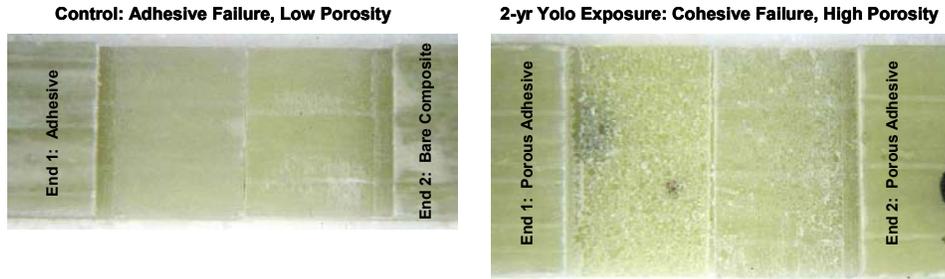
Figure 2.6. Fracture surfaces of LSS samples from Myers Technologies, Inc. bonded assemblies.

The results for the field durability study show a 60% reduction in lap shear strength for the 2-yr and 4-yr exposures relative to the control assembly. Typical fracture surfaces shown in Figure 2.6 demonstrate that the control samples exhibited an adhesive failure mode with very low porosity, while the 2-yr and 4-yr exposure samples exhibited cohesive failures within the adhesive layer with high porosity. T<sub>g</sub> of the MOR-AD-695-28 adhesive was 22 or 23°C (72 or 73°F) for the control and exposure assemblies. The results of the field durability study are inconclusive because it is impossible to determine whether the LSS reduction and changes in failure mode for the Yolo Causeway exposure samples are due to environmental effects or due to the high porosity in the adhesive layer.

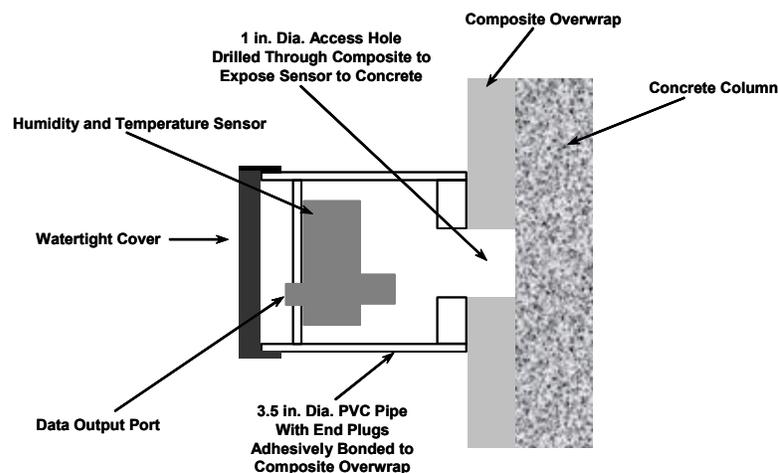
Figure 3.1. Schematic diagram of sensor attachment to a composite overwrapped column.

The sensors were mounted in sections of 3-1/2-in.-dia (8.89 cm-dia) PVC pipe (See Figure 3.1). The front of the sensor was in a small volume of air that would be exposed to the column concrete. The back of the sensor was mounted to a plate to make the data output port accessible by removing the watertight cover.

In this manner, the sensor measures the temperature and humidity of the air enclosed by the PVC pipe. This volume of air is directly exposed to the concrete. As the moisture in the concrete changes, the relative humidity in the enclosed volume of air changes correspondingly with a small time lag. The humidity and temperature data were taken each hour and stored in the sensor's memory. The data were downloaded from the memory once every 1–2 yr by removing the back cover and connecting a computer to the data output port. After the data were downloaded, the sensory memory was cleared and the sensor was programmed to continue acquiring data.

The temperature rising and falling on a daily basis is expected. What requires further explanation is the concomitant rise and fall of the humidity measured by the sensors. As shown in Figure 3.1, the sensors are contained in a volume that is completely sealed, and (after an initial settling time) the only

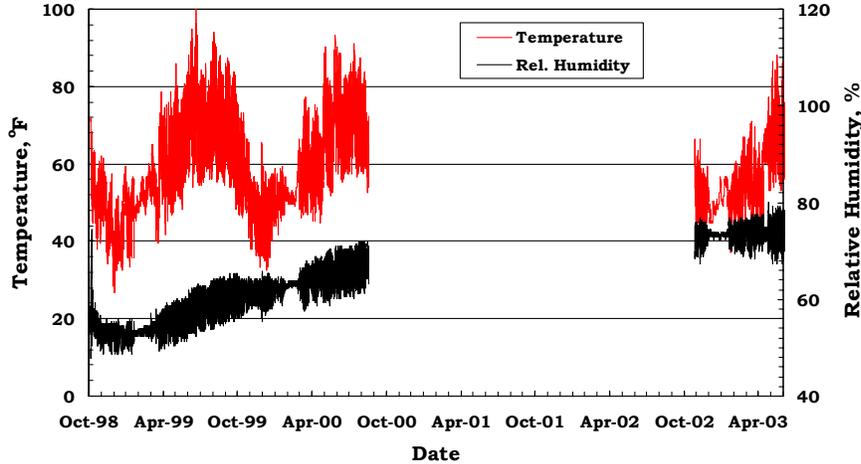
Figure 3.2. Temperature and relative humidity for the casing middle on Bent 178 Column 8.

Plots of temperature and relative humidity as functions of time are shown in Figure 3.2 for the sensor located in the middle of the composite casing on Bent 178 Column 8. The temperature data show the anticipated daily night-to-day variations and were colder in the winter and warmer in the summer. In late winter/early spring, the area is flooded, and the composite casings and sensors are under water. This is evident in both the temperature and the humidity data because the day-to-night variation was much smaller during the period of flooding. The water stayed a relatively constant 51°F, especially in February of 2000 when the water level was higher than in 1999 or 2003.

Data for the first two years from all six sensors were presented in Reference 19 and will not be repeated here. The plots in Figure 3.2 are representative of those for five of the six sensors for which data were obtained. The exception was the sensor located on Bent 178 Column 3, the column that was exposed to direct sunlight during the winter months. The sensor data for Bent 178 Column 3 are plotted in Figure 3.4 along with the data from Figure 3.2 for Bent 178 Column 8. The data clearly show higher daily peak temperatures for the Column 3 sensor due to direct sunlight from October to February for each of the three years. The direct sunlight also affected the relative humidity within the sensor volume. During periods of direct sunlight, the relative humidity increased significantly for Column 3, but showed little change, aside from daily fluctuations, for the shaded Column 8. During

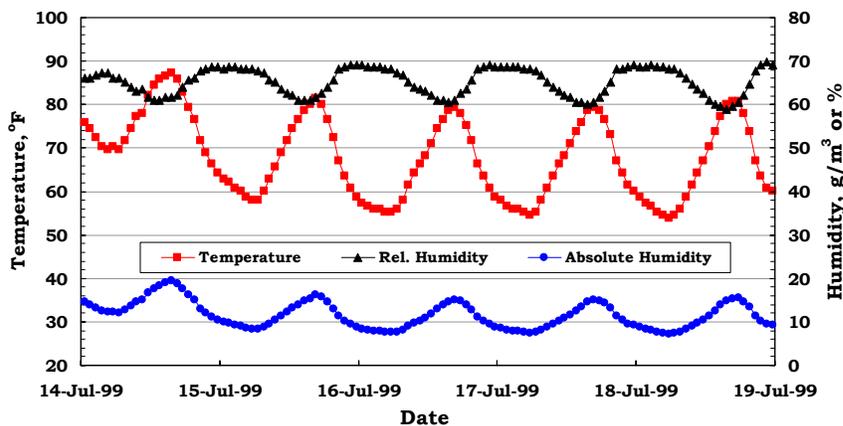
Figure 3.3. Typical temperature and relative humidity data from the casing top on Bent 177 Column 7 during five days in the summer of 1999. The labeled dates indicate midnight at the beginning of each day.

To answer this issue it is enlightening to look more closely at the humidity data. Temperature and humidity data taken over a five-day period in the summer of 1999 are shown in Figure 3.3. The graph shows both the absolute humidity in  $\text{g}/\text{m}^3$  and the relative humidity in %. It is apparent that the absolute humidity is in phase with the temperature, while the relative humidity is out of phase with the temperature. The relative humidity is falling when the temperature is rising. To make sure these data are consistent, all of the sensors were studied at different dates, and they all showed the same effect throughout the data acquisition period.

the concrete, then the absolute humidity, which is a direct measure of the moisture content, would be fixed. But the relative humidity, which is the ratio of the absolute humidity to the saturation moisture content at the air temperature, would still change with temperature. Since warm air holds more moisture than cold air, when the amount of moisture is fixed, the relative humidity decreases as the temperature increases.

Even though the absolute humidity in the sensor volume increased with temperature, the relative humidity decreased. This indicates that the magnitude of the moisture concentration increase for a given temperature change was less than the amount that the saturation concentration increases for that temperature change.

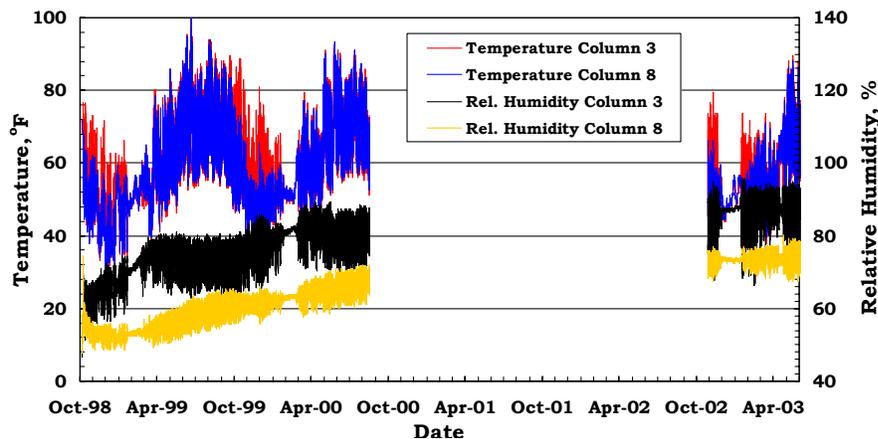
Figure 3.4. Temperature and relative humidity data from the casing middle on Bent 178 Column 3 and Column 8.

the summer months, the relative humidity remained relatively constant for the sensor on Column 3, but increased for the sensors on the other columns.

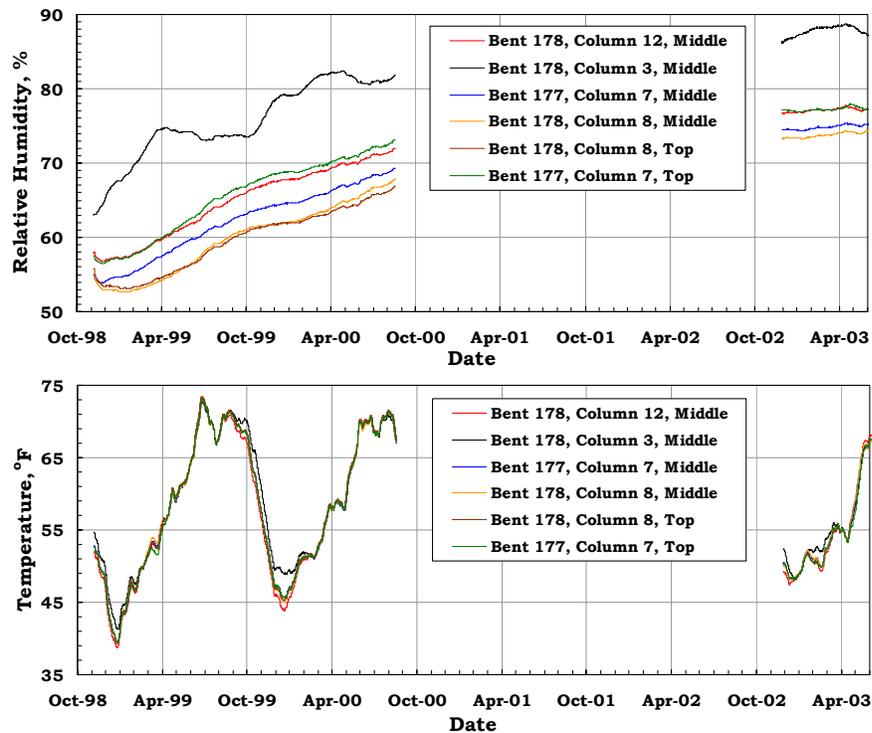
Figure 3.5. 31-day running average relative humidity and temperature for all six sensors.

To ascertain the long-term effects of the concrete moisture on the sensor volume (i.e., on the bond line environment), we need to integrate the data over a specific time period to average out the daily variations. Any integration period that averages out the daily fluctuations while maintaining seasonal variations can be used. Running averages of 24 h and 31 days were performed on the temperature and relative humidity data over the entire data acquisition period. Although the 24 h running average smoothed the humidity data, the temperature data were still very rough due to large day-to-day variations. It was concluded that the 31-day running average was useful for smoothing the data while maintaining seasonal variations and any differences between the different sensors. The results are shown in Figure 3.5 for all six sensors.

Several observations were made from the averaged data. The first observation is that the relative humidity decreased for the first four to six weeks after the sensors were installed on the columns that were shaded from direct sunlight. After this initial dry-out period, the humidity monotonically increased for the remainder of the measurement period. The initial dry-out period was probably due to the materials attempting to come into equilibrium with each other. The sensor assembly, the composite casing, and the adhesive used to bond the composite shells together had all been recently applied to the concrete. The data suggests that these materials absorbed moisture from the concrete during this time period. When compared to moisture uptake tests performed in the laboratory, it is not unusual for a composite system to require several weeks to come into equilibrium with its surroundings. The sensor on Bent 178 Column 3, which was exposed to winter sunlight, had a higher

initial relative humidity and did not show the initial dry-out period. The higher daytime temperatures allowed more rapid moisture diffusion into the composite casing and adhesive on this column. Apparently, the composite and adhesive had already absorbed sufficient moisture to complete the dry-out period before the sensor was installed.
