# The Application of Qualification Testing, Field Testing, and Accelerated Testing for Estimating Long-Term Durability of Composite Materials for Caltrans Applications

25 February 2005

G. L. STECKEL and G. F. HAWKINS  
Space Materials Laboratory  
Laboratory Operations

STATE OF CALIFORNIA  
DEPARTMENT OF TRANSPORTATION  
Sacramento, CA 94273

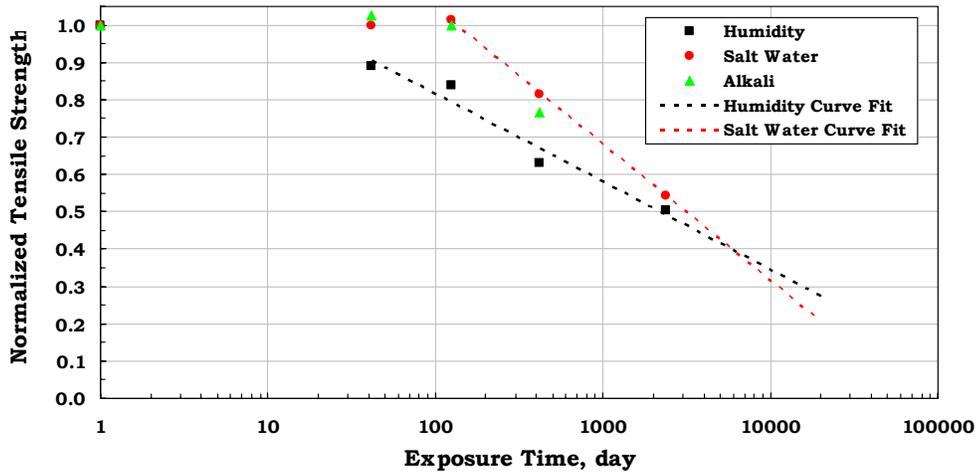
Figure 4.1. Retained tensile strength versus Log of exposure time in 100% humidity or salt water for SEH 51/Tyfo<sup>®</sup> S.

Figure 4.1 shows that the tensile strength versus Log exposure time plots were linear for the salt water and humidity exposures for the SEH 51/Tyfo<sup>®</sup> S system. The 100% humidity at 38°C (100°F) exposure caused significant strength reductions after only 41.7 days, while the salt water and alkali exposures at 23°C (72°F) did not cause any reduction until >125 days. However, once the degradation

initiated in salt water, it proceeded rapidly so that the strength reduction was approximately 50% of the control strength following the 2,363-day exposure in either the humidity chamber or salt water.

Least-squares analyses of the humidity and salt water exposure data were performed to generate the curve fit lines included in Figures 4.1–4.3. Least-squares curve fit parameters for the equation  $NTS = A + B\{\text{Log}(t)\}$ , where NTS is the normalized tensile strength,  $t$  is the exposure time in days, and  $A$  and  $B$  are the curve fit parameters, can be used to make long-term strength predictions. The curve fit parameters are presented in Table 4.4 along with normalized strength predictions for 30-yr and 50-yr service lives. For the SEH 51/Tyfo<sup>®</sup> S system the retained strength is 30–35% of the original strength after 30 yr and 20–30% after 50 yr. The slope of the curves is much lower for the E-glass/vinyl ester and E-glass/polyester composites so that these systems have predicted strengths after 50 yr that are similar to those after 30 yr. After 30 or 50 yr, the retained strength is approximately 65% of the original strength for the E-glass/vinyl ester system and approximately 70% for the E-glass/polyester system.

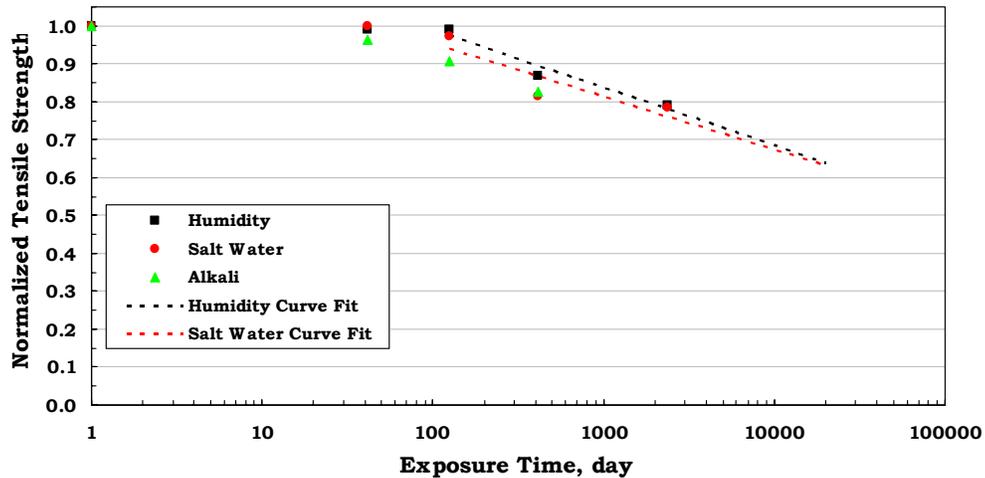
Figure 4.2. Retained tensile strength versus Log of exposure time in 100% humidity or salt water for E-glass/vinyl ester.

Vinyl ester and polyester matrices absorb much less water than the Tyfo<sup>®</sup> S epoxy matrix, which greatly enhances the resistance of E-glass/vinyl ester and E-glass/polyester composites to strength reductions in moist environments. Neither of these systems had strength reductions >10% for exposure times <417 days. Furthermore, strength reductions in the 100% humidity at 38°C (100°F) environment were no greater than those in the salt water or alkali solutions at 23°C (72°F). The retained strength was >75% for both of these systems after 2,363 days in either environment. It should be noted that for the E-glass/polyester system the average tensile strength after 125 days in the humidity chamber and after 41.7 days in the salt water bath were over 10% higher than the average for the control samples. For this system, the tensile strength was normalized to these higher strength values for the plots in Figure 4.3.

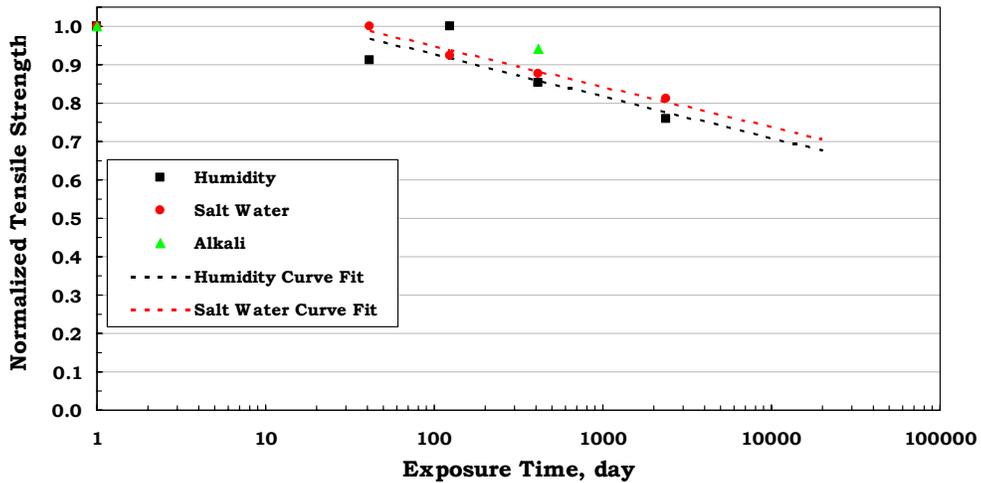
Figure 4.3. Retained tensile strength versus Log of exposure time in 100% humidity or salt water for E-glass/polyester.

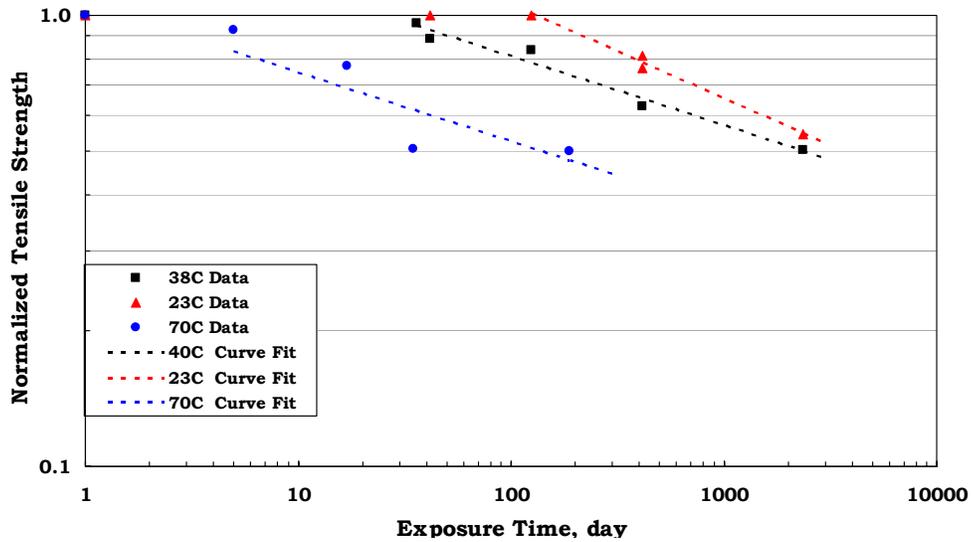
Figure 4.4. Retained tensile strength as a function of exposure time at 23, 38, and 70°C for SEH 51/Tyfo<sup>®</sup> S.

The accelerated data were combined with the data from the qualification testing for the humidity, salt water, and alkali solution exposures to develop Arrhenius expressions for relating residual strength to exposure time and temperature in moist environments. Analysis procedures published by Litherland, et al.<sup>10</sup> were followed. The first step in the analysis was to make Log-Log plots of the normalized tensile strength versus exposure time for each exposure temperature, i.e., 23°C (72°F) for salt water and alkali solutions, 38°C (100°F) for the humidity chamber, and 70°C (158°F) for deionized water. These plots are shown in Figure 4.4. The next step was to perform least-squares analyses of the data at each temperature as shown in the figure. These expressions were used to calculate the exposure time required to degrade the strength to several specific levels, NTS = 0.85, 0.70, 0.55, 0.40, 0.32, and 0.25, at each of the three temperatures. Log exposure time was then plotted as a function of 1/T for each strength level in Figure 4.5, where T is the absolute temperature. Finally, a least-squares analysis was performed on the calculated data points in Figure 4.5 to establish a relationship between Log exposure time and 1/T for each NTS level. The six linear curves in Figure 4.5 can be used to estimate the remaining tensile strength at the end of life for a given service temperature in a moist environment.

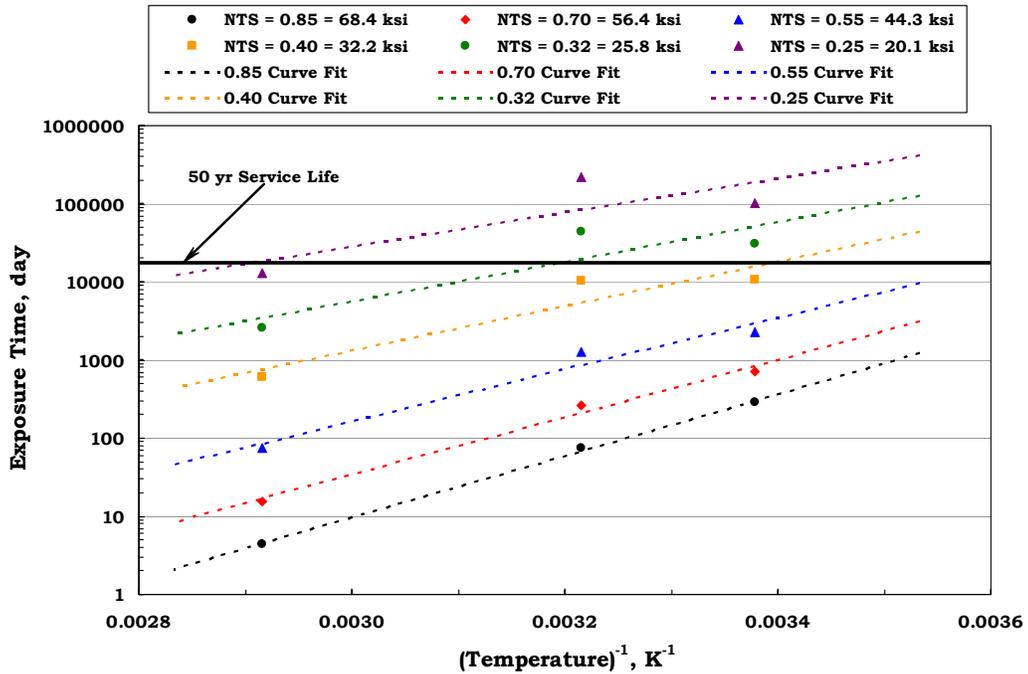
Figure 4.5. Predicted retained tensile strength as a function of exposure time and temperature for SEH 51/Tyfo<sup>®</sup> S.

A line was drawn across Figure 4.5 at a service life of 50 yr. The estimated tensile strength after 50 yr is approximately 40% of the initial strength at 23°C (72°F) and approximately 32% at 38°C (100°F). These values are higher, particularly at 23°C (72°F), than the respective values of 22% and 28% calculated using the more simplistic approach presented in Figure 4.1. The curves in Figure 4.5 probably give better estimates because of the more rigorous approach, which better utilizes all of the available data.
