The Corrosion of Corrugated Metal Culverts in California

Beaton, J.L and R.F. Stratfull

State of California
Department of Public Works
Division of Highways

A paper to be presented at the Annual Meeting of the Highway Research Board January 5-9, 1959.

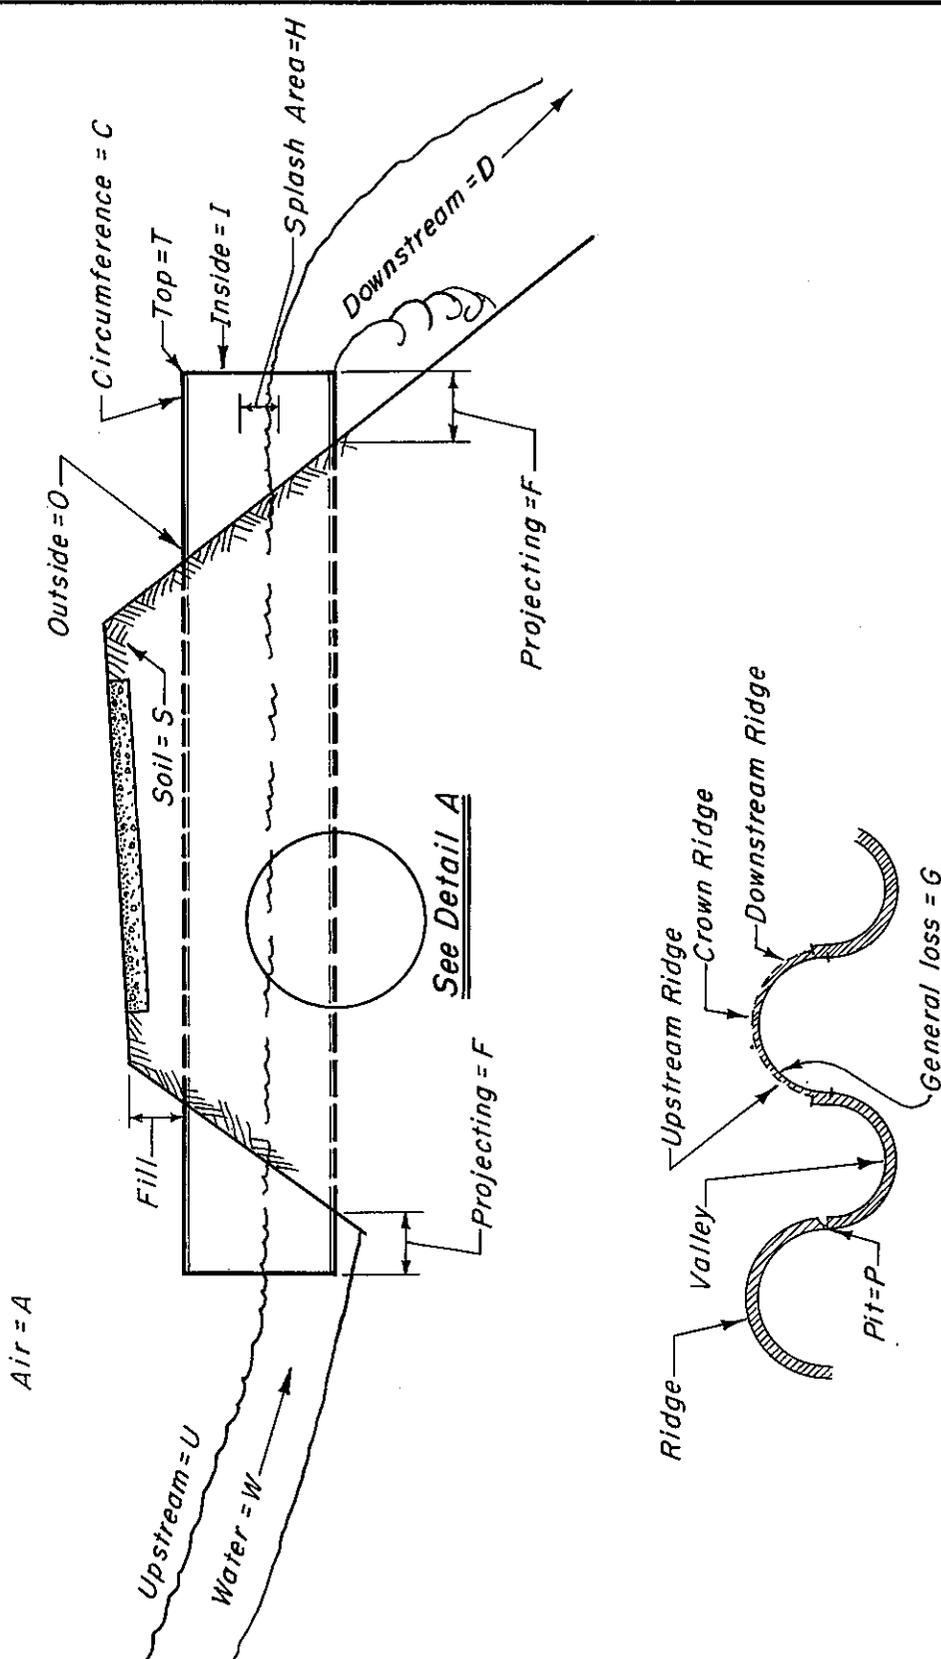
Detail A

CULVERT INSPECTION TERMINOLOGY

Schematic drawing of section through pipe corrugations.
