Report on Wrong-Way Automatic Sign, Light and Horn Device

June 1965

T. Tamburri

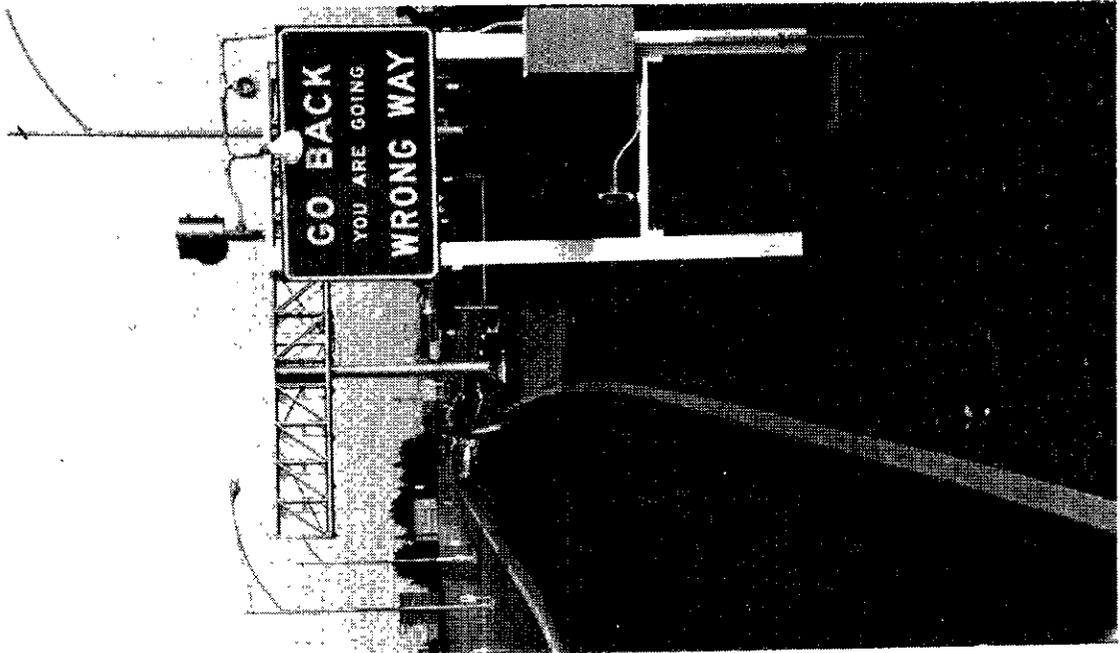
Figure 1

The warning device (Figure 1) consisted of a 5' x 3' white on red reflective background sign. The message was "GO BACK-YOU ARE GOING-WRONG WAY". Visual impact was increased by illuminating the sign only when actuated by a wrong-way vehicle. A standard 12" red signal head was placed below the sign 5' above ground level. The light was operated in the steady mode. Audio warning was accomplished by two electric horns, one continuous and the other pulsating.

All these components were actuated by a vehicle moving opposite to the normal off-ramp flow by using an inductive loop directional detector. A counter was installed

The warning device (Figure 1) consisted of a 5' x 3' white on red reflective background sign. The message was "GO BACK-YOU ARE GOING-WRONG WAY". Visual impact was increasing by illuminating the sign only when actuated by a wrong-way vehicle. A standard 12" red signal head was placed below the sign 5' above ground level. The light was operated in the steady mode. Audio warning was accomplished by two electric horns, one continuous and the other pulsating.

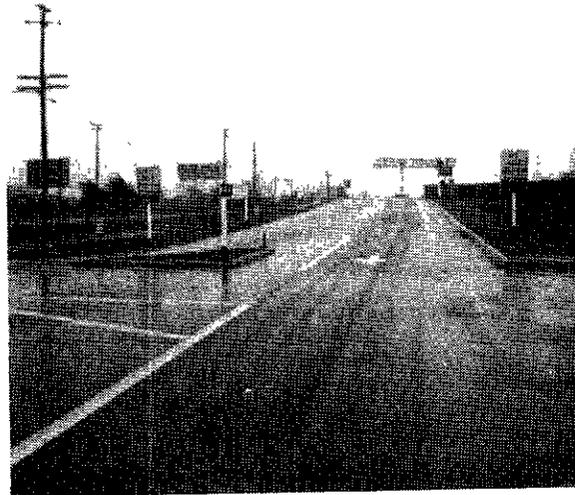
Figure 8
Off-ramp terminus after sign changes.

| <u>Sign Code</u> | <u>Sign Message</u> | <u>Remarks</u> |
|---|---|---|
| 5. R11R | DO NOT ENTER | Replaced white on black with black on white (Added additional sign.) (Figures 7 & 8) |

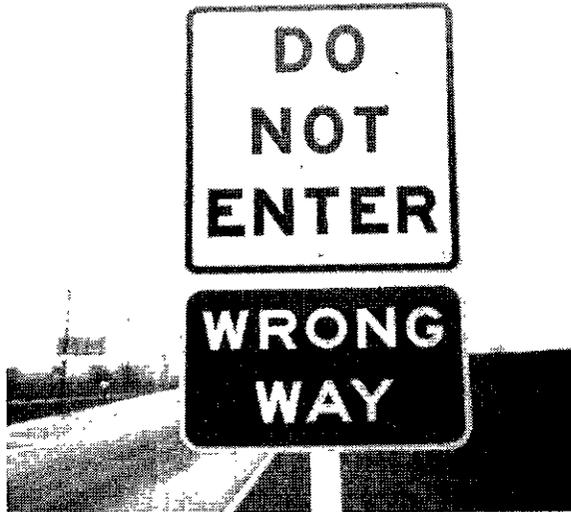
Figure 9

Close up of new R11R
augmented with red
background "WRONG WAY".

| <u>Sign Code</u> | <u>Sign Message</u> | <u>Remarks</u> |
|---|---|---|
| 6. R65R | WRONG WAY | New Signs added to R11R's (Figure 9) |
