# **STATIC AND DYNAMIC PERFORMANCE OF RC BRIDGE BENTS WITH ARCHITECTURAL-FLARED COLUMNS**

REPORT No. CCEER-03-08

A Report for the  
California Department of Transportation  
Sacramento, California  
under contract 59A0069

March 2004

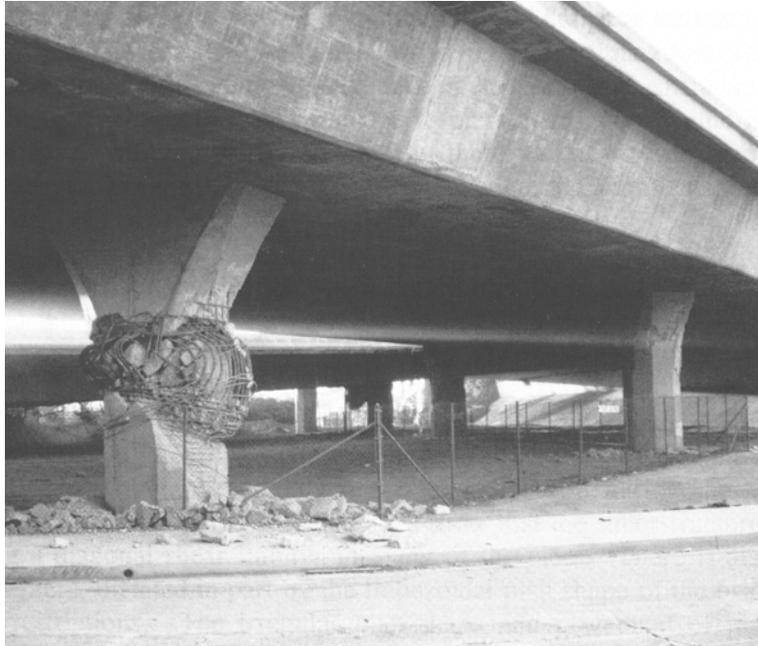
**Figure 1.1 Damage to columns of the SR 118 Mission-Gothic Undercrossing Los Angeles County (1994 Northridge Earthquake- Caltrans Report)**

The state of California has a large number of highways bridges; many of them have flared columns because they are aesthetically pleasing. During the 1994 Northridge Earthquake, it was observed that these columns can perform poorly (Fig. 1.1).

The bridge shown in Figs. 1.1 and 1.2 was designed in 1972, after the San Fernando Earthquake. It had seismic detailing including closely spaced spiral hoops. The columns were approximately 7200 mm (24 ft) tall and 1800 mm (6 ft) wide with an aspect ratio of 4:1. Columns had approximately 3600 mm (12 ft) tall flares at the top. The flares were designed as a non-structural member and were intended to spall off during an earthquake. The plastic hinge was intended to form at the top of the column after spalling of the flare. During the 1994 earthquake, instead of the plastic hinges forming at the top they shifted to the base of the flares. Due to lowering of plastic hinge, the column behaved like a much shorter column, resulting in an increased shear demand. This behavior was not included in the design and led to brittle shear column failures. The flares had minimum longitudinal reinforcement and minimum transverse reinforcement but did not fail during the earthquake. Studies after the earthquake showed that these flares essentially behave as structural flares under both static and dynamic loading<sup>2, 16</sup>.

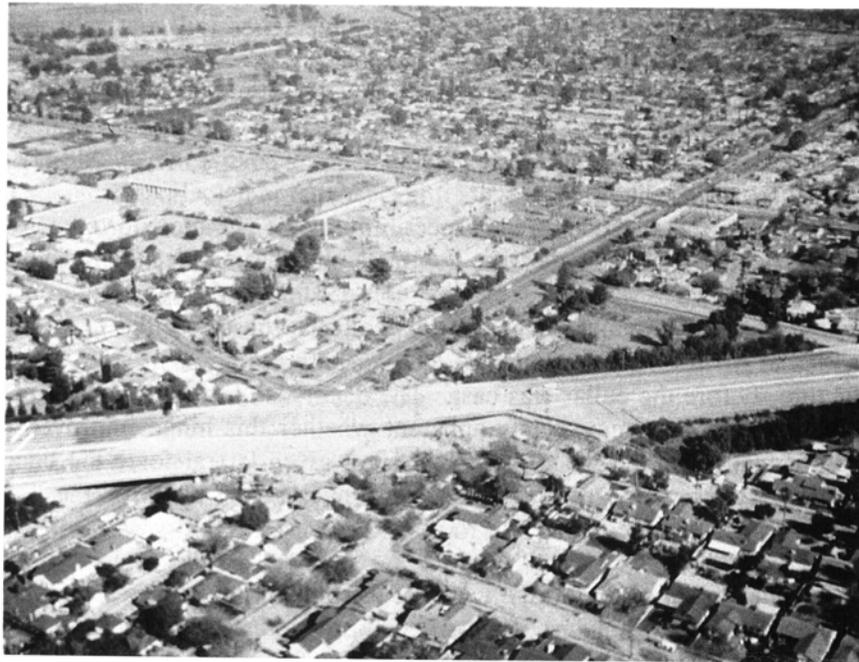
**Figure 1.2 Aerial View of the SR 118 Mission-Gothic Undercrossing Los Angeles County Showing Collapsed Eastbound Bridge (1994 Northridge Earthquake Caltrans Report)**

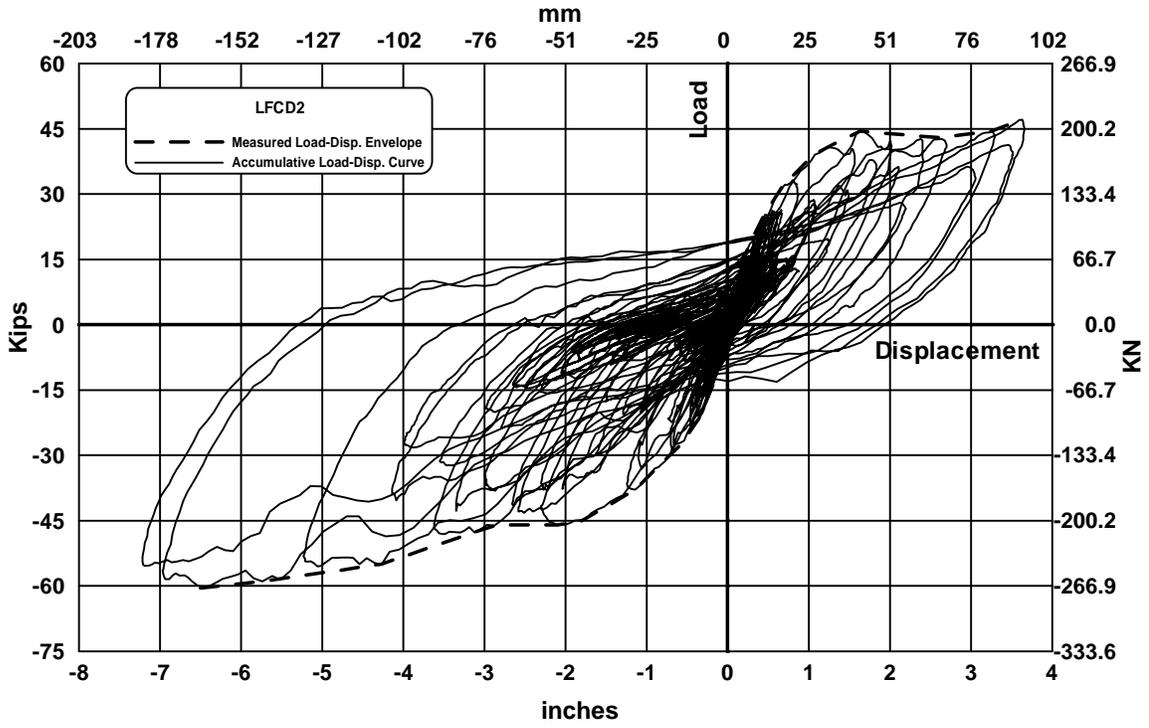
**Figure 1.5 Load-Displacement Relationship for LFCD2**

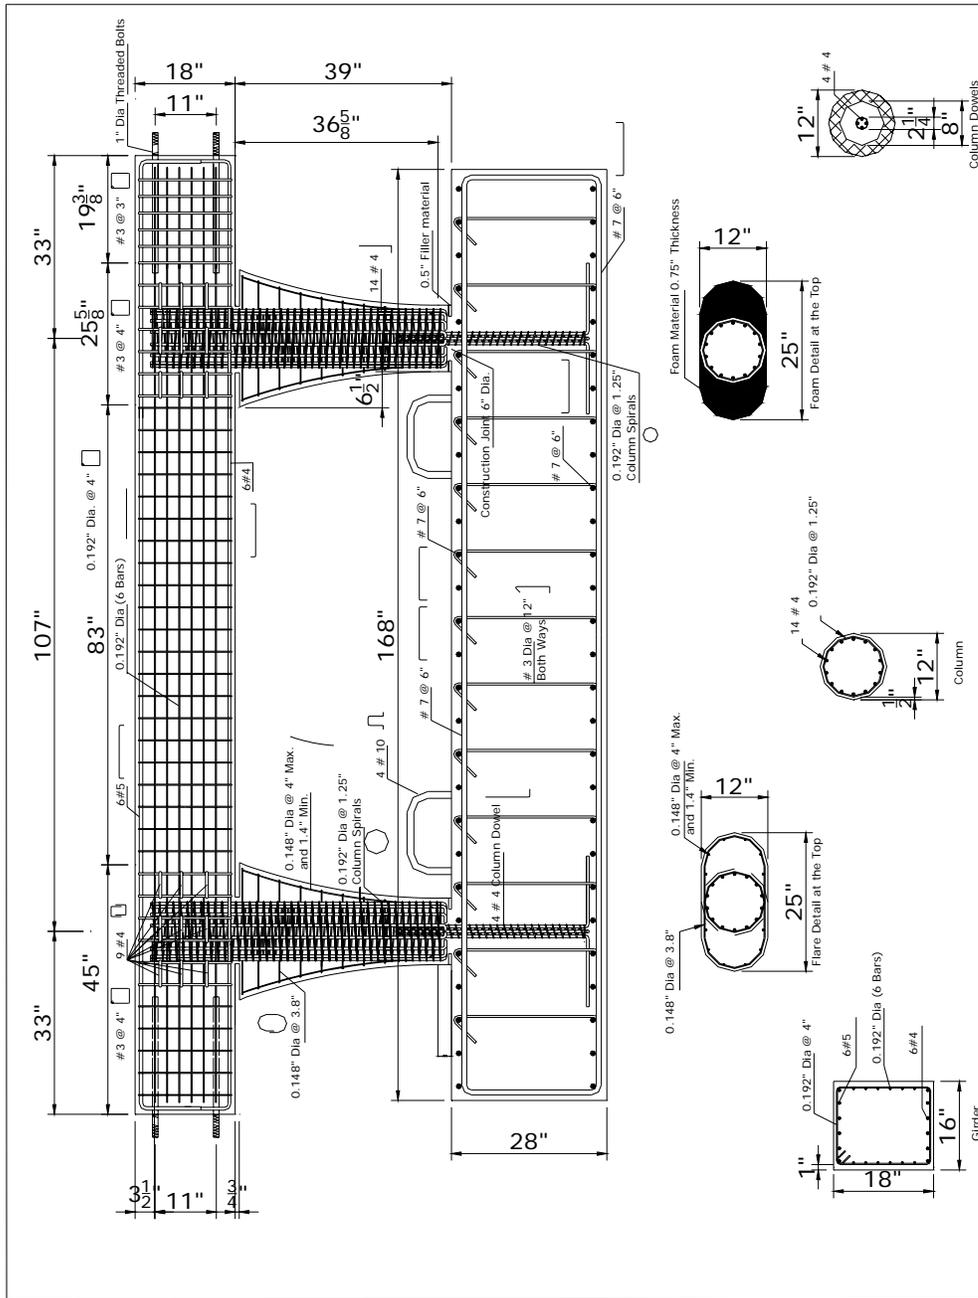
Figure 2.1a Reinforcement Details of SFCD3 (English Units)

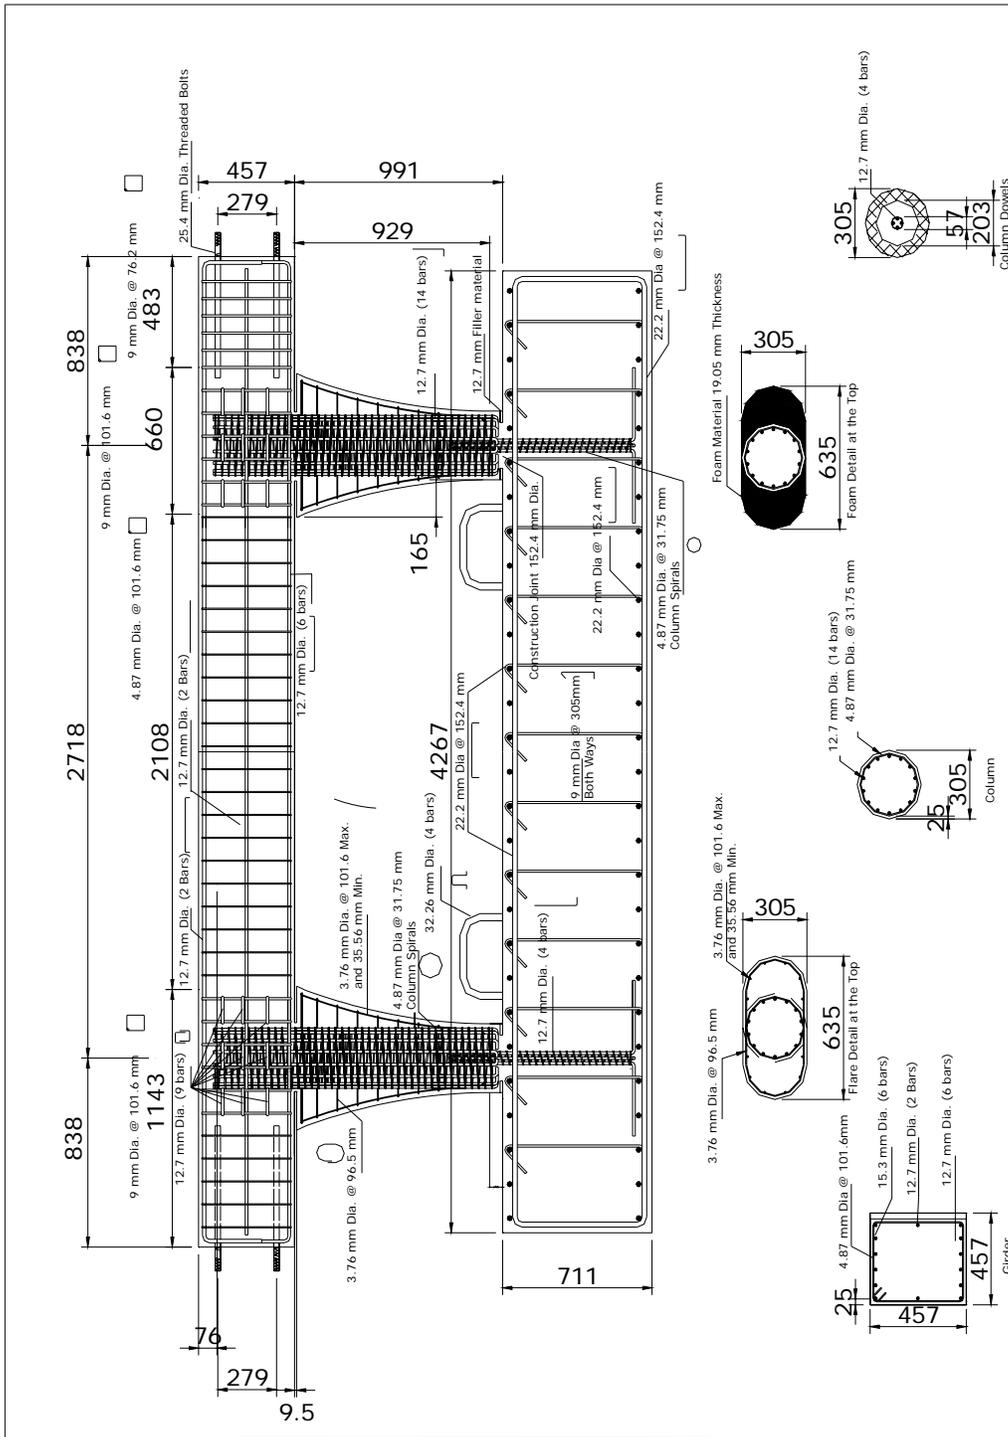
Figure 2.2b Reinforcement Details of SFCD2S (Metric Units)

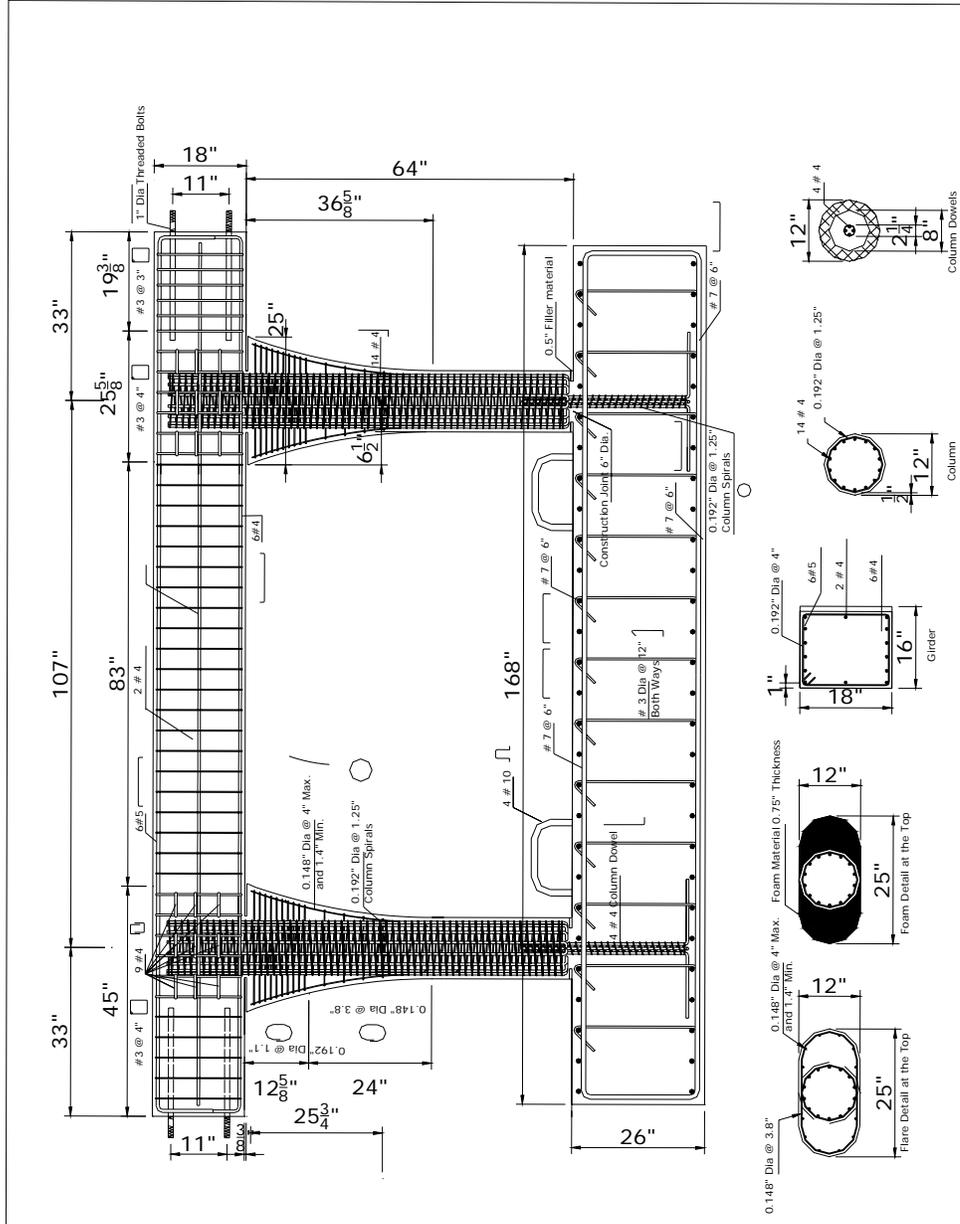
Figure 2.3a Reinforcement Details of LFCDIS (English Units)

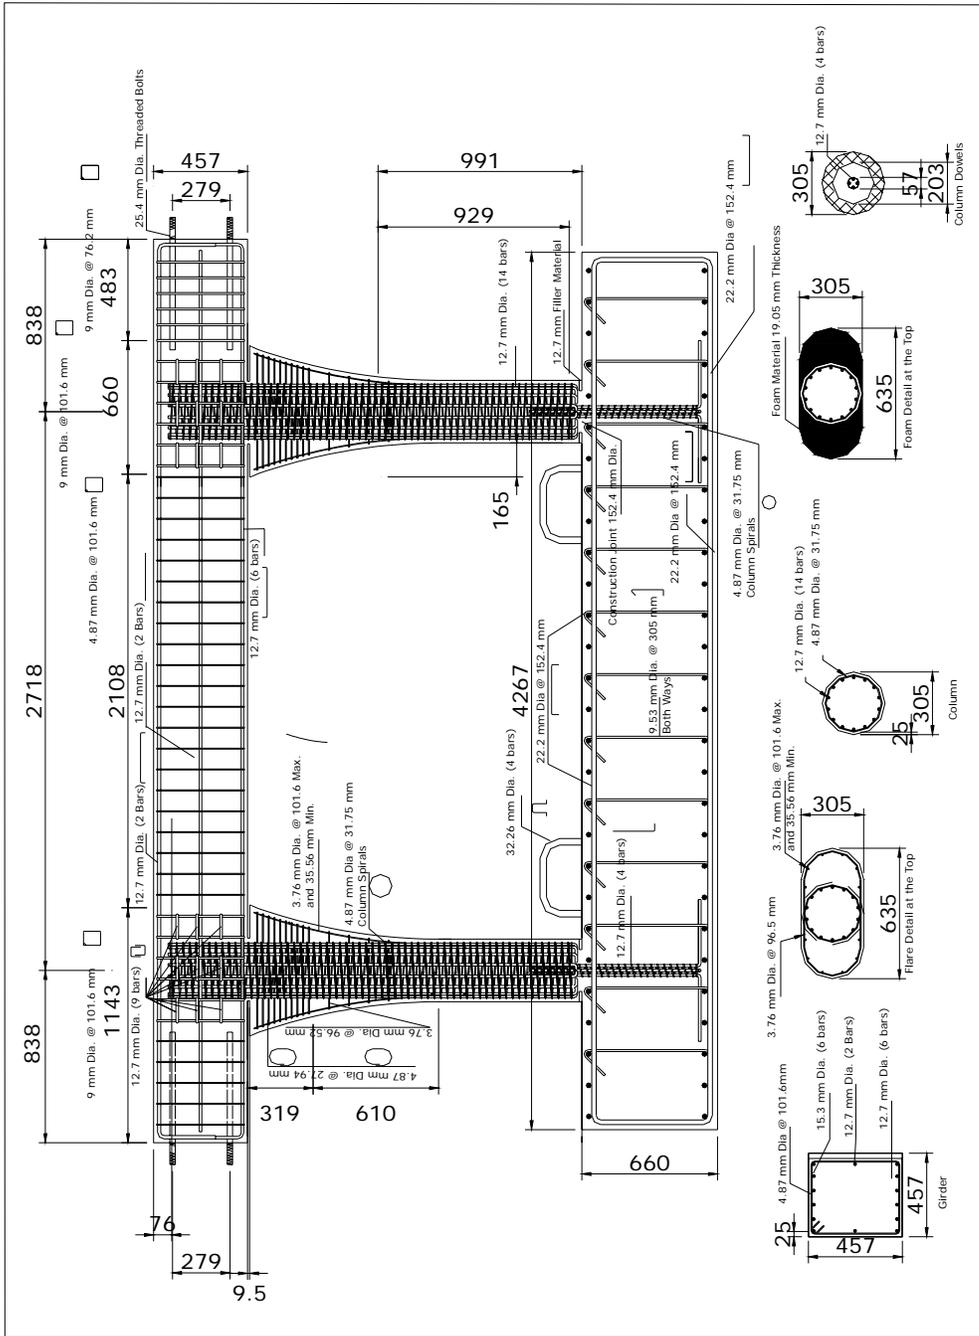
**Figure 2.3b Reinforcement Details of LFCDIS (Metric Units)**

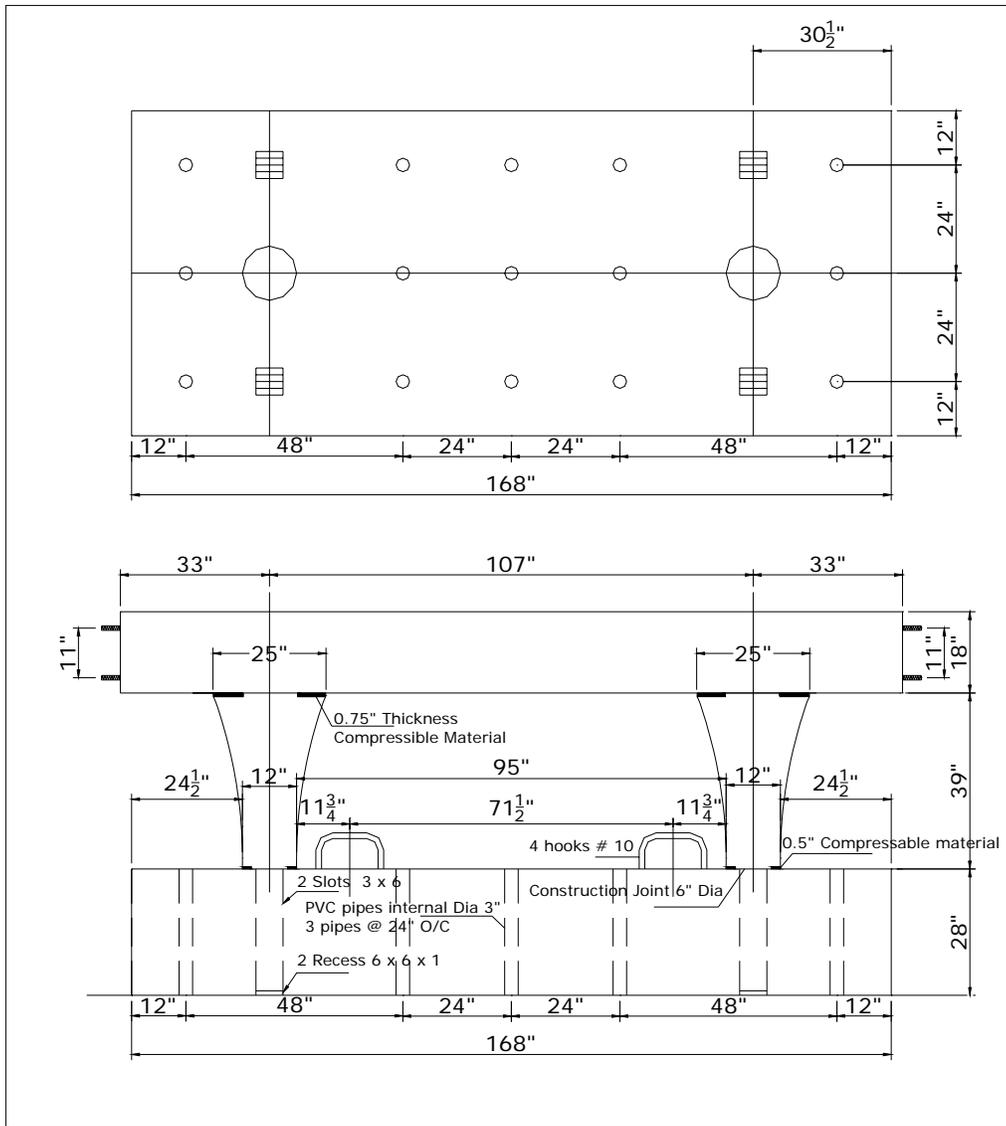
**Figure 2.4a Footing Details (English Units)**

The behavior of the bent along with bottom hinge was the focus of the study. Therefore, the footing was over-designed to avoid damage and to remain rigid. The footing dimensions were 4267 mm (168.0 in) long by 1829 mm (72.0 in) wide by 711 mm (28.0 in) high (Fig. 2.1). Mats of reinforcement on the top and bottom consisted of 22.2 mm diameter (# 7) bars at 152 mm (6.0 in) on center. Vertical 9.5-mm diameter (#3) bars were placed at every alternate joint of longitudinal reinforcement as shear reinforcement. For fixing the specimen to the table, 15 prestressing bars were used. The bars were passed through 76-mm (3.0 in) diameter vertical holes in the footing aligned with the threaded anchor holes of the table (Fig. 2.4).

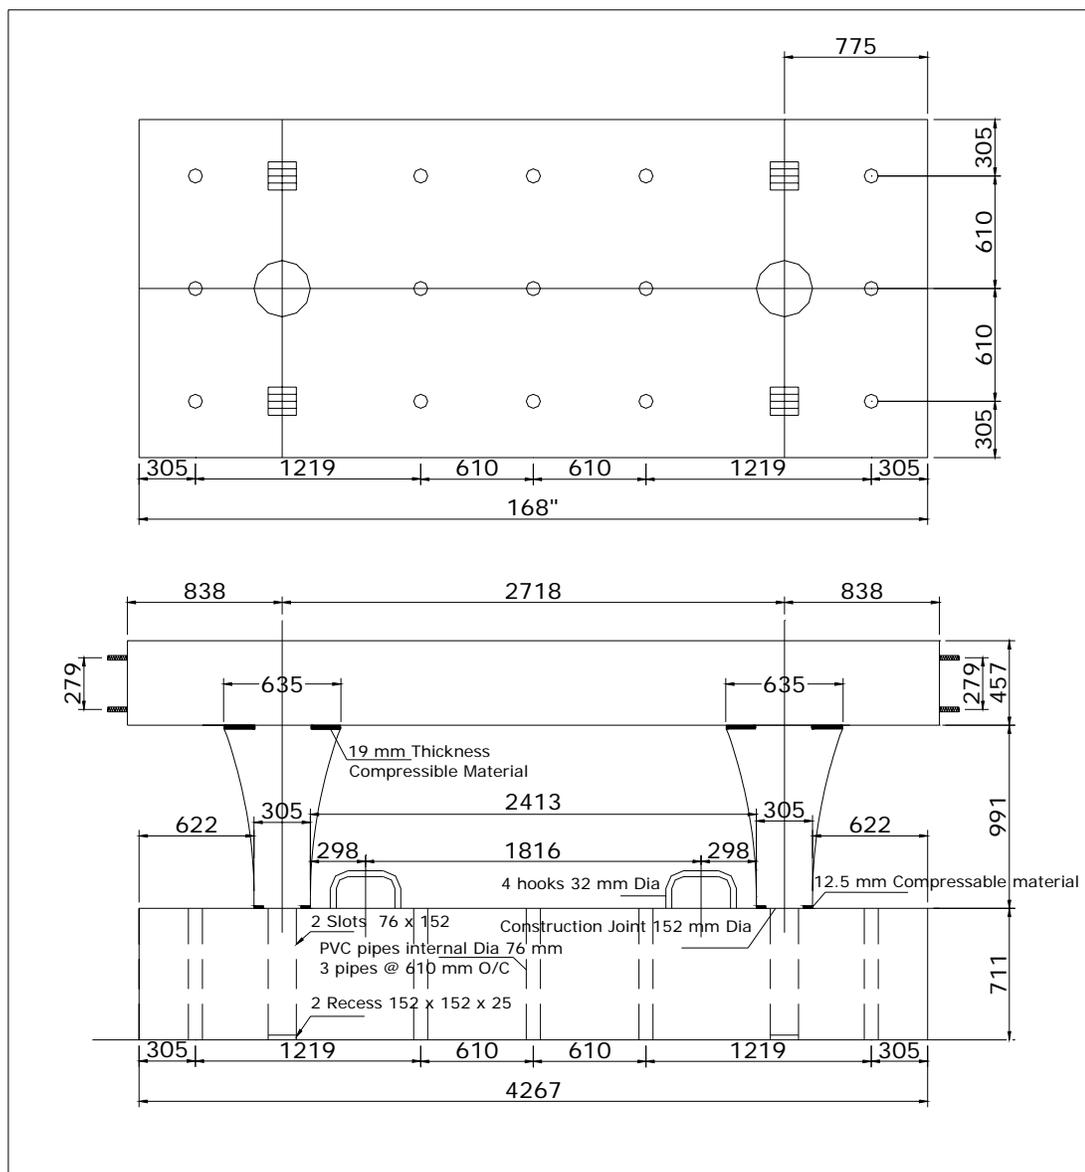
**Figure 2.4b Footing Details (Metric Units)**

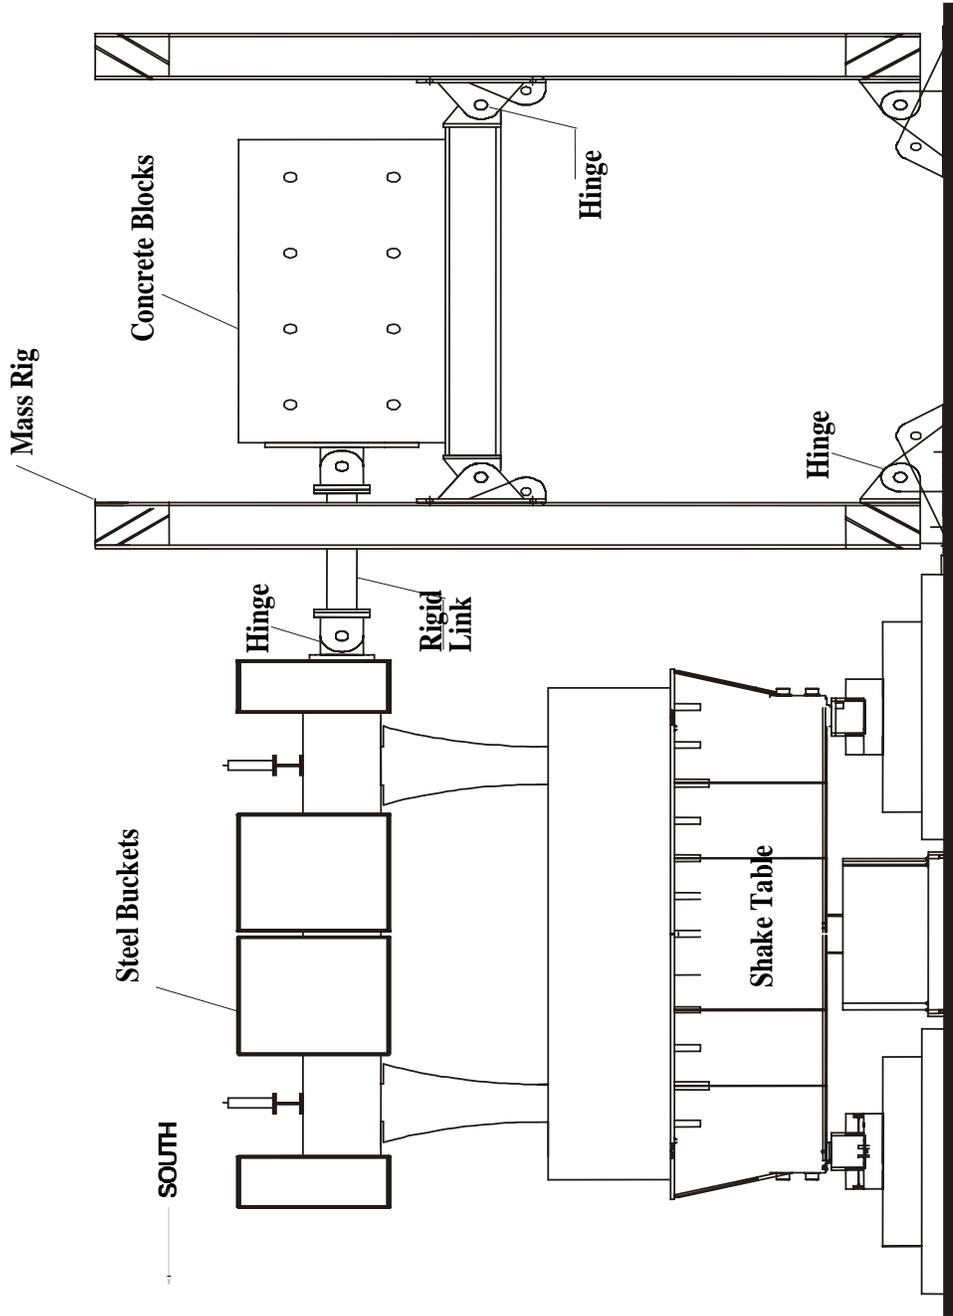
Figure 2.8 Test Setup for SFCD3

holes provided in the footing. Lead was used to provide the majority of the axial and inertia load. The lead was placed inside the steel buckets (Fig. 2.8). A total 12 buckets were used. The total mass of these buckets was 222 KN (50 Kips). The total axial load was 400 KN (90 Kips) and caused an axial force in the columns equal to  $0.1 f'c A_g$ . Part of the axial load was applied through the vertical rams. Rams were connected to a spreader beam mounted on the top of beam over the beam-column-joint. The total axial load applied through these rams was 178 KN (40 kips). An accumulator was used in the hydraulic line to minimize fluctuation of axial load.

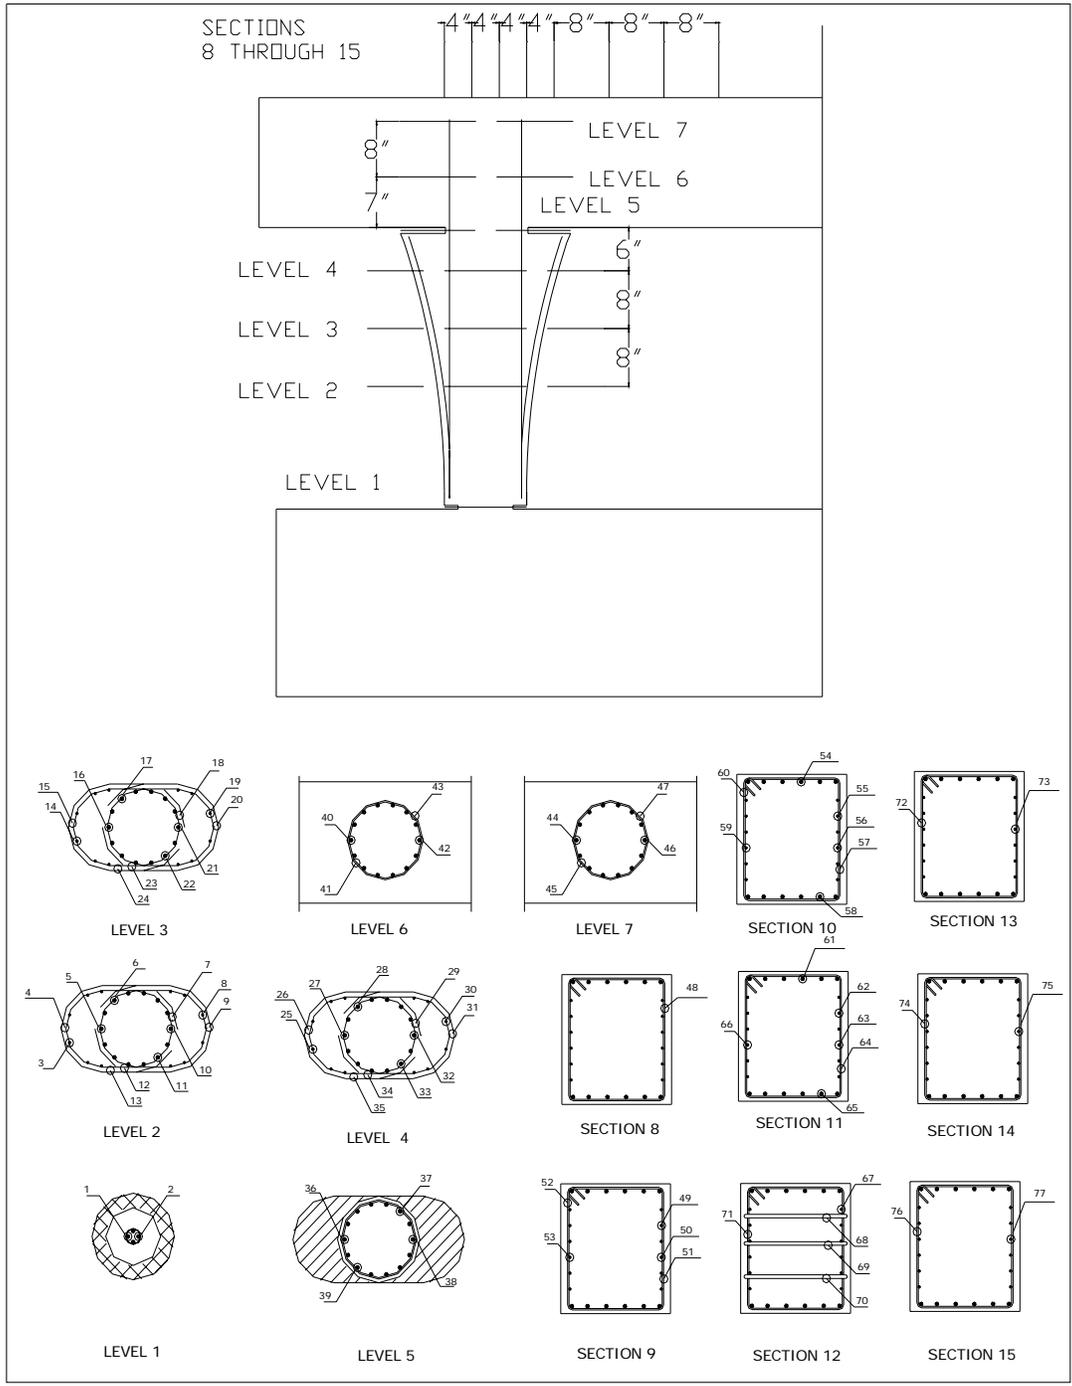
Figure 2.13a Strain Gages for SFCD3 (English)

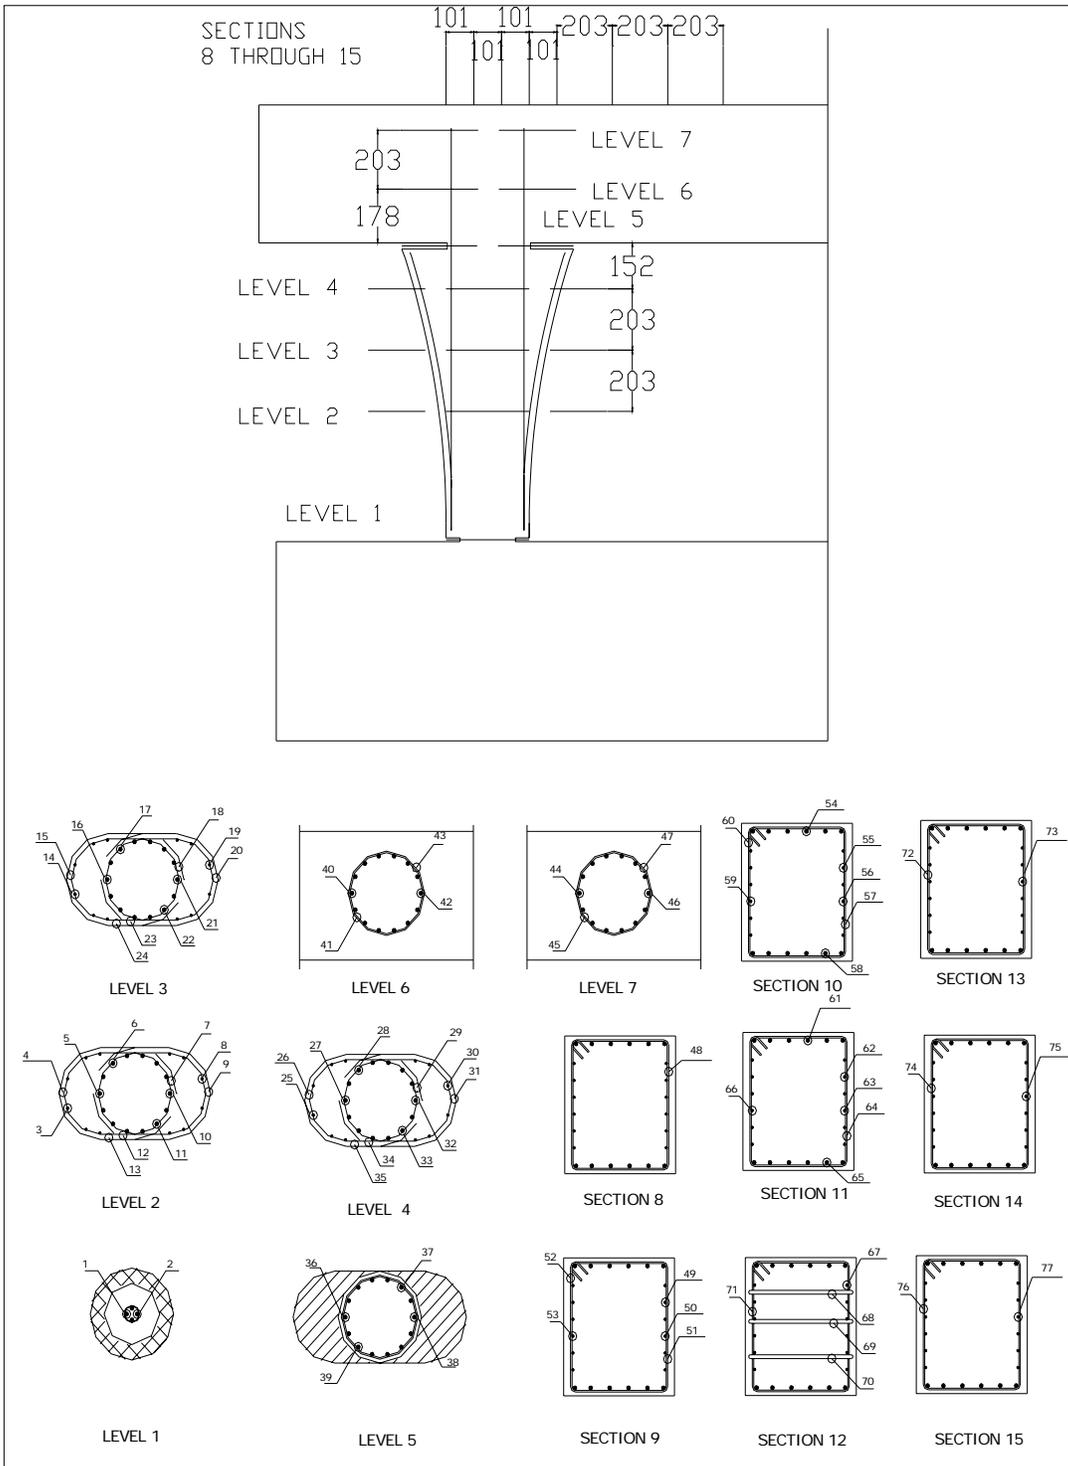
**Figure 2.13b Strain Gages for SFCD3 (Metric)**

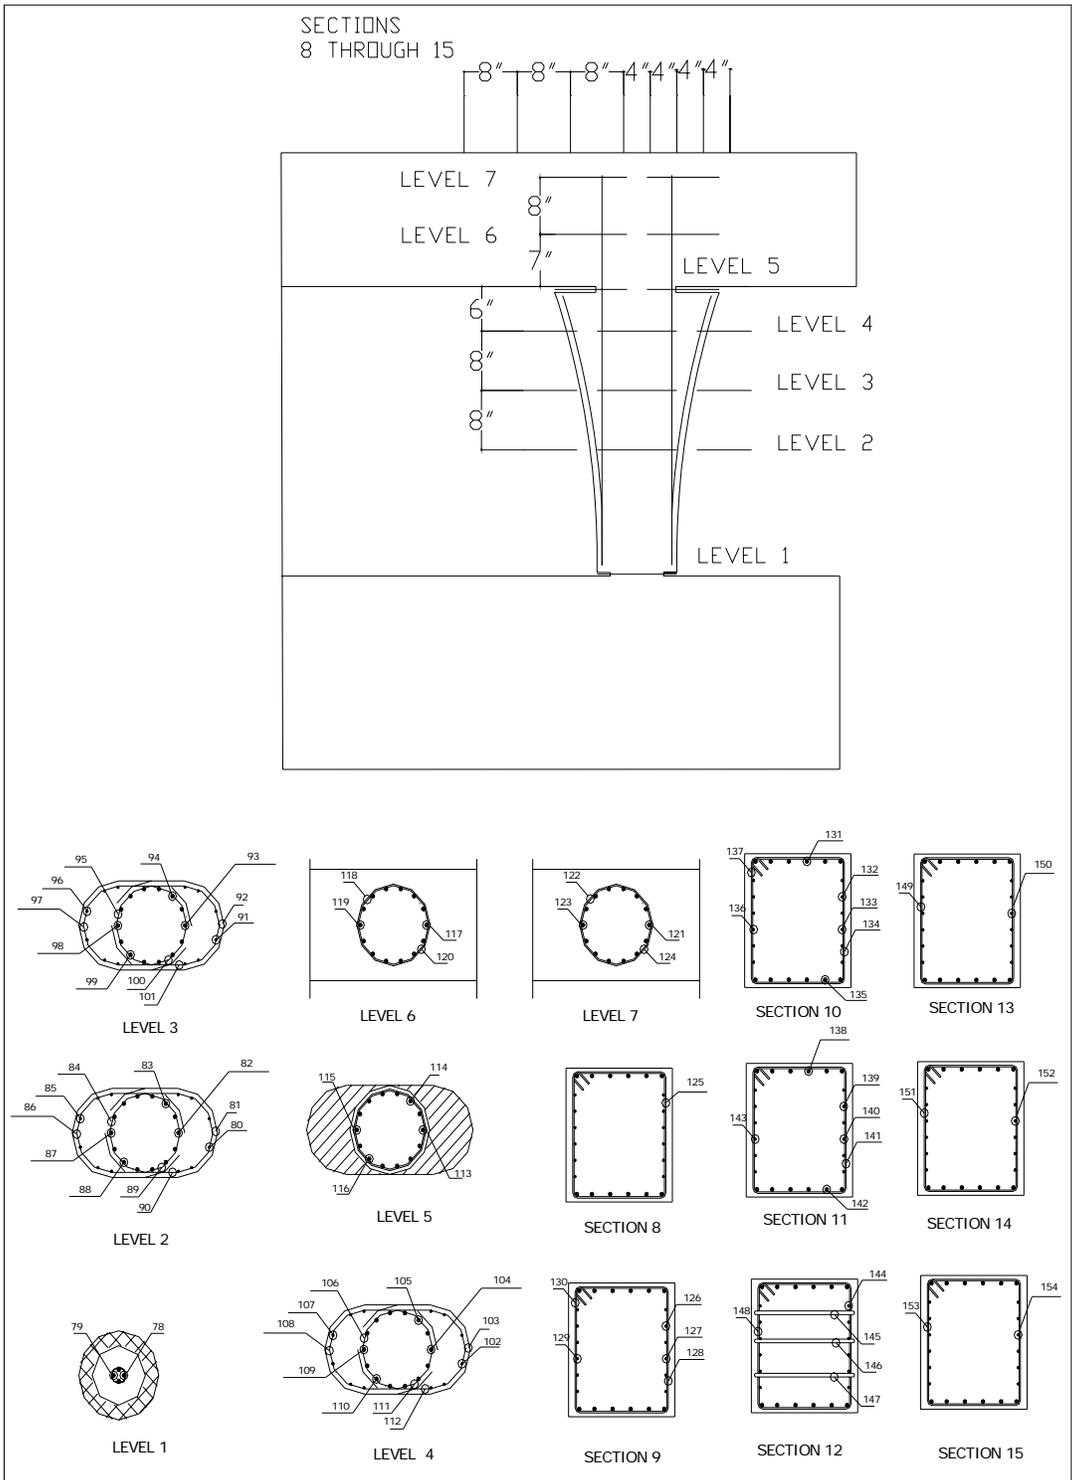
**Figure 2.13c Strain Gages for SFCD3 (English)**

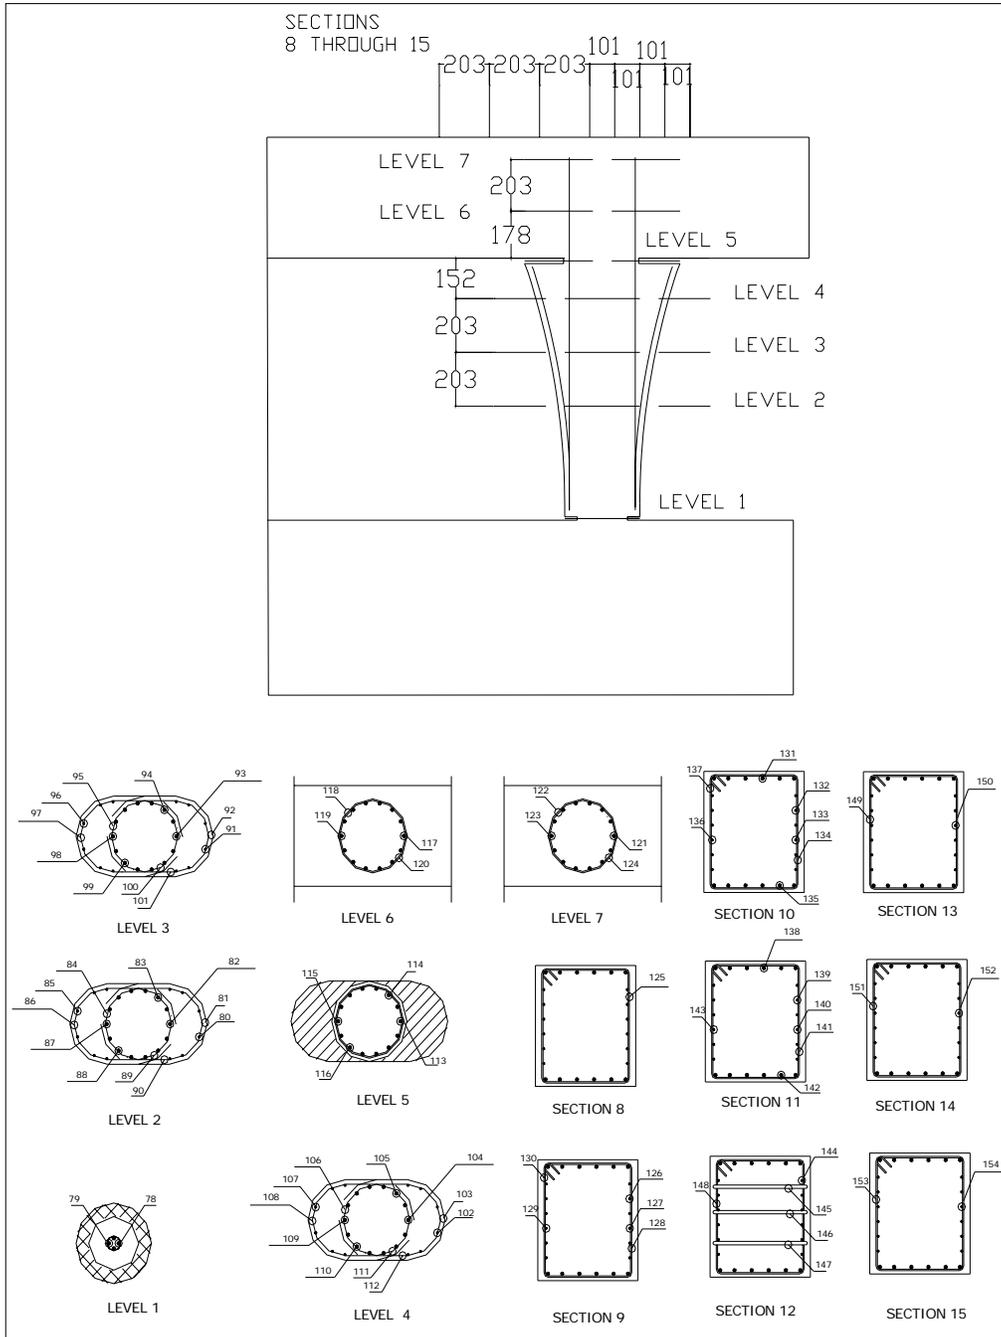
**Figure 2.13d Strain Gages for SFCD3 (Metric)**

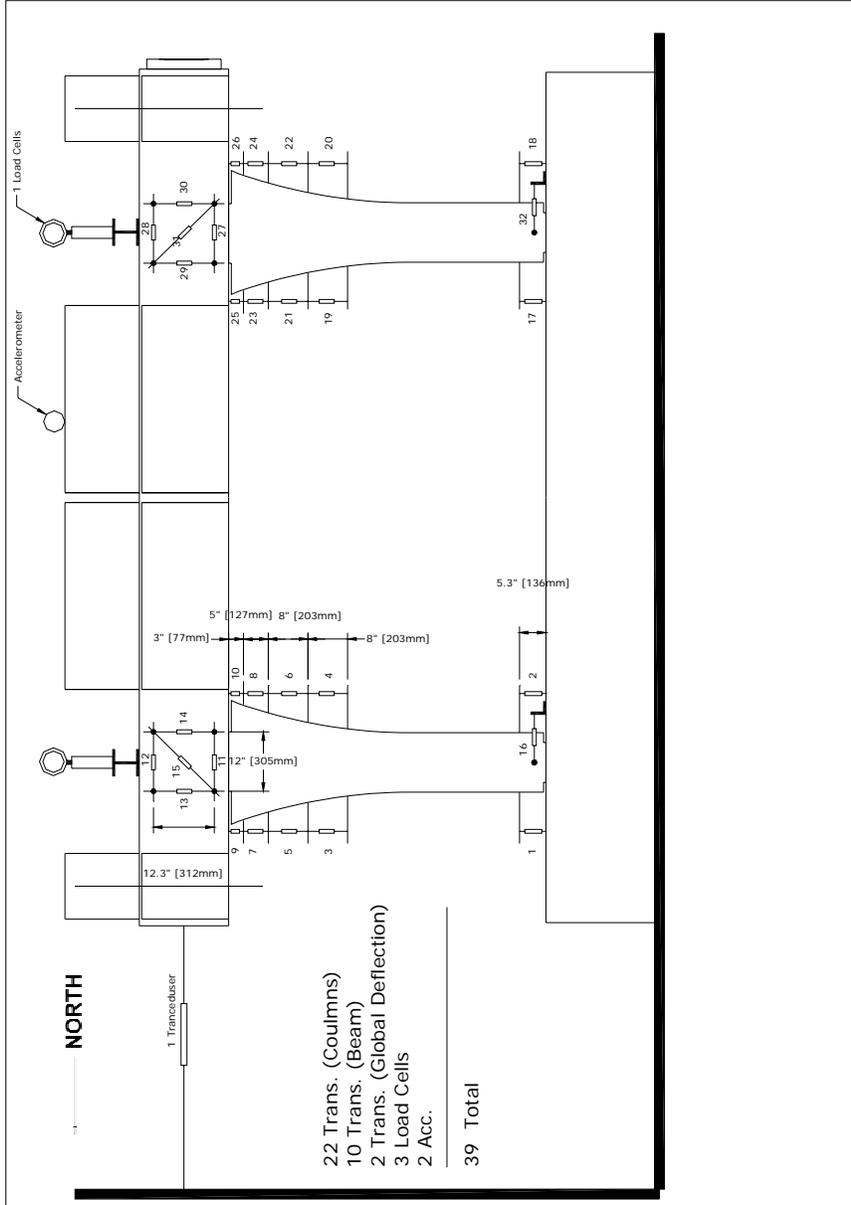
**Figure 2.15 Displacement Transducer for LFCDIS and SFCD2S**

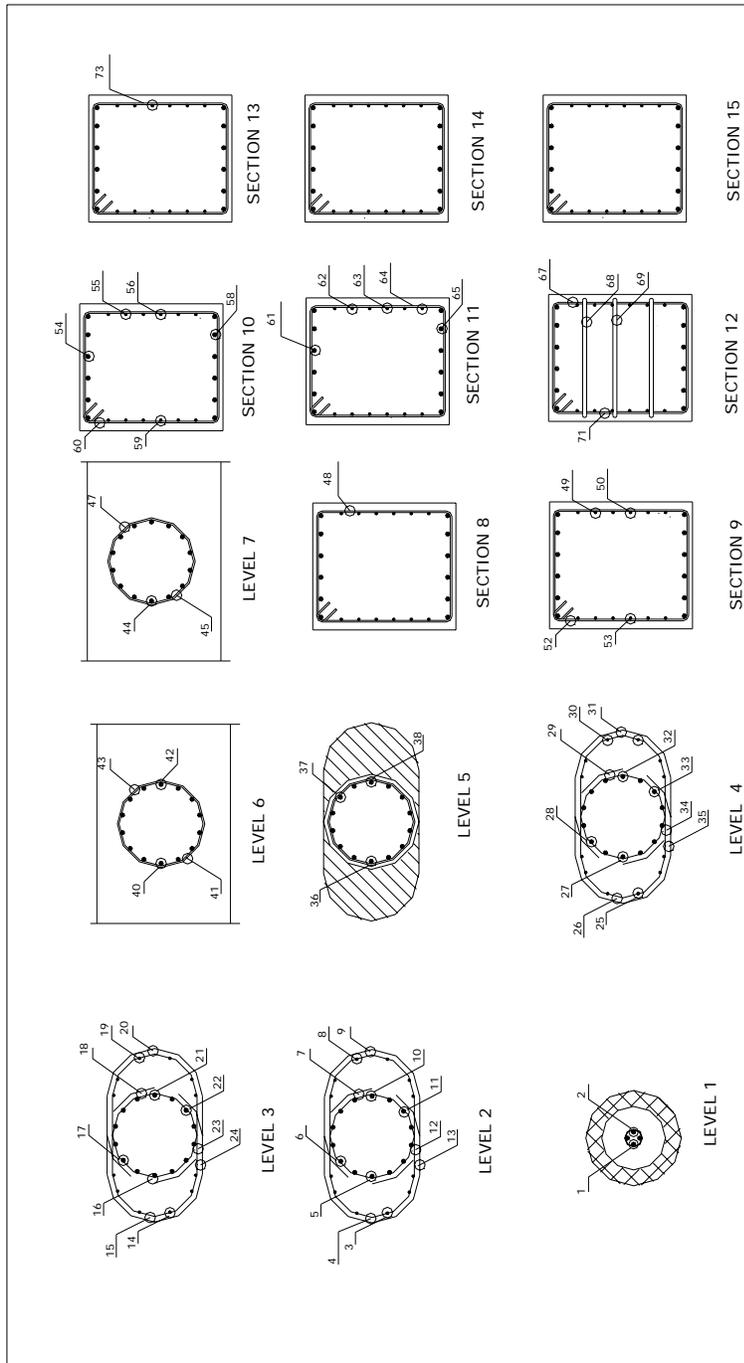
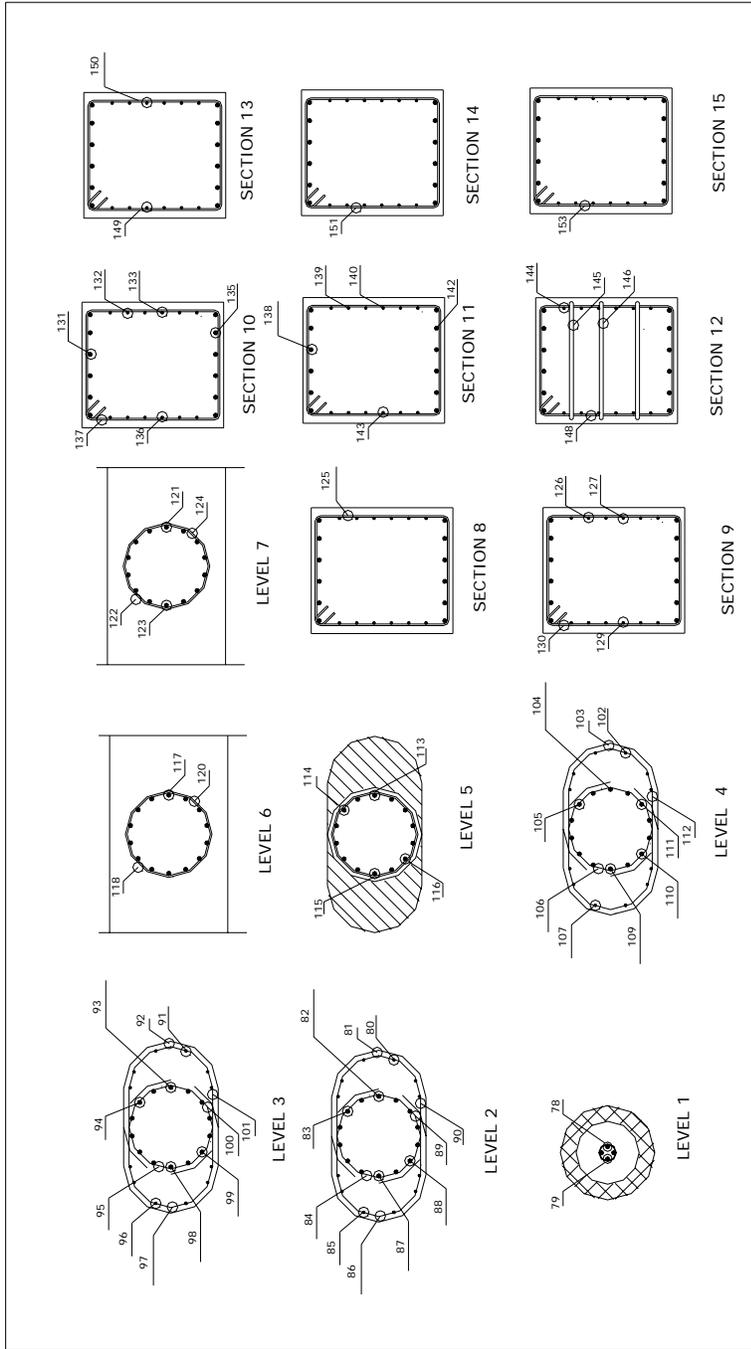
**Figure 3.1a Available Strain Gages Through Testing**

**Figure 3.1b Available Strain Gages Through Testing**

The specimen was loaded with increasing magnitudes of the 1994 Sylmar record from the Northridge Earthquake. The peak acceleration was 0.6g. Time was scaled based on the scale of the specimen. Accelerations were scaled based on the intensity of the earthquake desired. Table 3.1 shows the records that were applied. SFCD3 was equipped with 154 strain gages. Some strain gages were damaged during construction and handling and some were damaged during testing. Strain gages working properly through the tests are shown in Fig. 3.1. Locations of levels in the figure are described in Fig. 2.10.

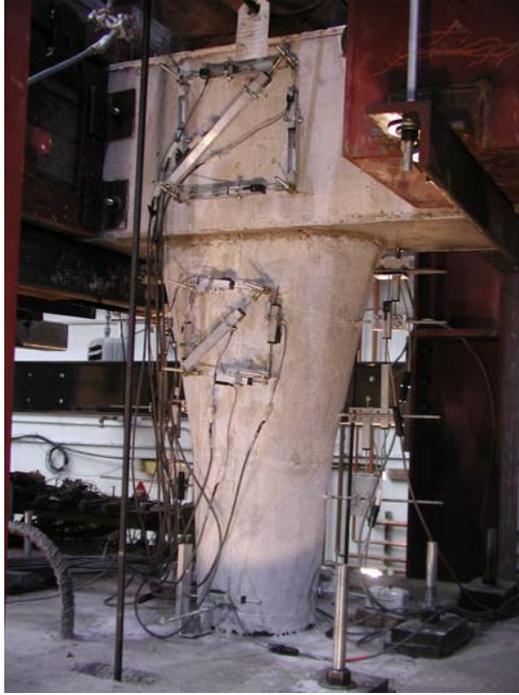
**Figure 3.2 No Cracks at 0.25 Times Sylmar**

No cracks were observed for run 0.25 times Sylmar (Fig. 3.2). Some vertical cracks were observed in the beam-column joint for the 0.50 and 0.75 times Sylmar runs, Figs. 3.3 and 3.4. These cracks propagated for the 1.00 times Sylmar run. There were flexural cracks in both columns with some shear cracks, Figs. 3.5 and 3.6. For the same run, flexural cracks propagated along with shear cracks in the beam-column joint, Fig 3.7. For 1.25 and 1.50 times Sylmar, cracks in beam-column joint and column-flares increased (Fig. 3.8). First crack at both the column-bases was observed at 1.75 times Sylmar (Fig. 3.9). This indicated gap closure at the column-base hinge in both columns. All preexisting cracks continued to propagate and widened throughout the test. New cracks (both shear and flexure) at column-base, column-flares and beam-column joint developed until 2.50 times Sylmar. Cracks in the beam-column joint and column flares were a combination of shear and flexure (Figs. 3.10 and 3.11). The first vertical crack in the flare developed at 2.50 times Sylmar (Fig. 3.12). This crack indicated the gap closure on the north flare edge side of south column. Through runs of 2.75 and 3.00 times Sylmar, all cracks continued to widen with spalling at the column-base and north flare edge of the south column (Figs. 3.13 and 3.14). At 3.25 times Sylmar, significant spalling occurred at the top flare edge of the south column. Hoop reinforcement in flare and hoop reinforcement at the column base were exposed in this column (Figs. 3.15 and 3.16). Intensive cracking in the column below the cap-beam was observed (Figs. 3.17 and 3.18). At 3.50 times Sylmar, the specimen failed at the south column base (i.e. hinge failure) with the extensive damage to the column core at the top of the columns (Figs. 3.19 and 3.20). The residual transverse displacement after failure was 9.0 mm (0.36 in) in the west direction. System showed almost no transverse displacement for all runs

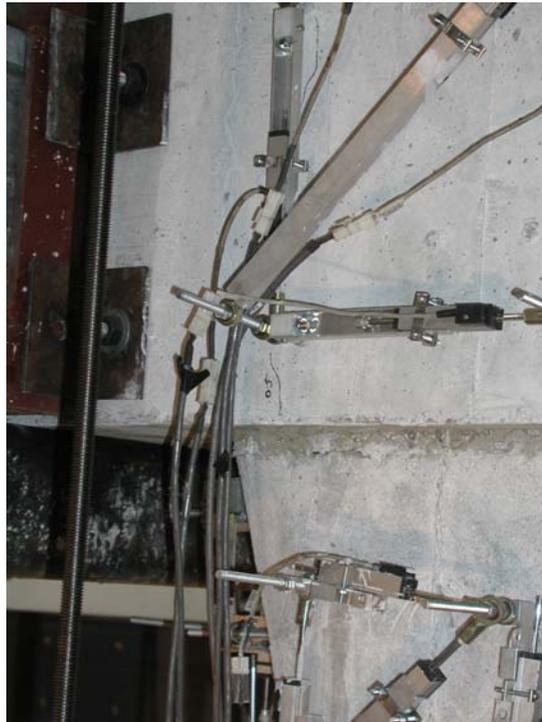
**Figure 3.3 Vertical Crack at 0.50 Times Sylmar**
