# **STATIC AND DYNAMIC PERFORMANCE OF RC BRIDGE BENTS WITH ARCHITECTURAL-FLARED COLUMNS**

REPORT No. CCEER-03-08

A Report for the  
California Department of Transportation  
Sacramento, California  
under contract 59A0069

March 2004

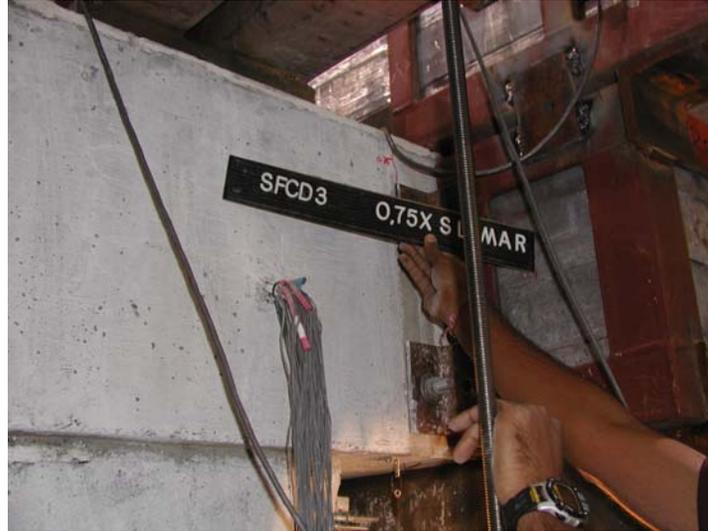
**Figure 3.4 Vertical Cracks at 0.75 Times Sylmar**

No cracks were observed for run 0.25 times Sylmar (Fig. 3.2). Some vertical cracks were observed in the beam-column joint for the 0.50 and 0.75 times Sylmar runs, Figs. 3.3 and 3.4. These cracks propagated for the 1.00 times Sylmar run. There were flexural cracks in both columns with some shear cracks, Figs. 3.5 and 3.6. For the same run, flexural cracks propagated along with shear cracks in the beam-column joint, Fig 3.7. For 1.25 and 1.50 times Sylmar, cracks in beam-column joint and column-flares increased (Fig. 3.8). First crack at both the column-bases was observed at 1.75 times Sylmar (Fig. 3.9). This indicated gap closure at the column-base hinge in both columns. All preexisting cracks continued to propagate and widened throughout the test. New cracks (both shear and flexure) at column-base, column-flares and beam-column joint developed until 2.50 times Sylmar. Cracks in the beam-column joint and column flares were a combination of shear and flexure (Figs. 3.10 and 3.11). The first vertical crack in the flare developed at 2.50 times Sylmar (Fig. 3.12). This crack indicated the gap closure on the north flare edge side of south column. Through runs of 2.75 and 3.00 times Sylmar, all cracks continued to widen with spalling at the column-base and north flare edge of the south column (Figs. 3.13 and 3.14). At 3.25 times Sylmar, significant spalling occurred at the top flare edge of the south column. Hoop reinforcement in flare and hoop reinforcement at the column base were exposed in this column (Figs. 3.15 and 3.16). Intensive cracking in the column below the cap-beam was observed (Figs. 3.17 and 3.18). At 3.50 times Sylmar, the specimen failed at the south column base (i.e. hinge failure) with the extensive damage to the column core at the top of the columns (Figs. 3.19 and 3.20). The residual transverse displacement after failure was 9.0 mm (0.36 in) in the west direction. System showed almost no transverse displacement for all runs

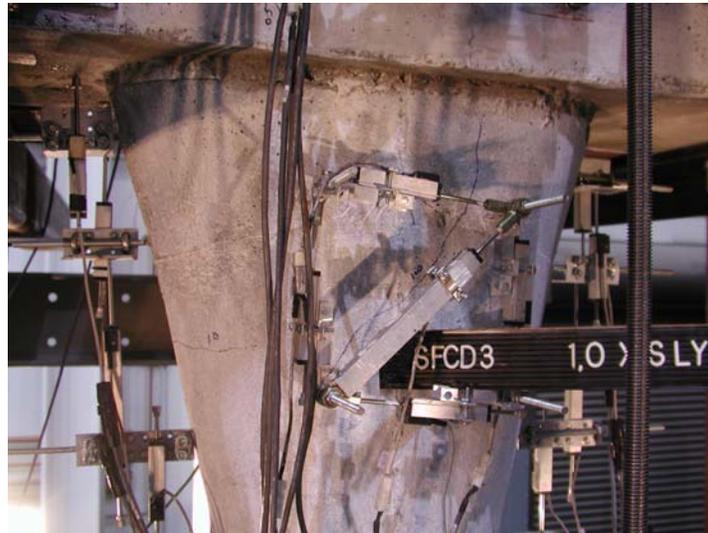
**Figure 3.5 Flexural and Shear Crack at 1.00 Times Sylmar**

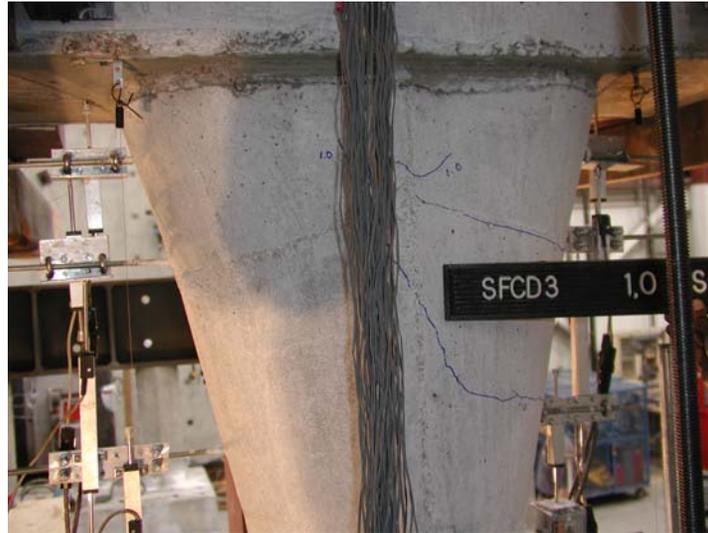
**Figure 3.6 Flexural and Shear Cracks at 1.00 Times Sylmar**

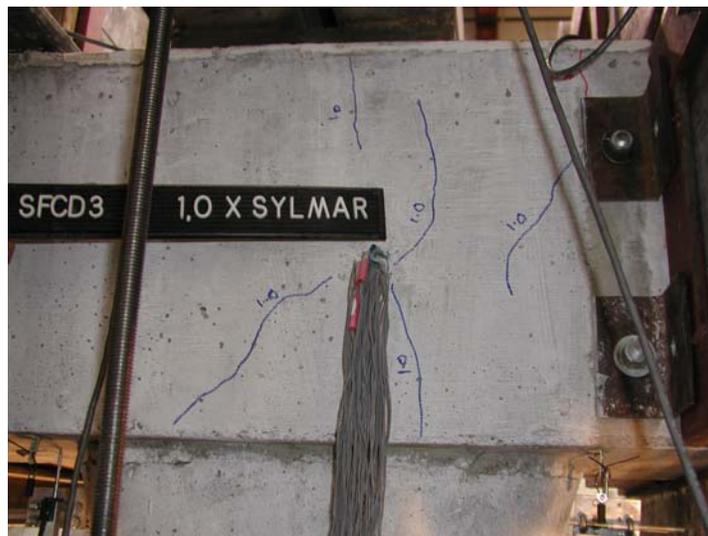
**Figure 3.7 Flexural and Shear Cracks in Joint at 1.00 Times Sylmar**

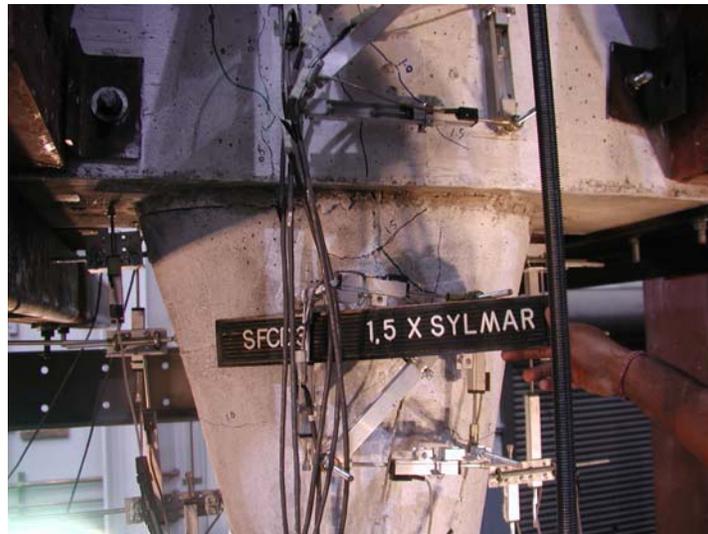
**Figure 3.8 Cracks at 1.50 Times Sylmar**

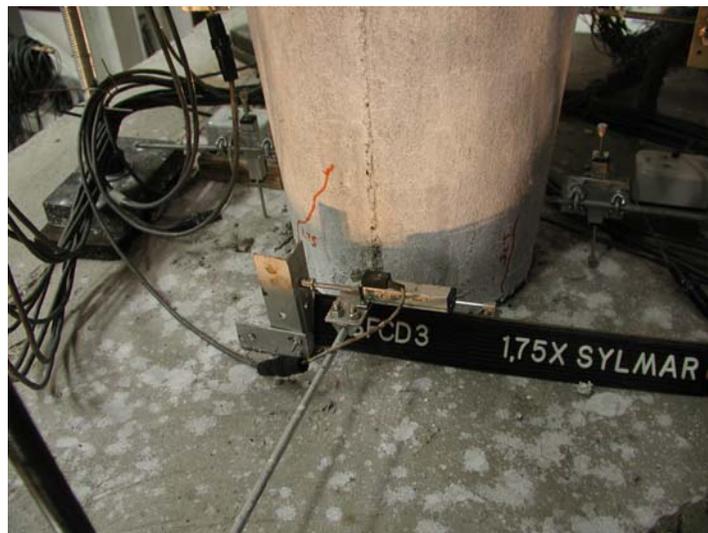
**Figure 3.9 First Cracking in Base at 1.75 Times Sylmar**

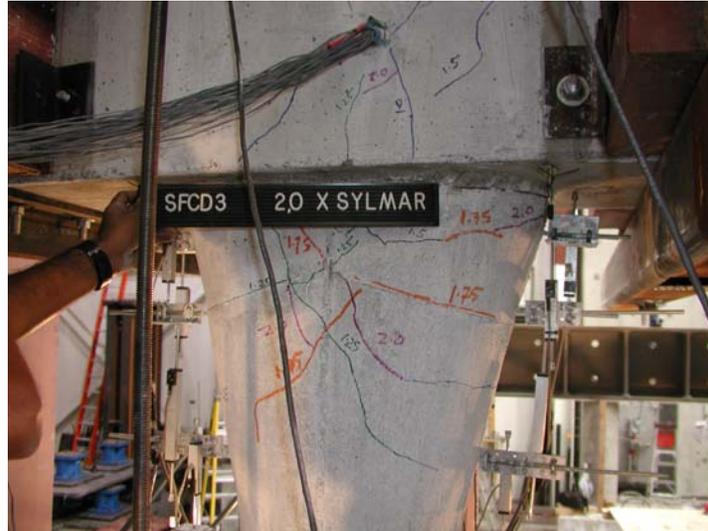
**Figure 3.10 Shear Flexure Interaction Cracks at 2.00 Times Sylmar**

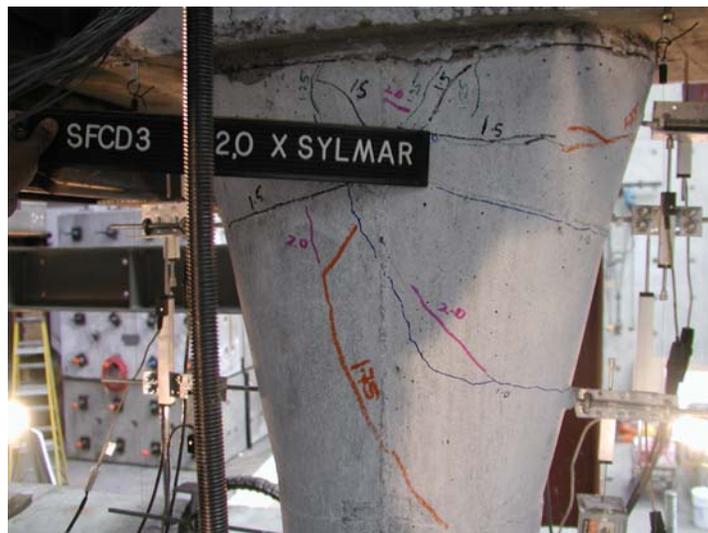
**Figure 3.11 Shear Flexure Interaction Cracks at 2.00 Times Sylmar**

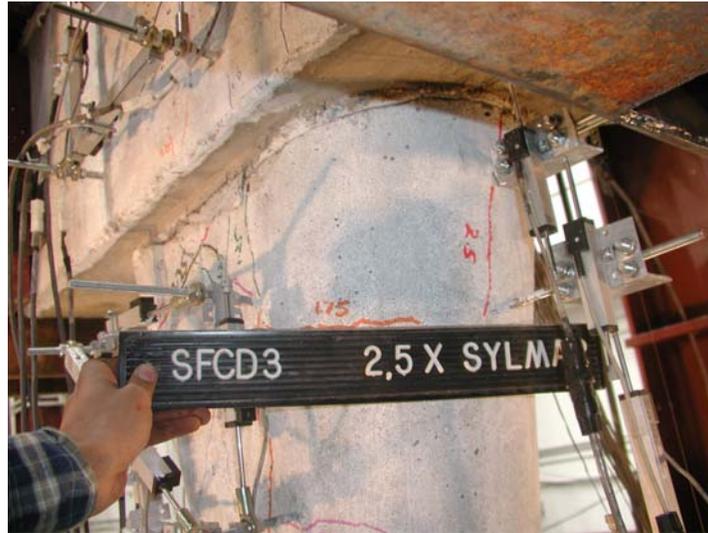
**Figure 3.12 Vertical Crack in Flare at 2.50 Times Sylmar**

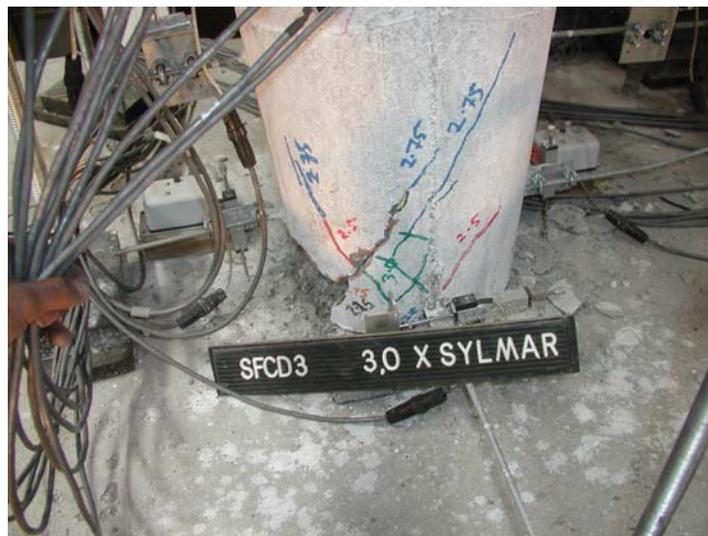
**Figure 3.13 Spalling at the Column Base at 3.00 Times Sylmar**

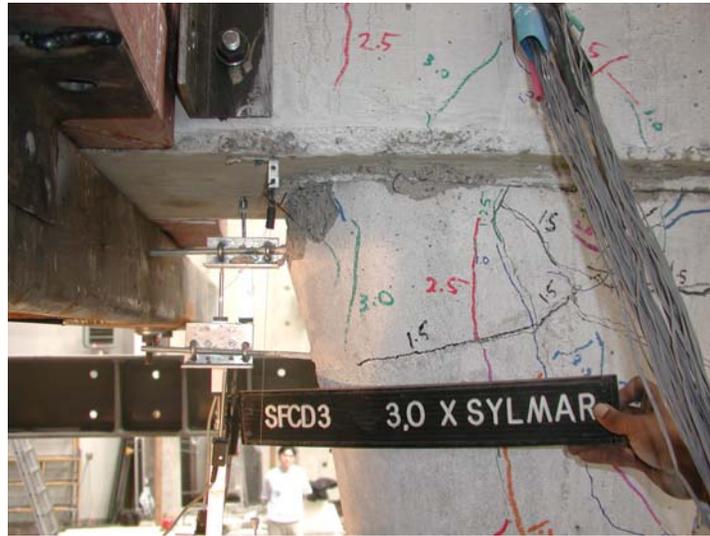
**Figure 3.14 Spalling at Flare Edge at 3.00 Times Sylmar**

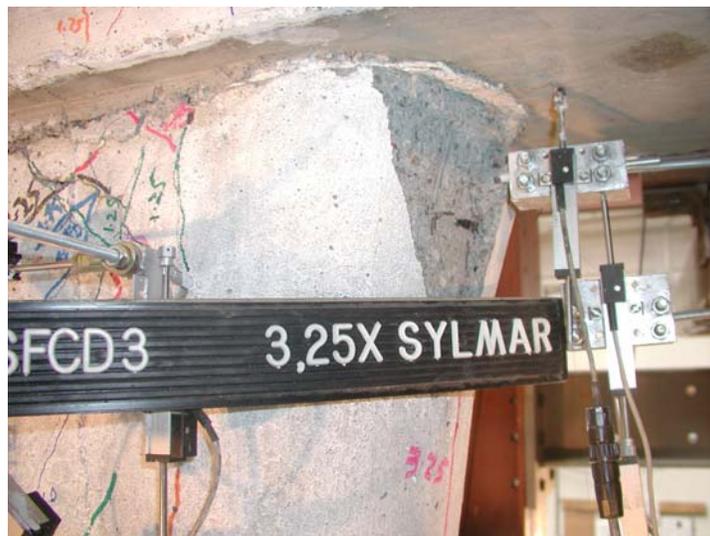
**Figure 3.15 Exposed Flare Hoops at 3.25 Times Sylmar**

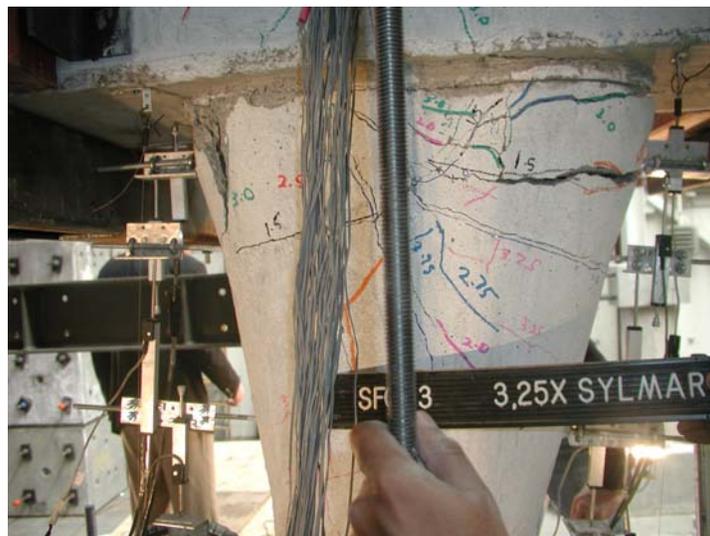
**Figure 3.17 Cracking in Column at 3.25 Times Sylmar**

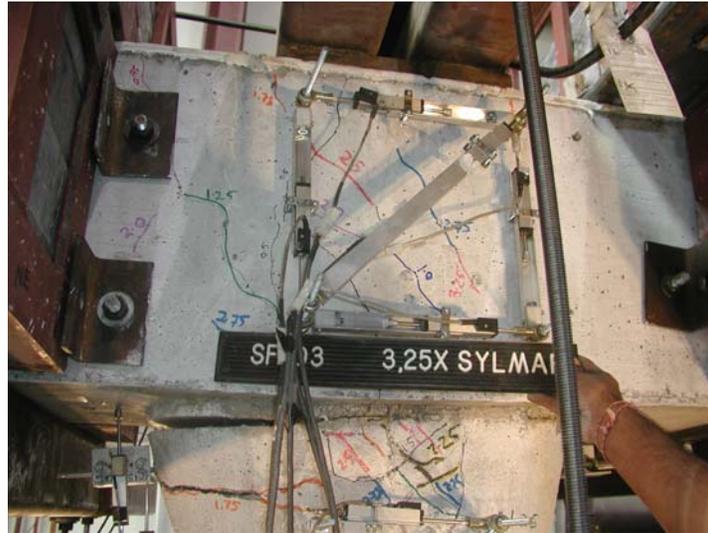
**Figure 3.18 Cracking in Joint at 3.25 Times Sylmar**

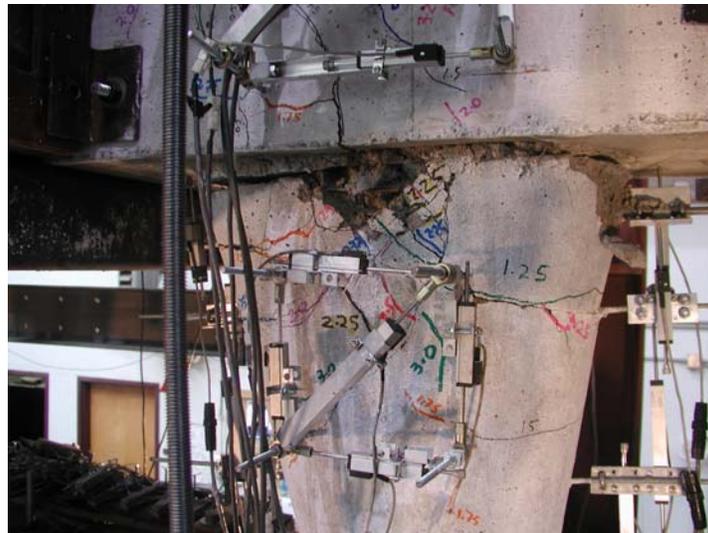
**Figure 3.19 Intense Spalling at Gap After Failure**

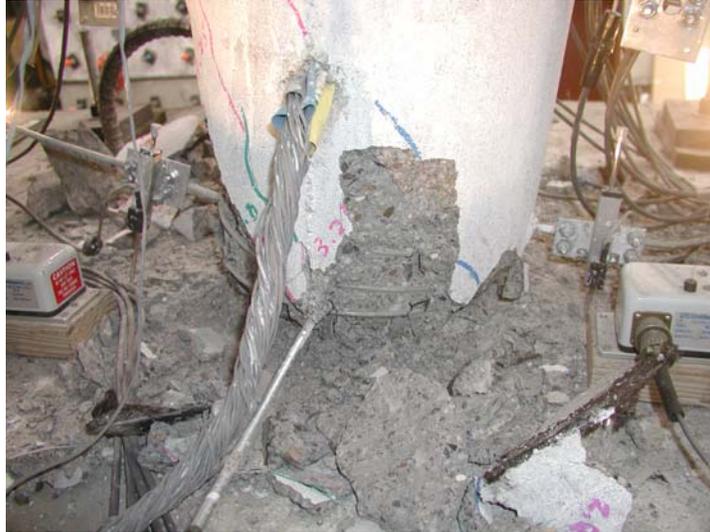
**Figure 3.20 Failed Column-Base**

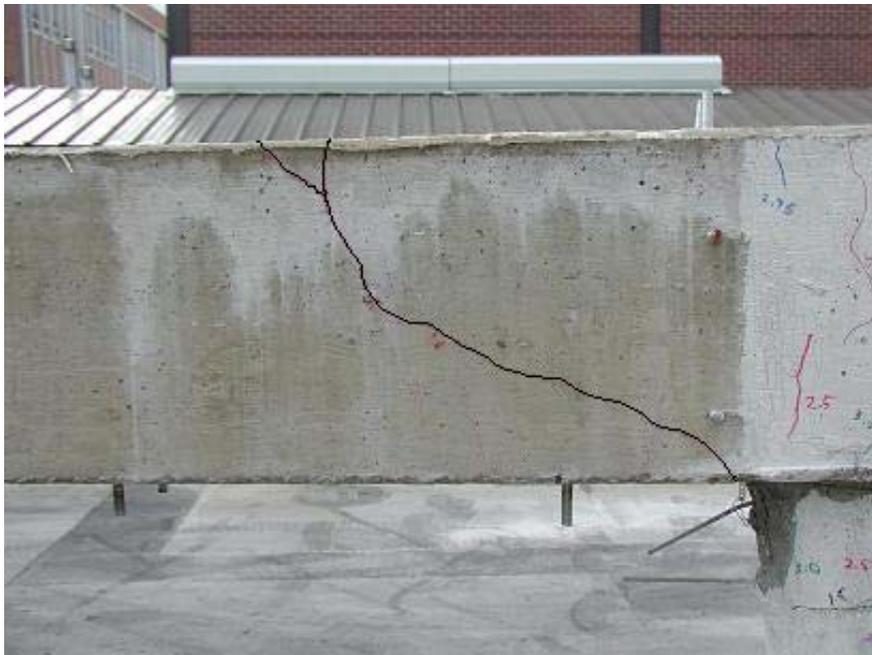
**Figure 3.21 Shear Crack After Bucket Removal**

except the last run of 3.50 times Sylmar. The maximum transverse displacement in this run was 14.9 mm (0.59 in), which was due to failure of the specimen. After bucket removal, small amount of flexural cracks were observed along with a shear crack in the cap-beam above the south column flare-edge (Fig. 3.21). Table 3.2 summarizes the cracking pattern in each structural element for each run of Sylmar.

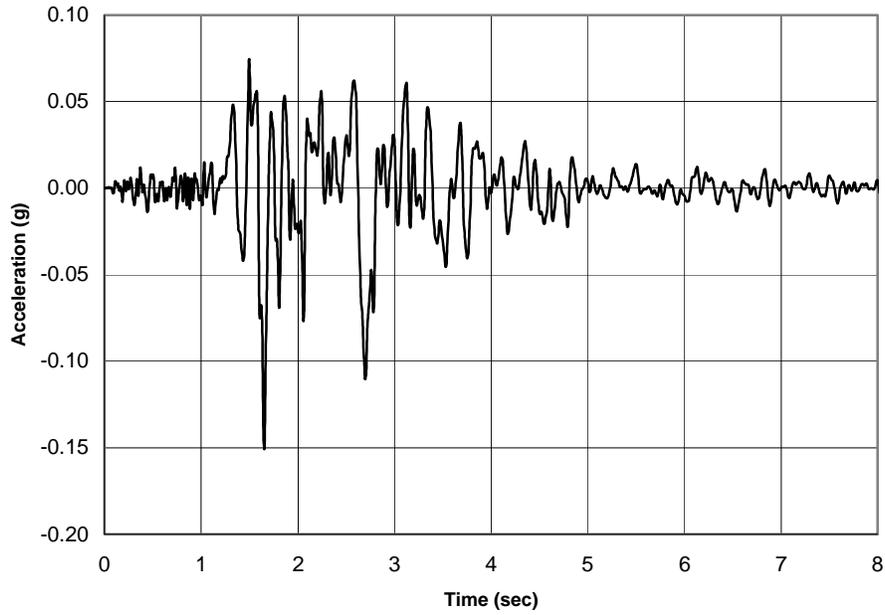
**Figure 3.22 Scaled Sylmar Acceleration for 0.25 Times Sylmar**

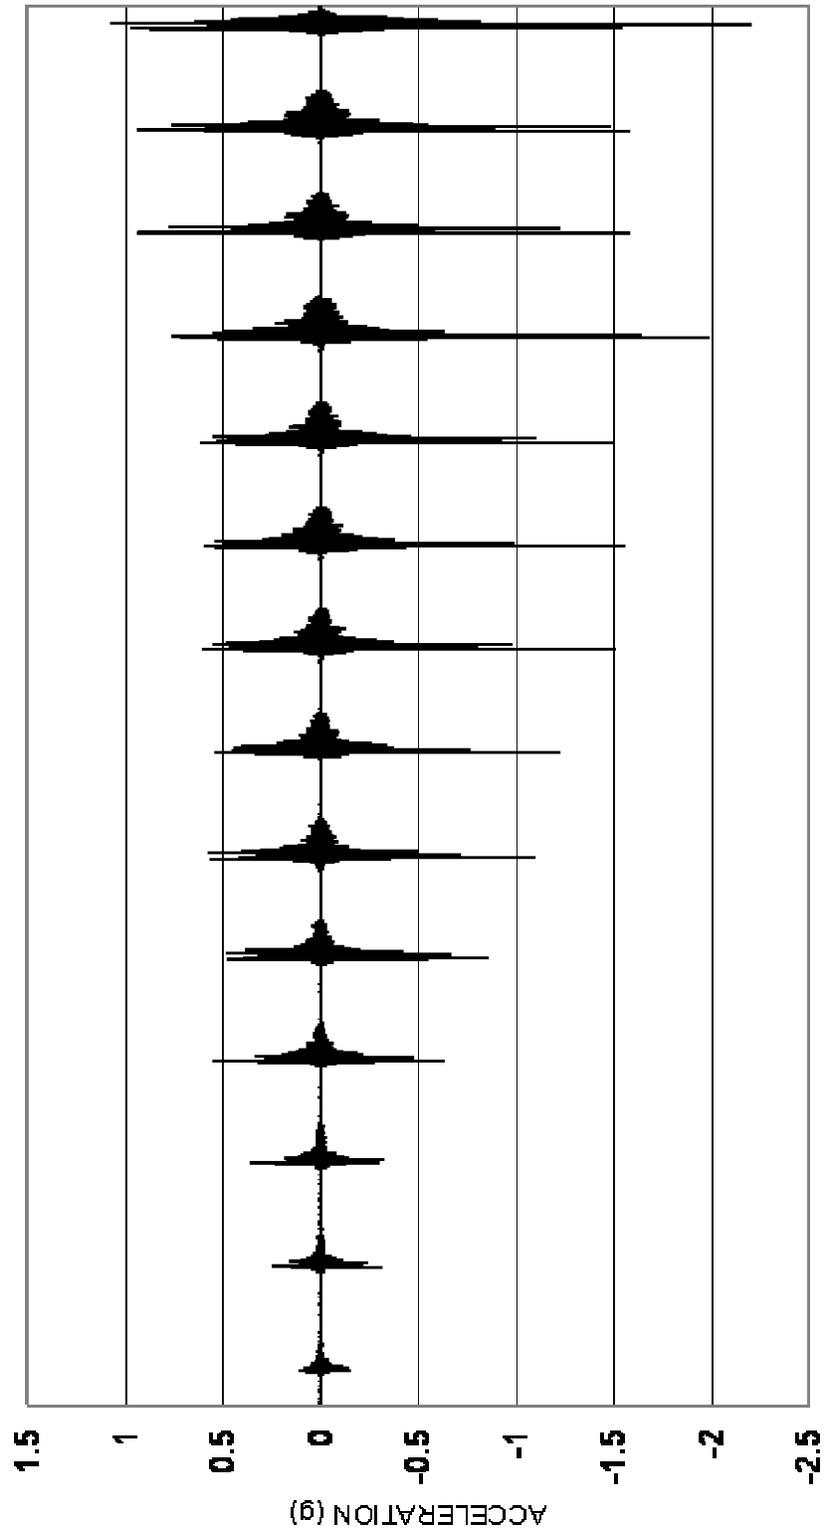
Figure 3.26 Time History of Achieved table Accelerations for All Runs

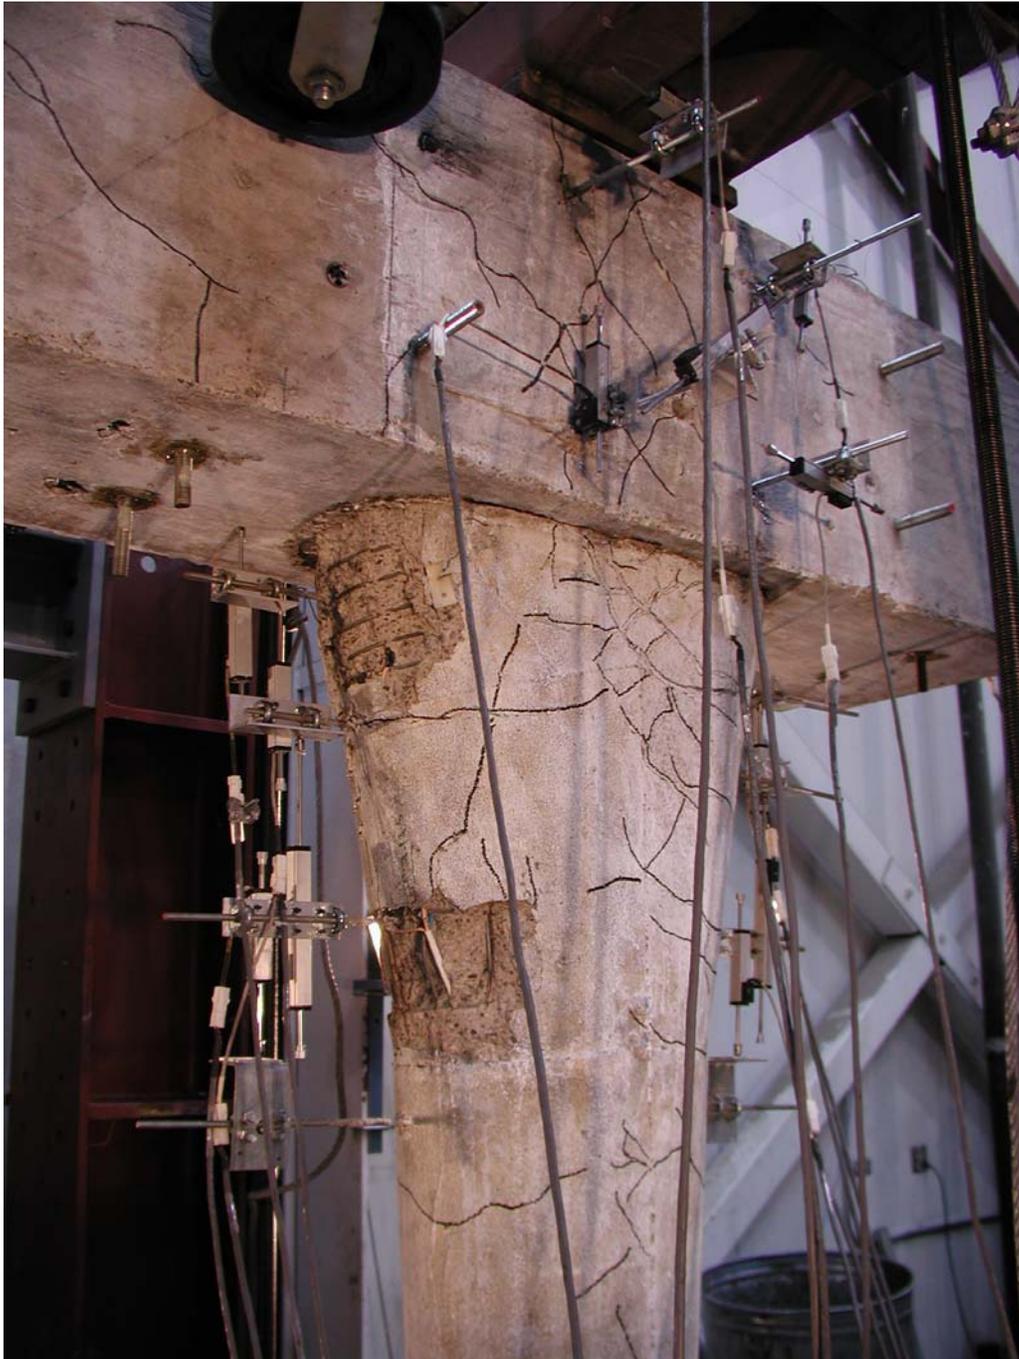
**Figure 4.1 Initial Condition of the Structure**

LFCD1S was severely damaged in the shake table testing but did not fail. There were shear cracks in the beam-column connections, plastic hinge region of the columns, base-hinge, and in the beam. There were flexural cracks in the beam-column connections and the plastic hinge region of the column. Spalling was seen at the top of the flare and in the middle of flare height (Fig. 4.1). The applied shake table displacement can be seen in Fig. 4.2 as the dotted line.

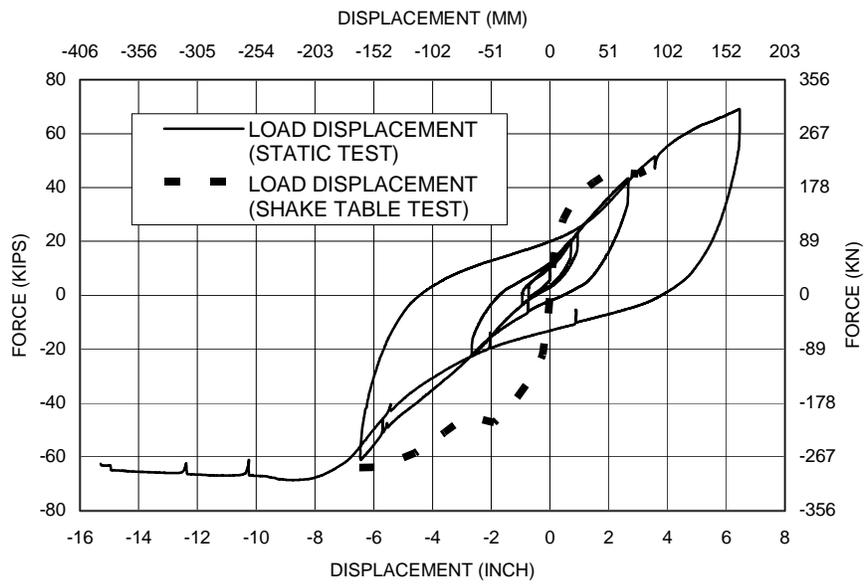
**Figure 4.2 Load-Displacement Relation for LFCD1S**

For the pull zone, the static load graph is very close to the end points of the shake table tests (Fig. 4.2). Where in the push zone, the static test looks like a continuation of dynamic test. During Load Step-8, when the specimen was pulled to 165.1 mm (6.5 in), it suffered new damage lowering the stiffness and capacity of the structure. The maximum force was 305.4 KN (68.66 Kips) at the displacement of 205 mm (8.09 in). Maximum displacement ( $\Delta u$ ) was determined as the displacement corresponding to the maximum absolute load ( $P_u$ ) carried by structure during the shake table test. The maximum load ( $P_u$ ) was taken from the shake table testing. The maximum displacement corresponding to this load was 389 mm (15.3 in).

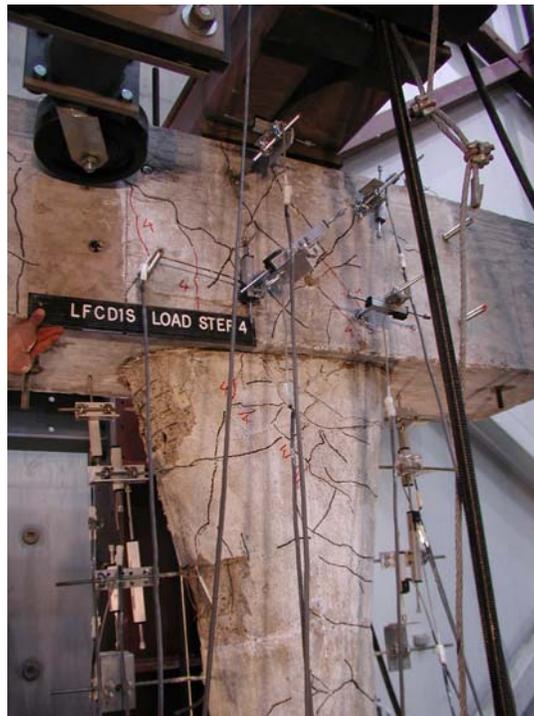
**Figure 4.3 Cracks in LFCD1S at Load Step-4**

were also new shear and some flexural cracks observed in the flare at this load step (Fig. 4.3). Load Step-5 was to push the system to 67.3 mm (2.65 in), which was equal to the gap closure at the top of column flare. The actual displacement achieved at this load step was 67.6 mm (2.66 in). Additional cracking was observed at this stage. The cracks observed were the same as Load Step-4 but opposite in direction (Fig. 4.4). Load Step-6 was to pull the specimen to 67.3 mm (2.65 in). The actual displacement achieved was 67.8 mm (2.67 in). New shear and flexure cracks were observed in the column throughout the height. More cracks in the joint were observed. Load Step-7 was to push the specimen to 165 mm (6.50 in), which was the maximum displacement when tested on the shake table. Specimen went through all the displacements of Load-Steps 1 through 7, when it was tested on the shake table. The actual displacement achieved for Load-Step 7 was 164 mm (6.46 in). New shear and flexural cracks observed over both columns. Preexisting flexural cracks widened (Fig. 4.5). New cracks were observed at the base-hinge (Fig. 4.6). Load Step-8 was to pull the specimen to 165 mm (6.5 inch). Specimen never went through this displacement when tested on the shake table. The actual displacement achieved was 164 mm (6.46 in). Intense cracking was observed at this stage. Extensive shear cracking was observed in the columns and the beam. These cracks were long and wide (Figs. 4.7 through 4.9). Load Step-9 was to push the specimen till failure. After 209 mm (8.22 in) of displacement, the load carried by system started to drop. The specimen was pushed to a displacement of 388 mm (15.3 in), where the load had dropped to 91 % of the maximum load. Very wide shear and flexural cracks in the beam were observed. Extensive spalling in the flare was also observed. The flare longitudinal reinforcement buckled (Fig. 4.10). A wide gap opening was observed at the base-hinges (Fig. 4.11). Flexural cracks were large in the column (Fig. 4.12).

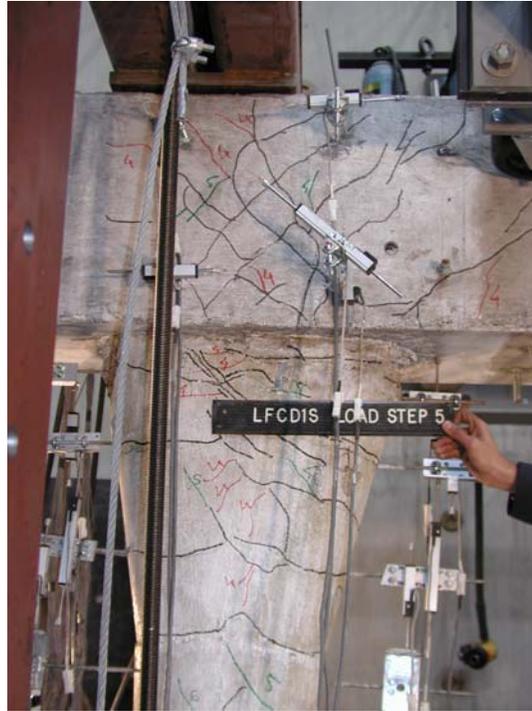
**Figure 4.4 Cracks in LFCD1S at Load Step-5**

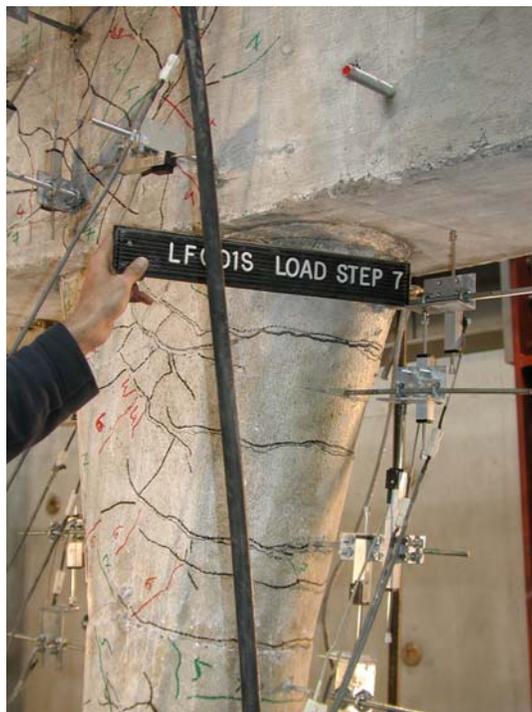
**Figure 4.5 Cracks in LFCD1S at Load Step-7**

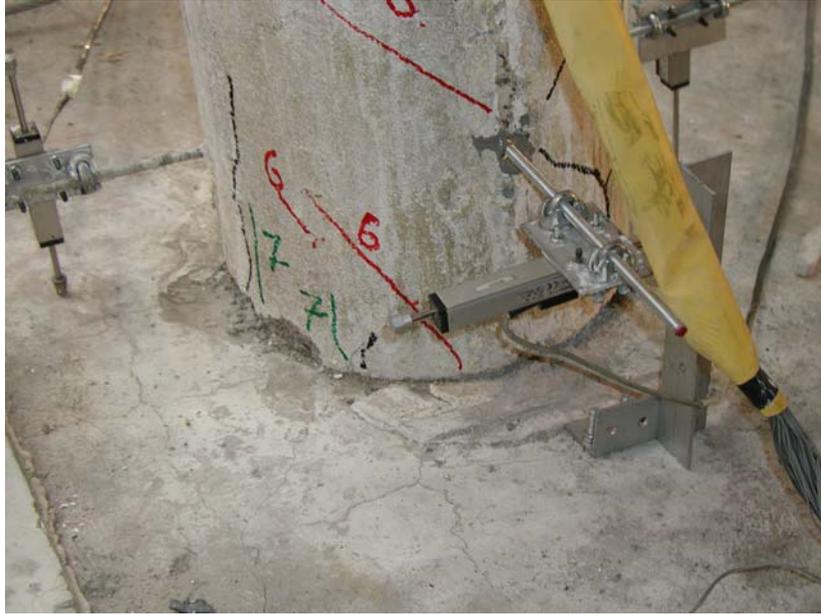
**Figure 4.6 Cracks in LFCD1S at Load Step-7**

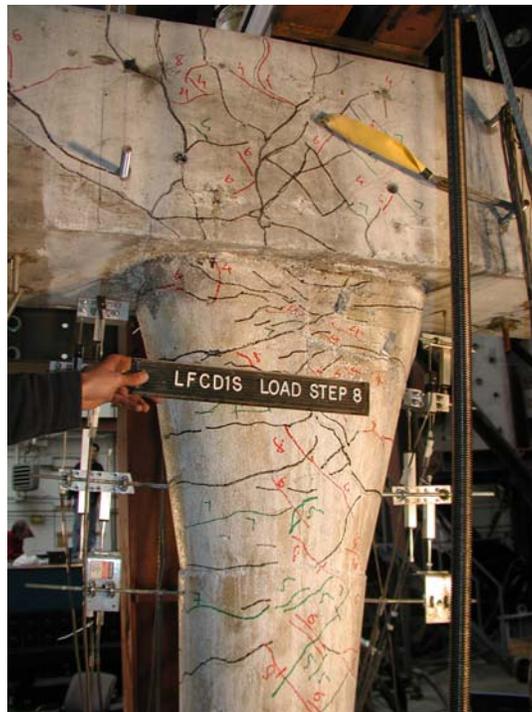
**Figure 4.7 Cracks in LFCD1S at Load Step-8**

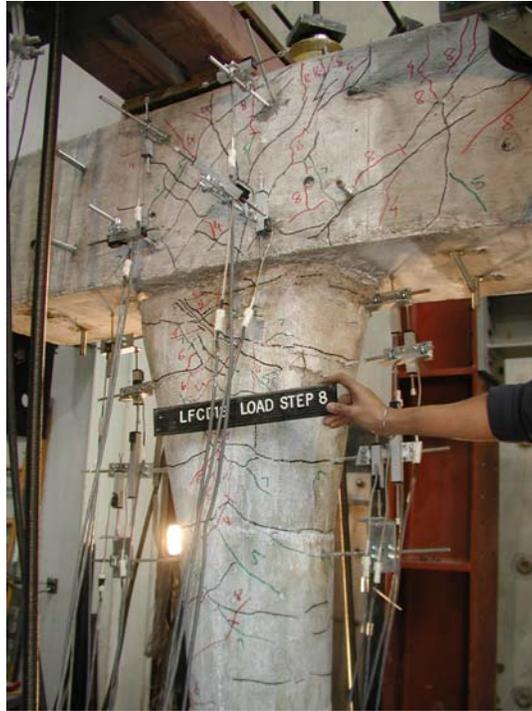
**Figure 4.8 Cracks in LFCD1S at Load Step-8**

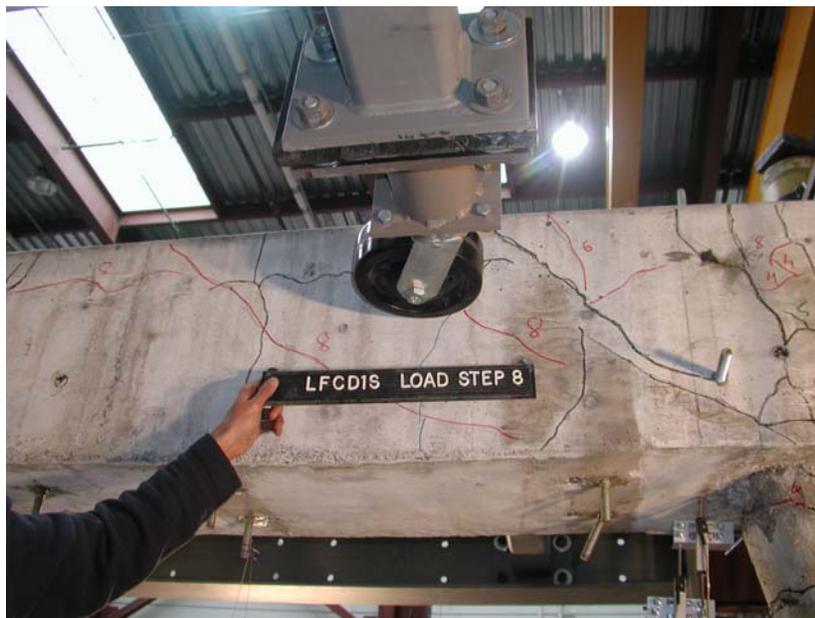
**Figure 4.9 Cracks in LFCD1S at Load Step-8**

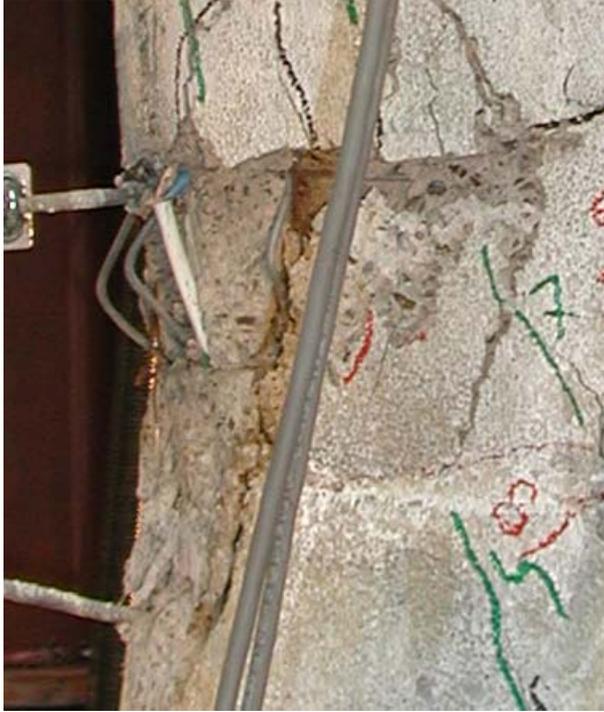
**Figure 4.10 Cracks in LFCD1S at Load Step-9**

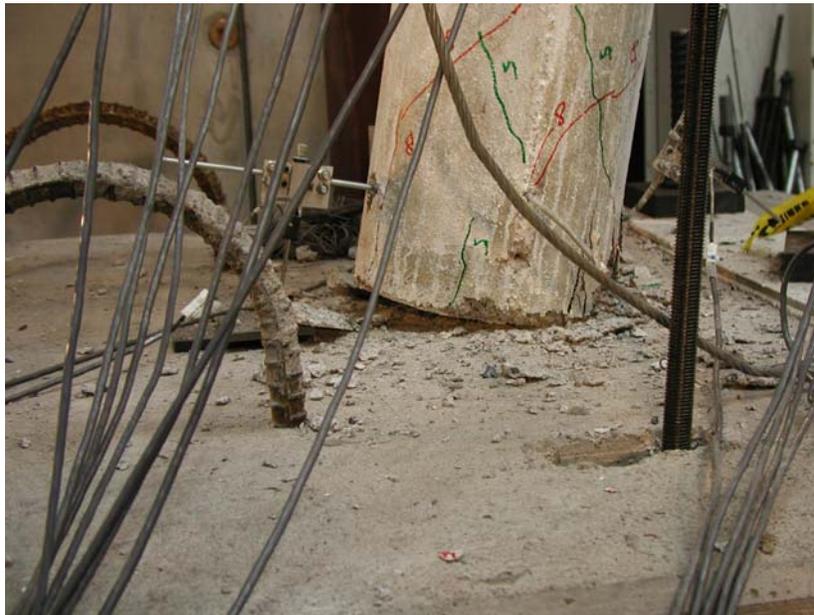
**Figure 4.11 Cracks in LFCD1S at Load Step-9**

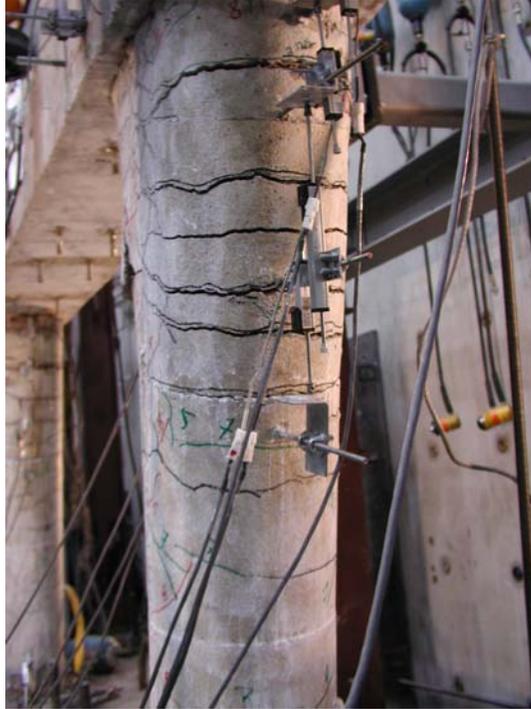
**Figure 4.12 Cracks in LFCD1S at Load Step-9**

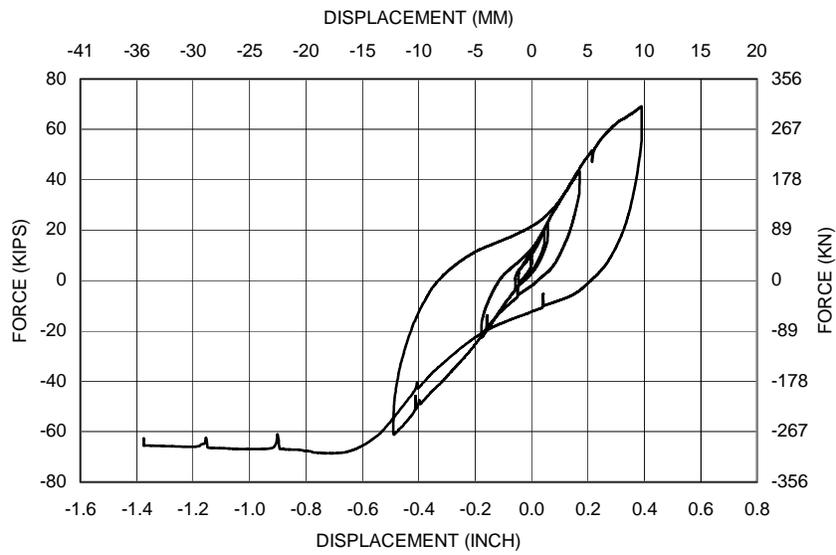
**Figure 4.13 Slippage at South Column Base for LFCD1S**

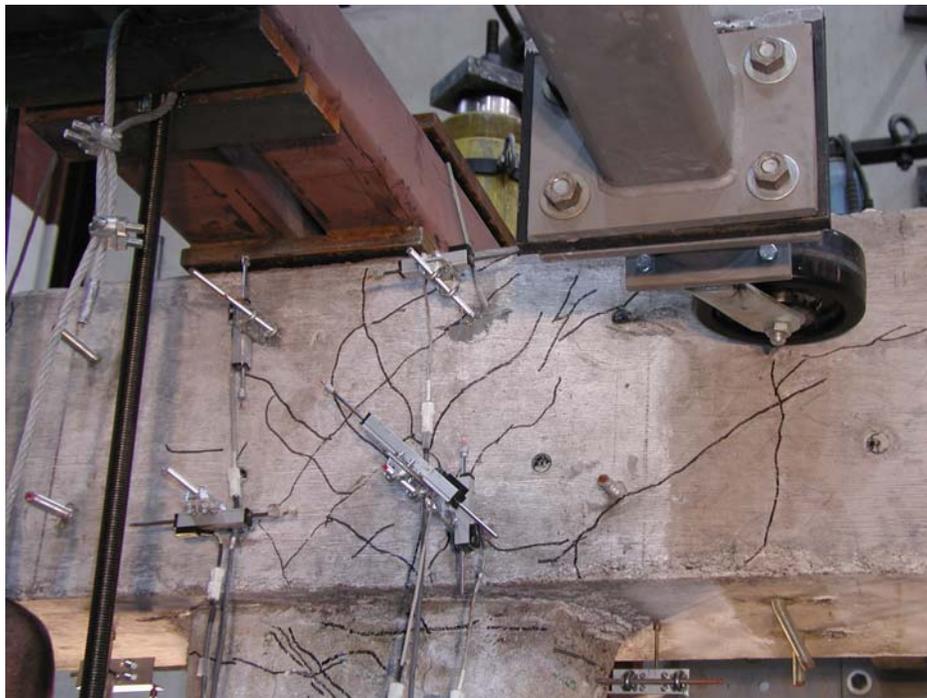
**Figure 4.15 Initial Cracks in Beam-Column Connection for LFCD1S**

The beam-column connection was cracked during the shake table testing (Fig. 4.15). The displacement transducers were used to determine the relative post-cracking principal stresses. These transducers helped in studying the level of cracking and variation in the principal stresses in the beam-column connection. The principal stresses were calculated by using the same procedure described in section 3.5. Figs. 4.16 and 4.17 show the maximum and minimum relative principal stresses, respectively, in the south beam-column connection. The sudden change in the stress values at the end of the loading curve indicates development of a large crack inside the instrumented area of the beam-column connection. Figs. 4.18 and 4.19 show the maximum and minimum principal stresses, respectively, in the north beam-column connection. The comparison of principal stresses in both beam-column connections shows approximately the same stress range. Principle stress values were very close to each other in both the beam-column connections except for the last load step.

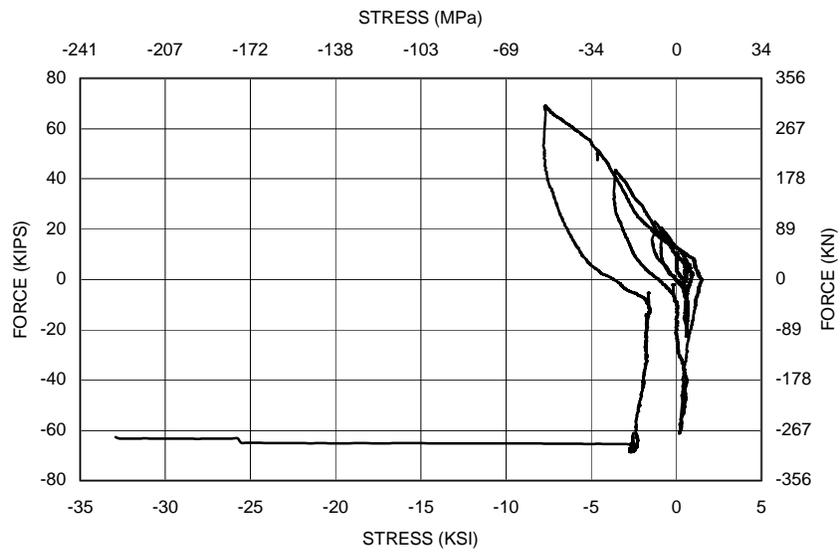
**Figure 4.16 Principal Stress ( $\sigma_1$ ) in South Beam-Column Connection for LFCD1S**

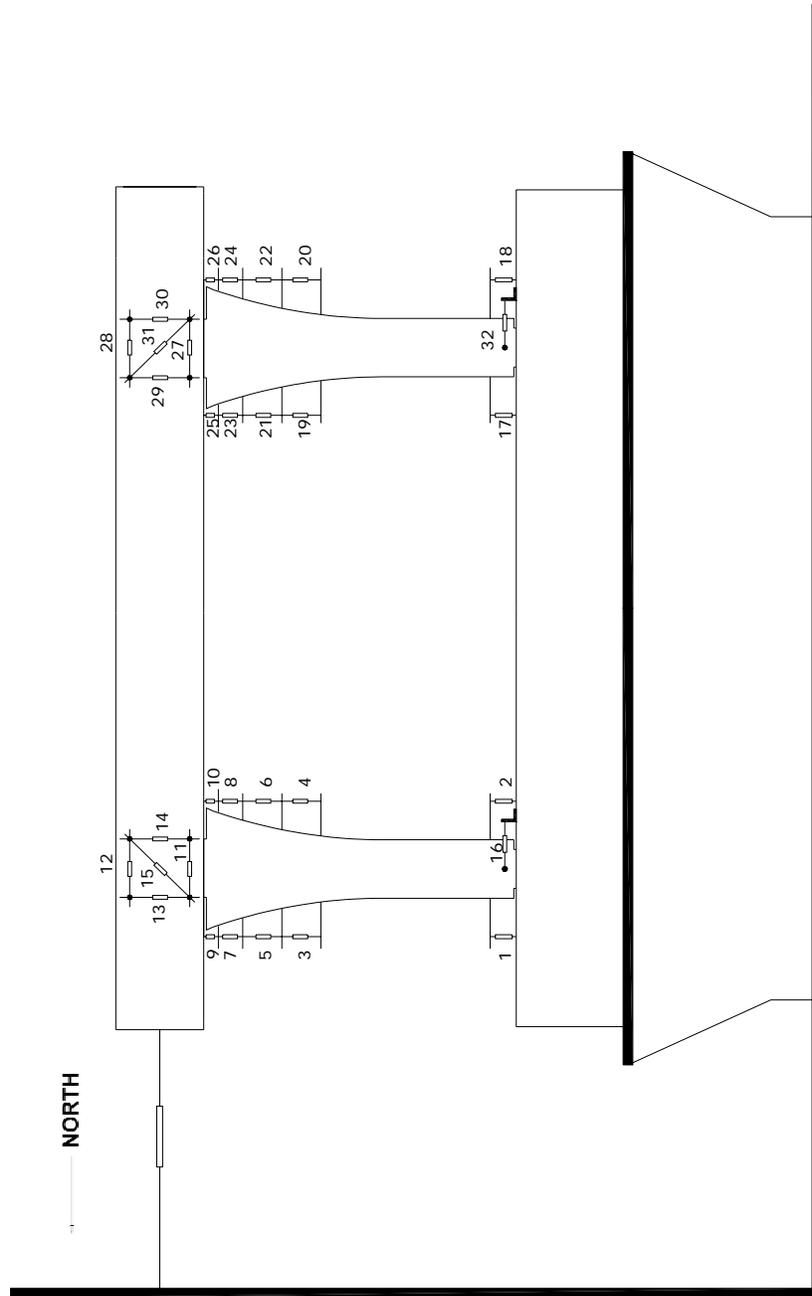
**Figure 4.20** Location of Measured Curvature

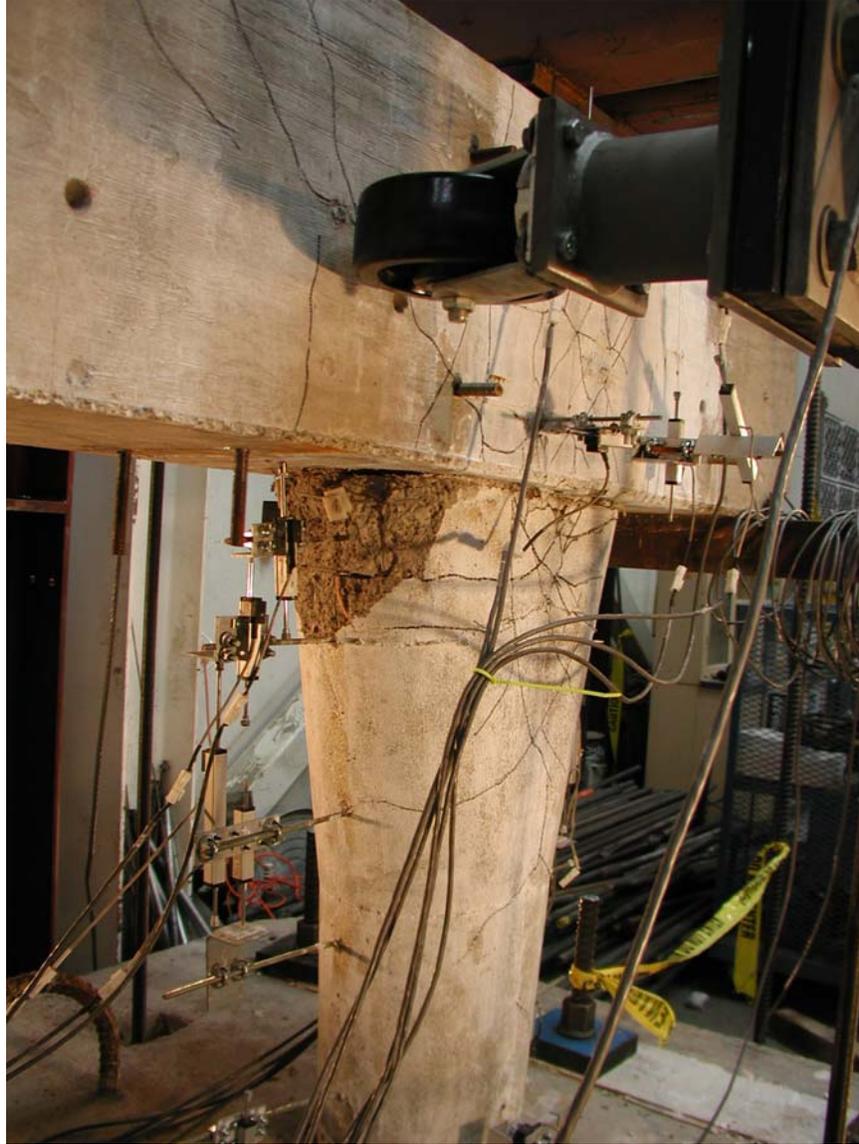
**Figure 4.34 Initial Condition of SFCD2S**

SFCD2S was initially tested on the shake table by Nada et al<sup>16</sup>. There were shear cracks in the beam-column connections, plastic hinge region of columns, base-hinge, and in the beam. There were flexural cracks in the beam-column connection and the plastic hinge region of the column (Fig. 4.34). Fig. 4.35 show the load-displacement envelop for the shake table test.

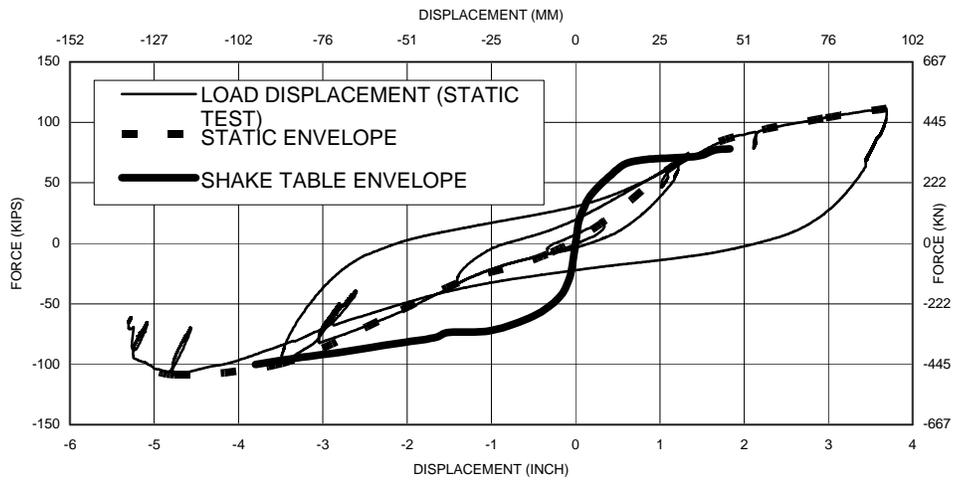
**Figure 4.35 Load-Displacement Curve for SFCD2S**

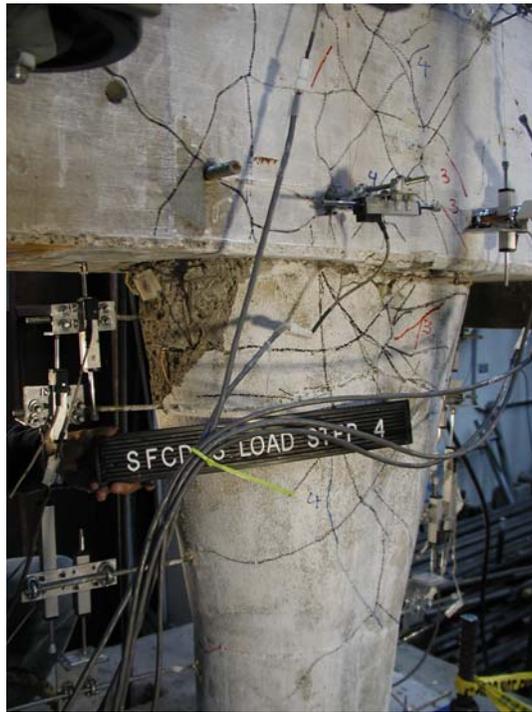
**Figure 4.36 Shear Cracks in SFCD2S at Load Step-4**

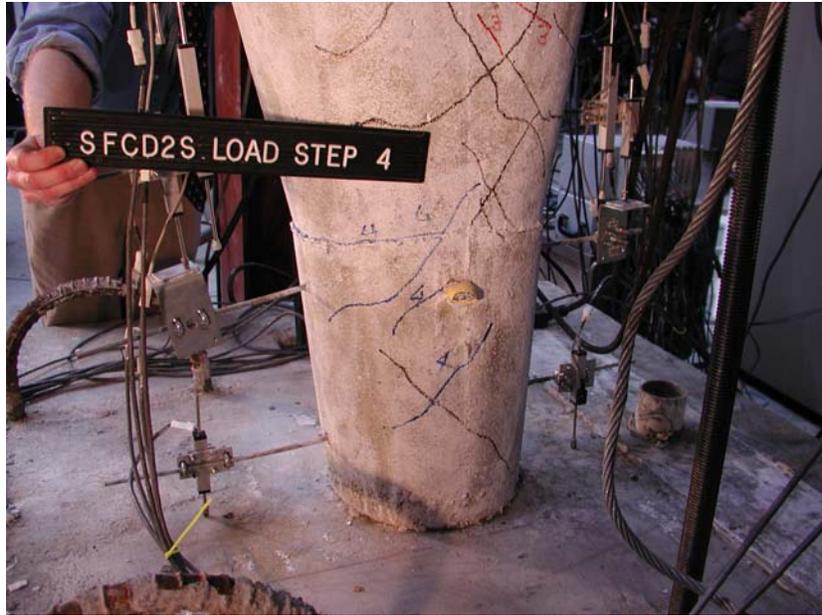
**Figure 4.37 Shear Cracks in SFCD2S at Load Step-4**

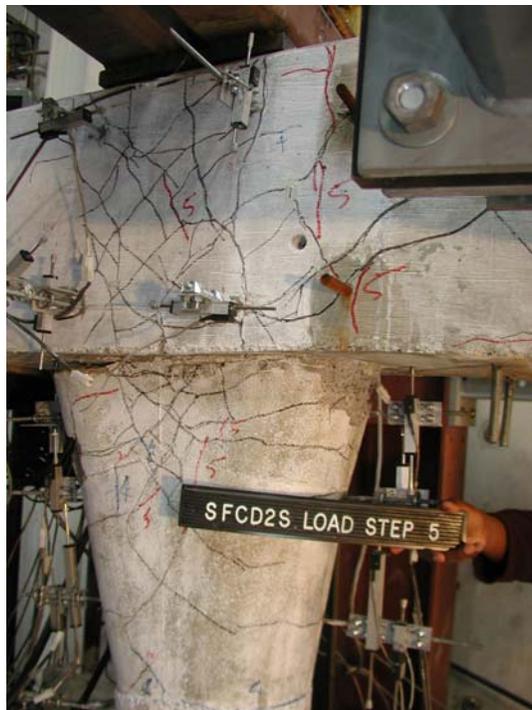
**Figure 4.38 Cracks in SFCD2S at Load Step-5**

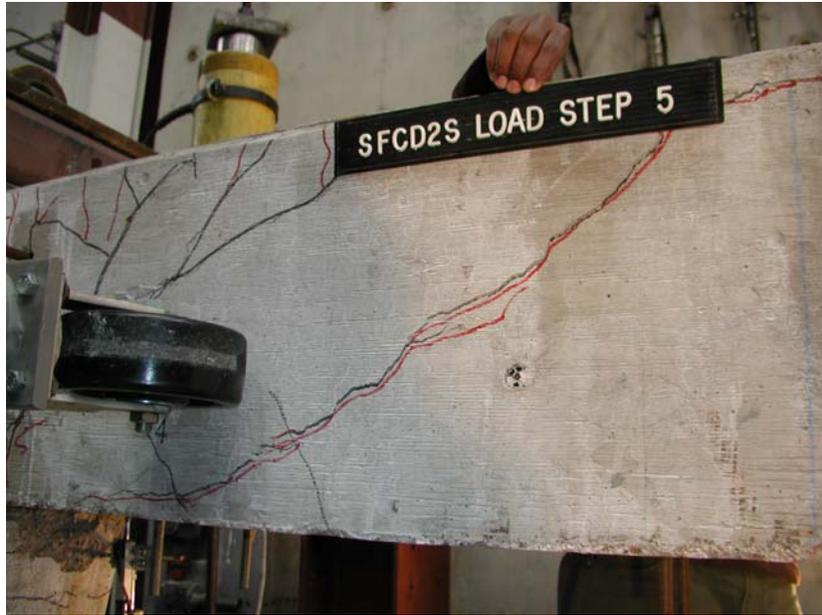
**Figure 4.39 Cracks in SFCD2S at Load Step-5**
