# **STATIC AND DYNAMIC PERFORMANCE OF RC BRIDGE BENTS WITH ARCHITECTURAL-FLARED COLUMNS**

REPORT No. CCEER-03-08

A Report for the  
California Department of Transportation  
Sacramento, California  
under contract 59A0069

March 2004

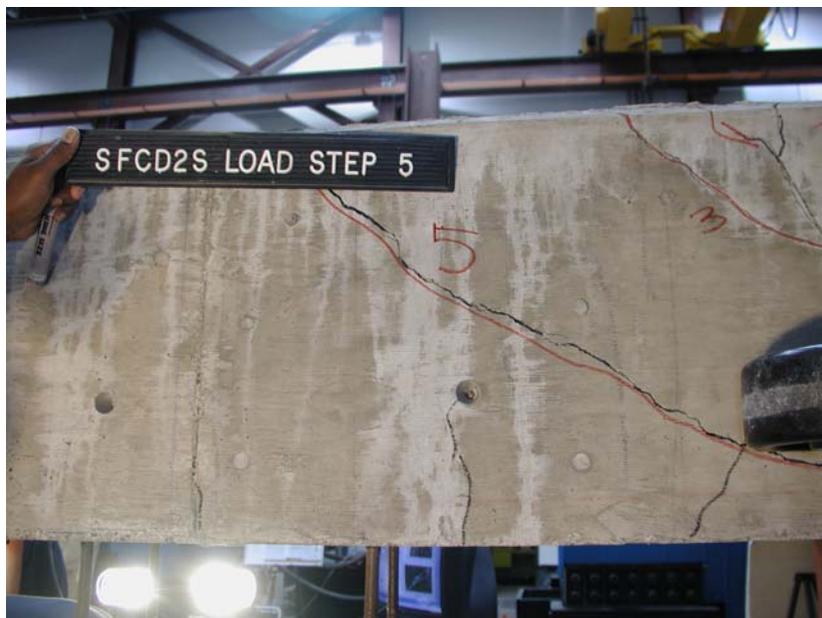
**Figure 4.40 Cracks in SFCD2S at Load Step-5**

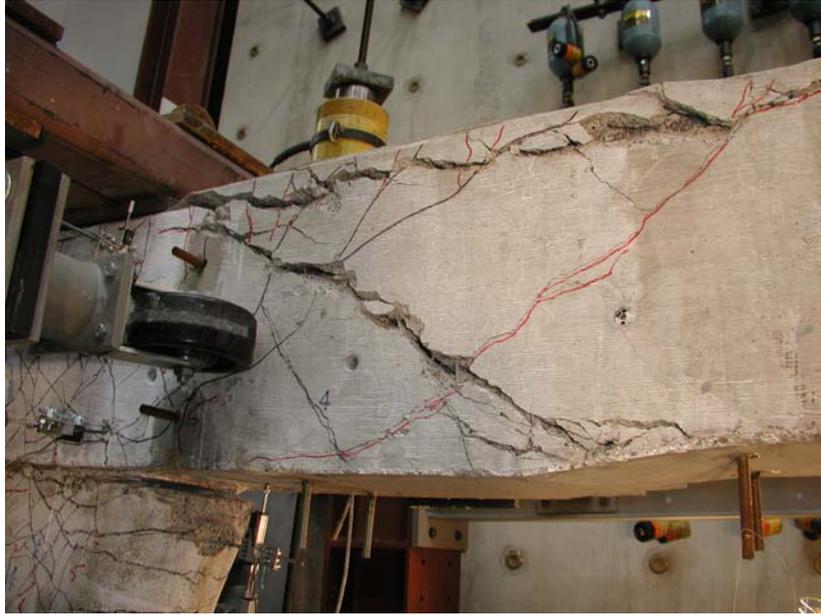
**Figure 4.41 Beams Shear Failure in SFCD2S**

Load Step-2 was to push the specimen to 41.9 mm (1.65 in). This displacement caused gap closure at the top of the column. The actual displacement achieved was 35.6 mm (1.40 in). No new cracking was observed. Load Step-3 was to pull the specimen to 41.9 mm (1.65 in). Actual displacement achieved was 31.0 mm (1.22 in). The difference between the target and achieved displacement was because of the slippage between the footing and the flooring. There were some new cracks observed in both beam and columns. The cracks were very small and comprised of both shear and flexure. Minor cracks were observed at the base hinge. Load Step-4 was to push the specimen to 94.0 mm (3.70 in). This displacement was equal to the maximum displacement the specimen went through when tested on the shake table. The actual displacement achieved was 88.6 mm (3.49 in). New flexural and shear cracks were observed. Some of the preexisting flexural cracks widened. The shear cracks that developed were very long (Figs. 4.36 and 4.37). The shear cracks developed were perpendicular to the cracks developed in the Load Step-3. Load Step-5 was to pull the specimen to 94.0 mm (3.70 inch). Specimen never went through this displacement when tested on the shake table. The maximum shake table test displacement in this direction was 60.0 mm (2.36 in). The actual displacement achieved was 93.7 mm (3.69 in). New shear and flexure cracks developed in the column and beam column connection (Fig. 4.38). Widening and lengthening of shear cracks were observed in the beam (Figs. 4.39 and 4.40). Load Step-6 was to push the system to failure. The maximum displacement achieved was 134.1 mm (5.28 in). The structure failed at this displacement due to beam shear (Figs. 4.41 and 4.42). Shear and flexural reinforcement in the beam were exposed at failure.

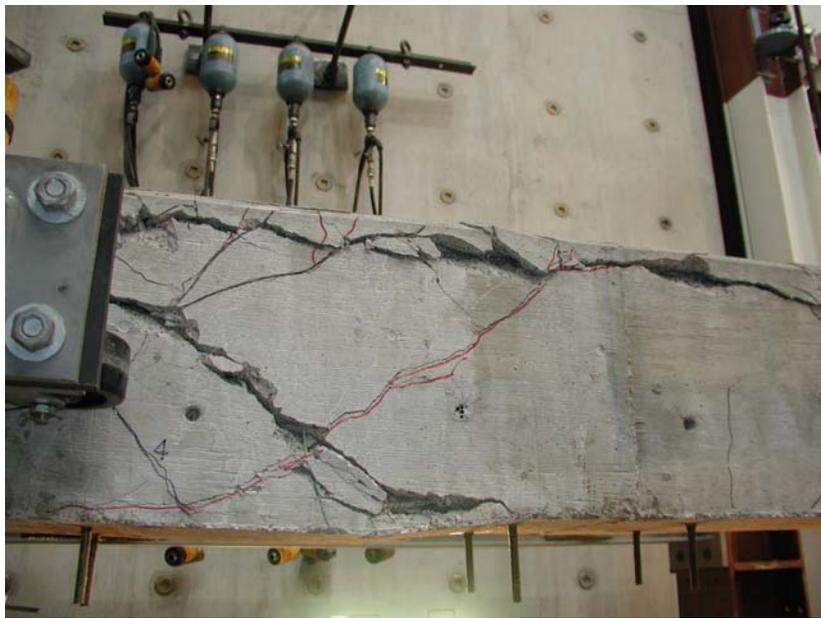
**Figure 4.42 Beams Shear Failure in SFCD2S**

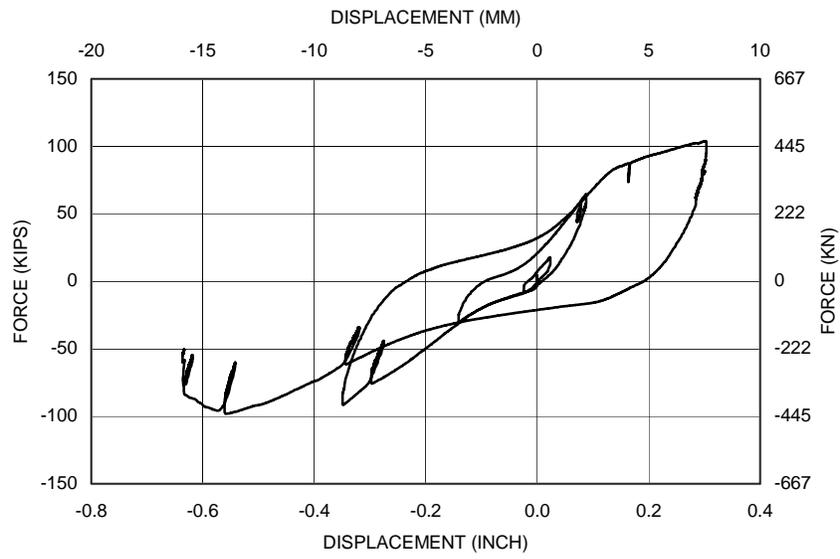
**Figure 4.43 Slippage at South Column Base in SFCD2S**

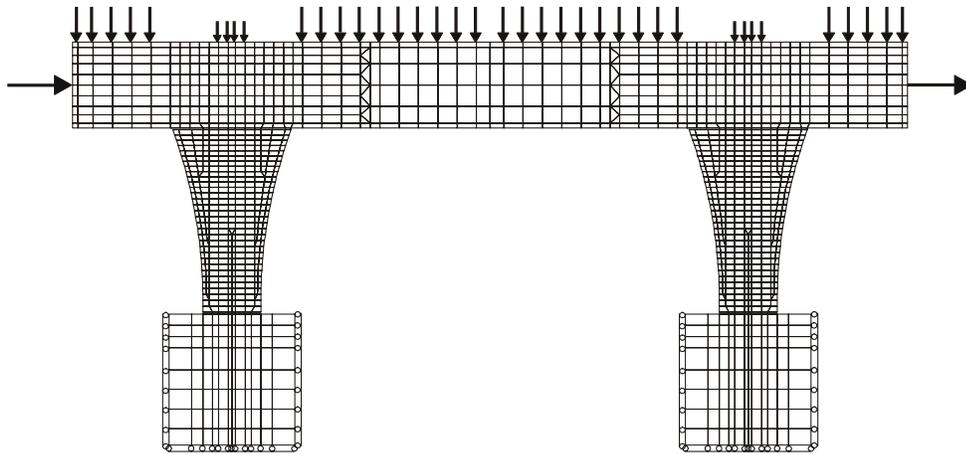
**Figure 5.3 Finite Element Mesh for the Structure Along With Loading and Boundary Conditions**

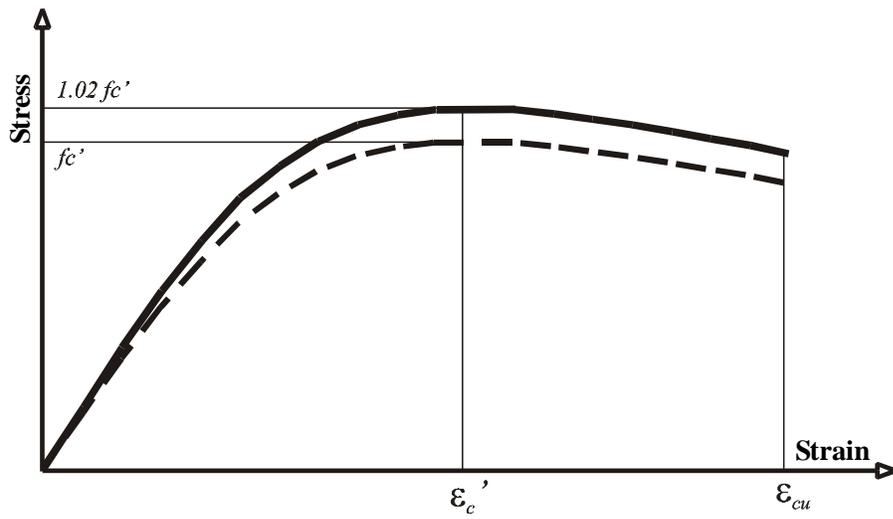
**Figure 5.4 Uniaxial Stress-Strain Relationship for Concrete**

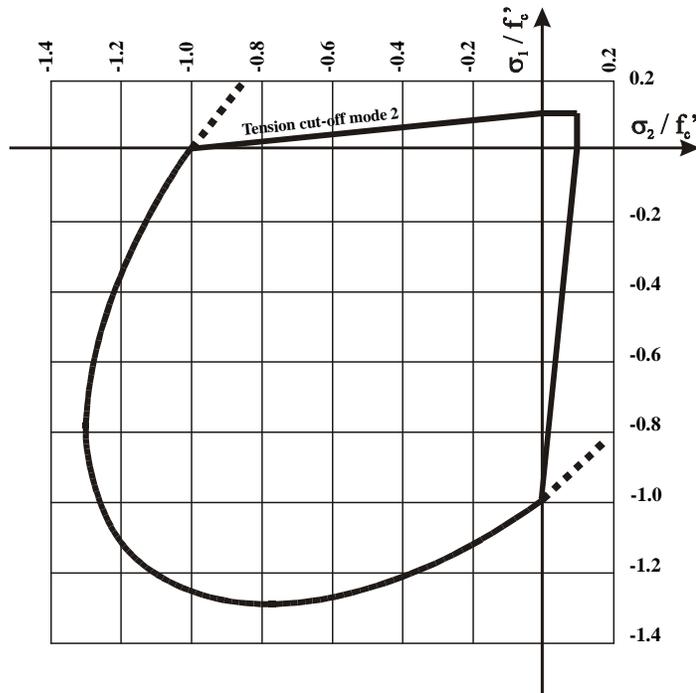
**Figure 5.5 Drucker-Prager Biaxial Failure Envelope With Tension Cut-Off**

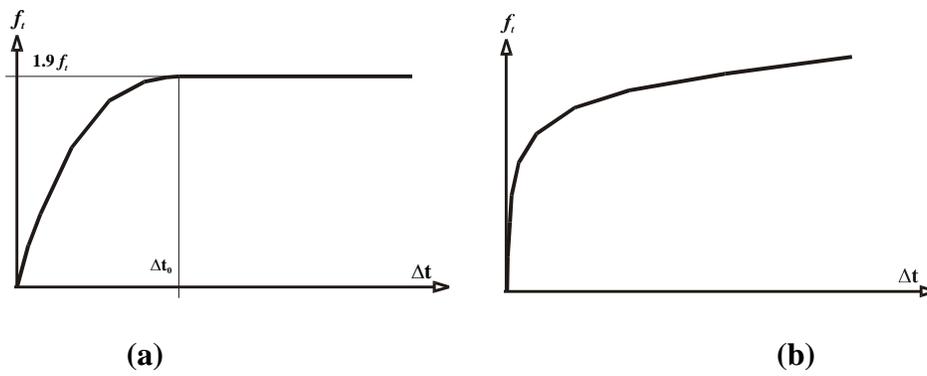
**Figure 5.6 Shear-Traction Relationship Models (a) Dörr's Model (b) Noakowski Model**

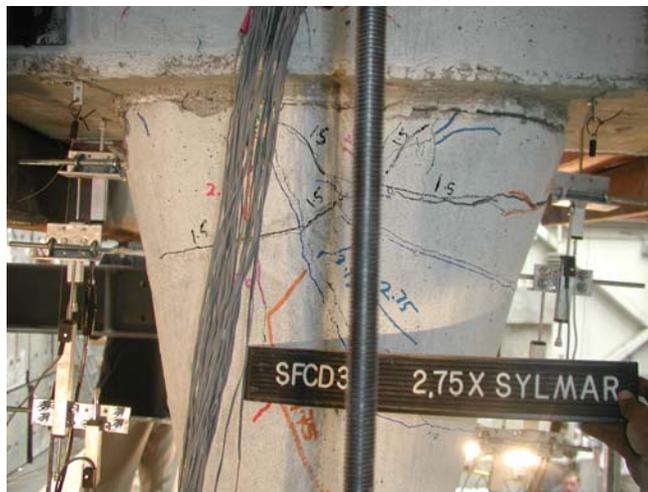
**Figure 5.25 Cracking Inside the Gap After 2.75 Times Sylmar**

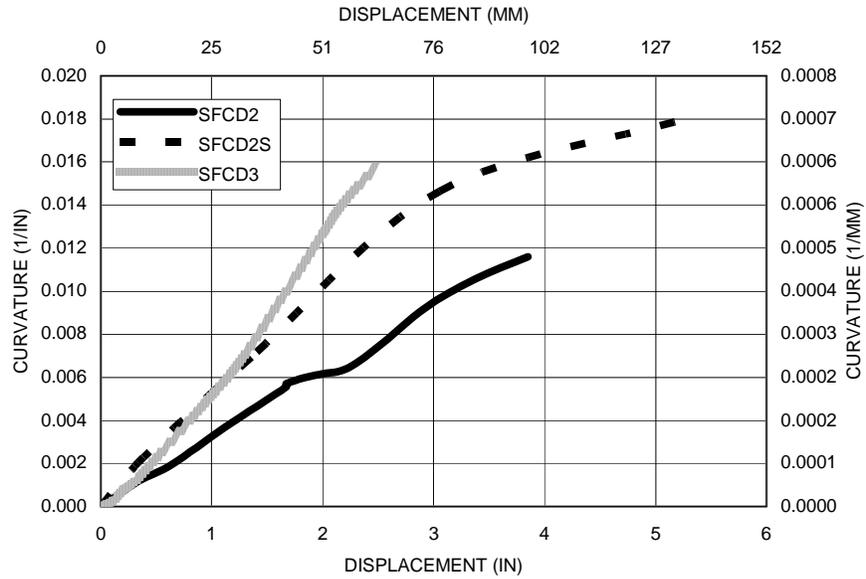
**Figure 5.26 Comparison of Curvature at the Top of East Column in SFCD2 and North Column in SFCD2S, SFCD3**
