A Study of Factors Affecting Abrasion Resistance of Concrete Surfaces

November 1965

State of California  
Transportation Agency  
Department of Public Works  
Division of Highways  
Materials and Research Department

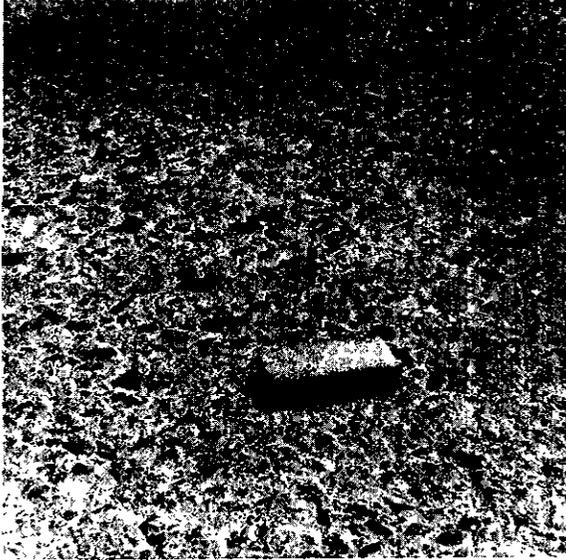
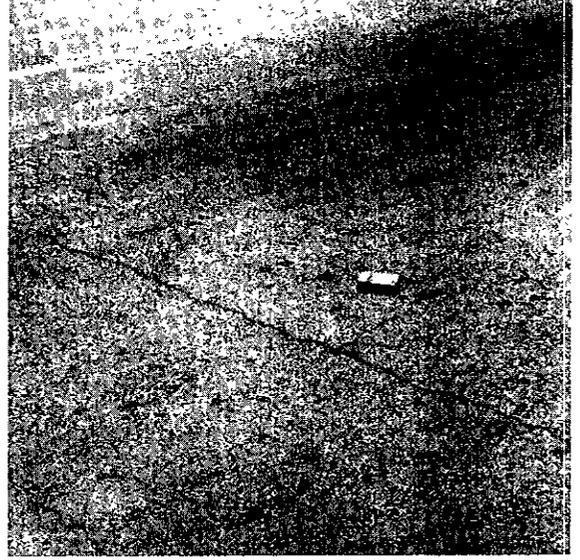
Bridge deck deterioration

California has also experienced problems with concrete surface deterioration. (See photographs.) One of the troublesome spots is on Interstate Highway 80 in the Sierra Nevada mountains. Although air entrainment was used in the areas where freezing and thawing could be a factor, surface defects, such as scaling, ravelling, and cracking, have occurred. Deterioration has been so extensive that in 1964, 34 bridge decks were resurfaced with an epoxy resin type overlay to retard further damage. The average age of these bridges was about 5 years.

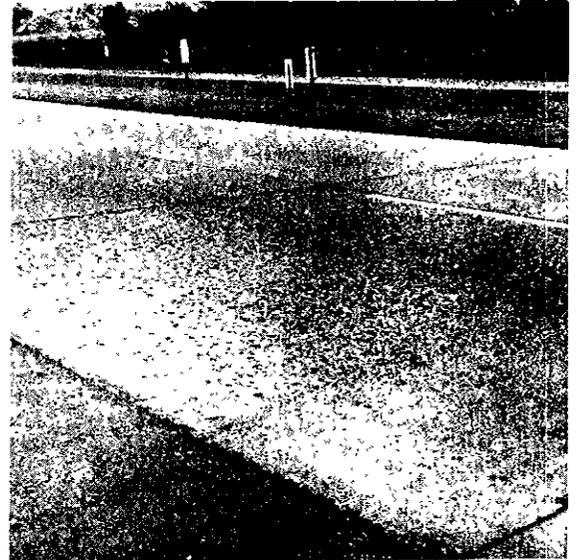
**Concrete pavement surface deterioration**

The problem of concrete distress is not limited to mountainous regions where it is thought that de-icing chemicals have contributed to the rapid deterioration of concrete surfaces. A highway near Los Angeles in the southern part of the State shows scaling and abrasion damage although it is not subjected to freezing temperatures. Whether common factors exist which contribute to surface deterioration in these completely different environments, has not yet been determined.

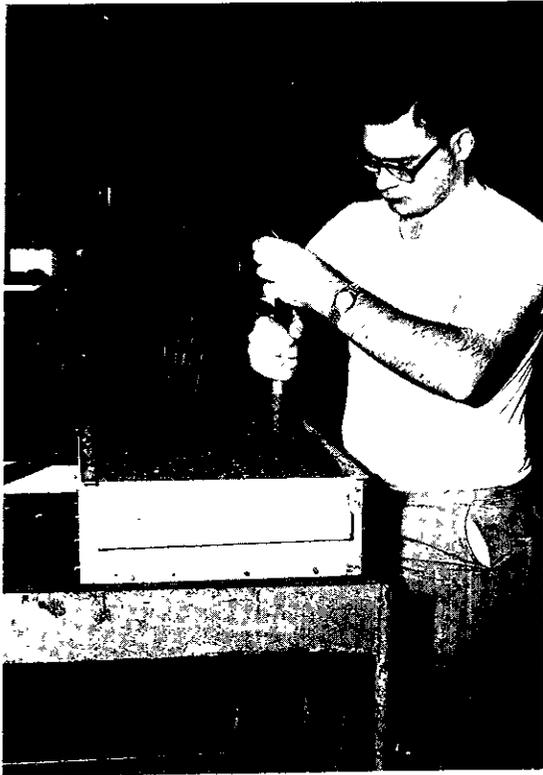
7 Vibration of test block

Test concrete was made using 3/4-inch maximum size aggregates from the American River near Sacramento. (See Table 11 for grading.) An exception was made in two of the mixes where a lower quality sand was substituted for the American River sand. Cement was Type II modified at 6 sacks per cubic yard. Mixing was done in an open tub type mixer following a standard laboratory procedure. Slump, unit weight, and air content was determined and the concrete was then placed in 14x21x5-inch wooden molds. A 1-1/4-inch stinger-type vibrator was used for compaction by quickly inserting the tip of the vibrator into the concrete and removing just slowly enough not to leave a void. The same pattern of 20 vibrator strokes was used on each test slab.

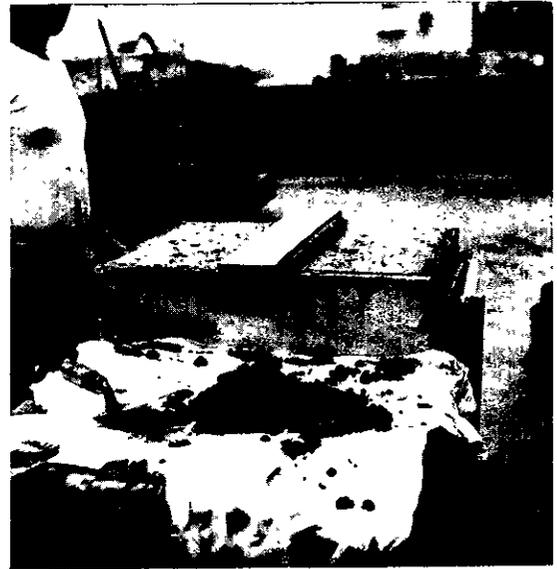
8 Floating process

Time After Vibration	Early Finish	Delayed Finish
30 minutes	Float in 4 passes, removing approximately 1/2 of excess mortar	Spray with water, float in 4 passes removing approx. 1/3 of remaining excess mortar
45 minutes	Float in 4 passes, removing excess mortar down to top of form. Broom the surface.	Spray with water, float in 4 passes removing 1/2 of the remaining excess mortar
180 minutes	No further treatment	Spray with water, float in 4 passes removing excess mortar down to the top of form. Broom the surface

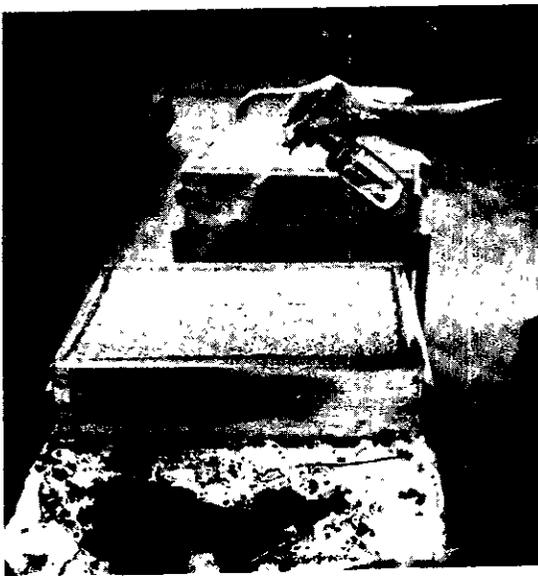
9 Fog spray being applied to concrete during delayed finishing process

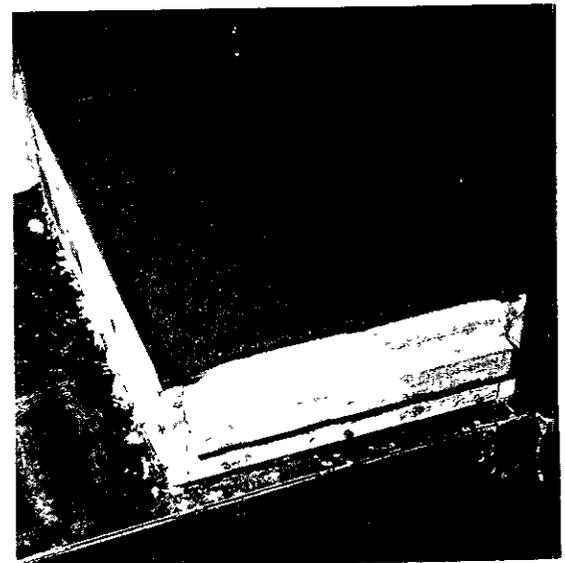
10 Finished block showing broomed surface

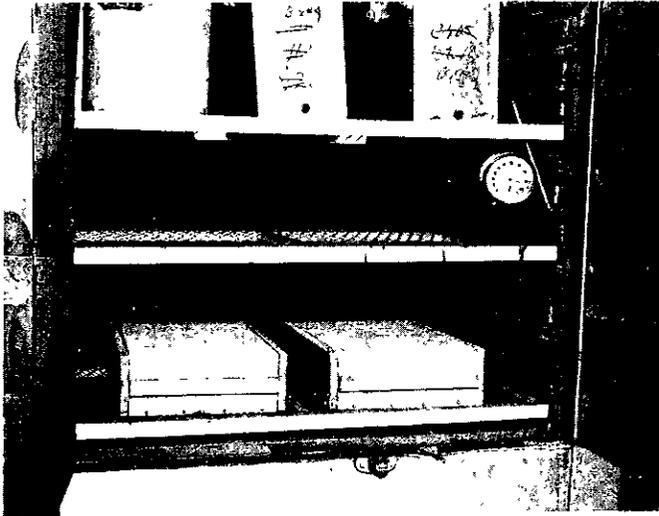
11 Test blocks in 100°F oven

To simulate a lack of proper curing (indicated in tables as "Adv." for adverse) during the first 3 days following placement, eight test blocks were left uncovered for the first 24 hours, then placed in a 100°F oven for 8 hours a day on 3 consecutive days. Blocks were stored in laboratory air when not in the oven. After the "drying" period, blocks were stripped from

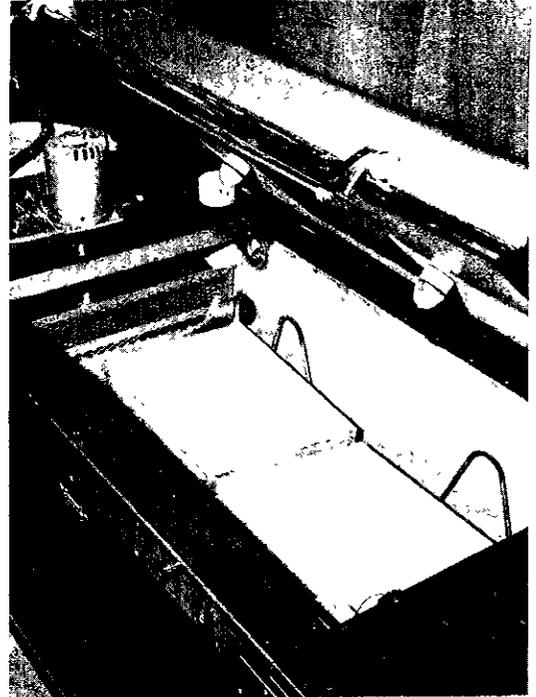
12 Blocks being frozen during early curing period

Three of the test blocks received a freezing treatment intended to simulate unexpected freezing conditions which might occur during construction. After approximately 24 hours of moist curing, the block was placed in a freezer and exposed to air at 15°F for 8 hours a day on 3 consecutive days. Blocks were covered with wet mats when not in the freezer. Thermocouples placed in the concrete indicated minimum temperatures of 24° at a 1-inch depth and 27° at 2 inches. At 4 days of age, the concrete blocks were stripped from the molds and placed in the moist curing room. They remained there for 3 days before being removed and stored in laboratory air.

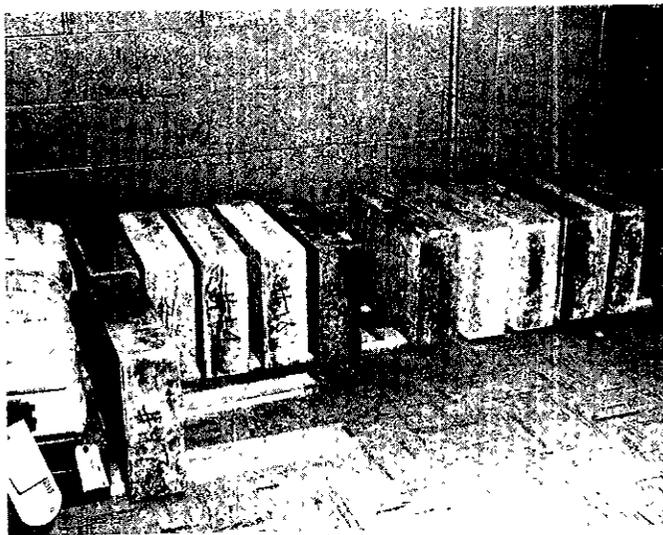
13 Storage in laboratory air

For those blocks receiving a standard cure (indicated in tables as "Std."), wet mats were applied as soon as the surface sheen had left the concrete. Forms were removed the following day and the concrete blocks placed in the moist curing room. When the concrete was 7 days old, the test blocks were removed from the moist curing room and stored in laboratory air which is maintained at approximately 73°F and 50% relative humidity.

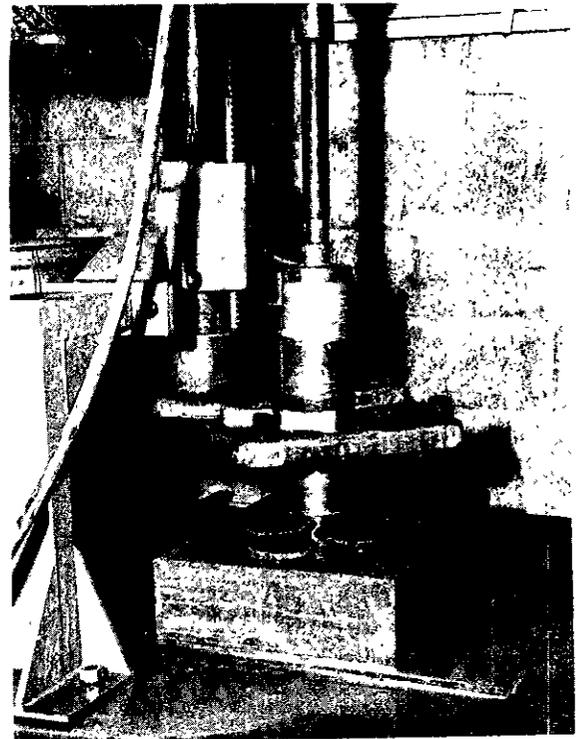
14 Coring operation

Test blocks were cored when the concrete was 17 to 19 days old. Five 4-inch diameter cores were taken from each block for the abrasion test. An additional core was taken from selected blocks for determining void characteristics by the linear traverse method.

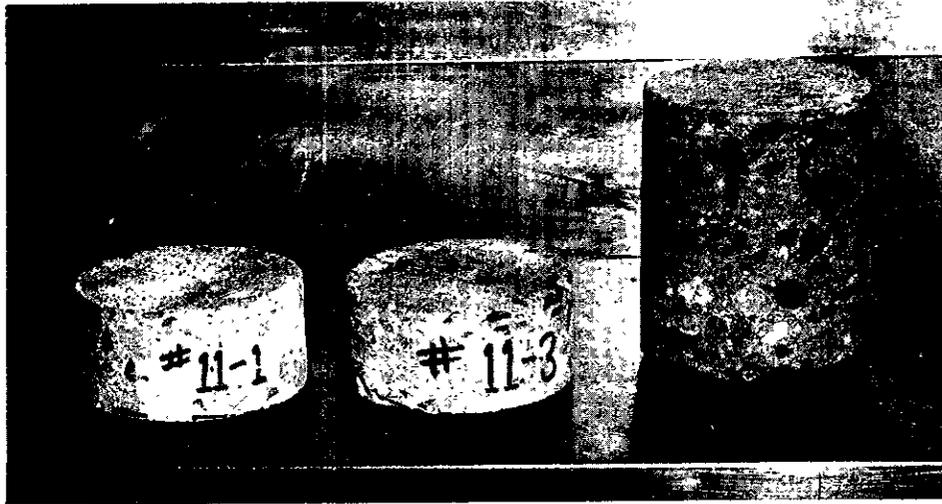
15      Specimens before and after sawing  
to 2-inch test height

Since the abrasion specimens were to be 2 inches high, the bottom 3 inches of each core was cut off and discarded. The

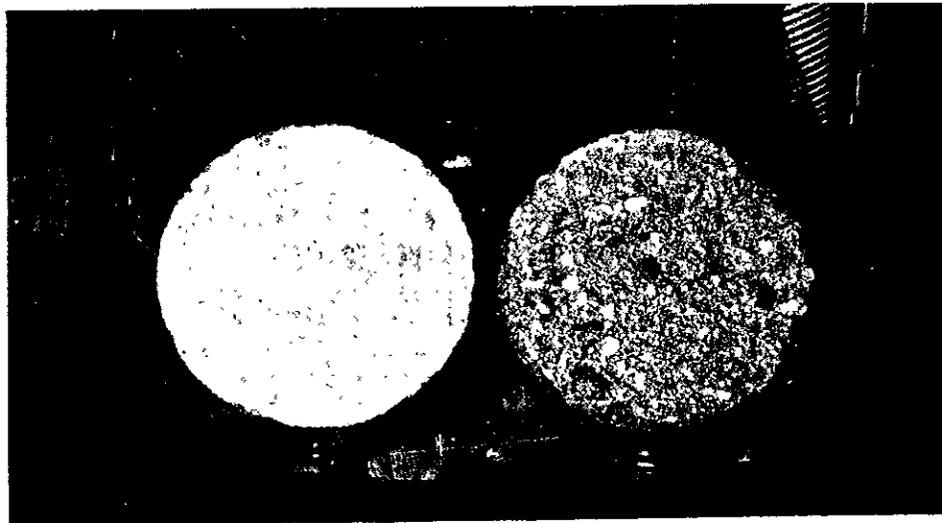
16      Untested (left) and tested specimens

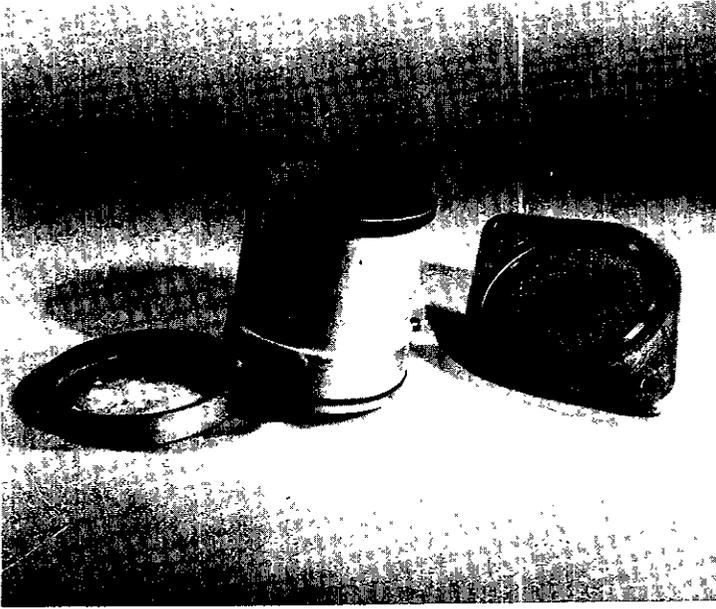
17 Container for abrasion test

Since it was felt that an impact type test might be more satisfactory for evaluating abrasion resistance, a test method of this type was devised. This was done by modifying an existing test which had been developed for determining the surface abrasion of a compacted bituminous mixture<sup>(8)</sup>. The complete procedure, as adopted and used in this project, is described and illustrated at the end of this report. Briefly, the test consists of placing a 4-inch diameter by 2-inch high specimen in a 5-inch high container, adding steel balls and water, and shaking for three minutes on a mechanical shaker. (See photographs.)

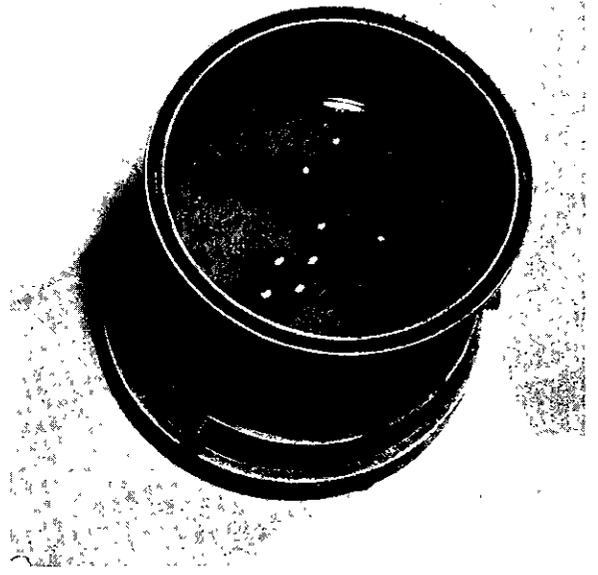
18 Specimen in place for abrasion test

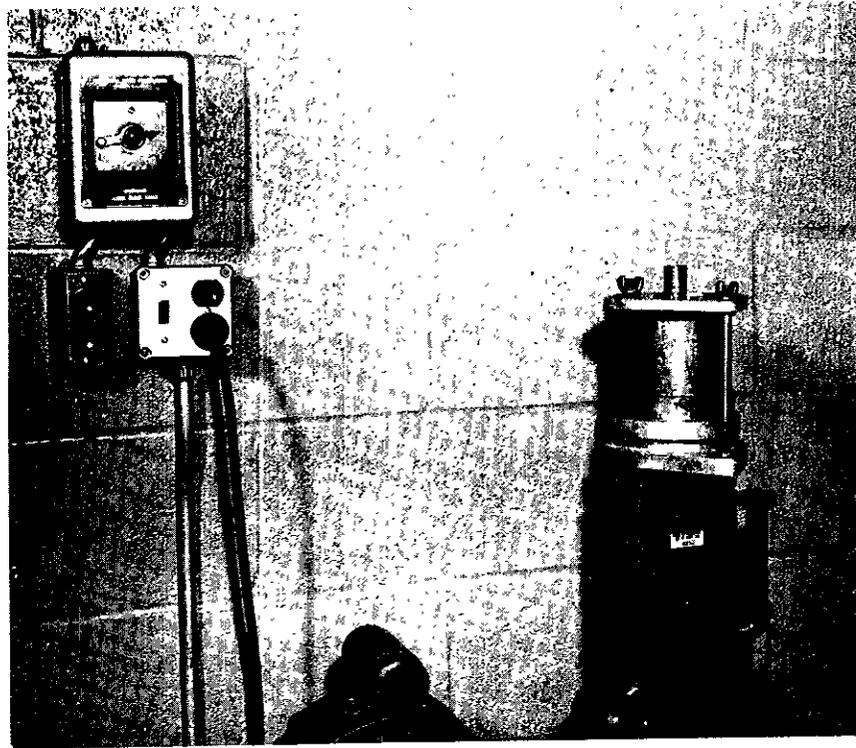
19 Abrasion test in progress
