# Use of Organic Amendments for Revegetation of Disturbed Sites with Adverse Soil Conditions

**Final Report**

**Report No. CA06-0170**

**December 2008**

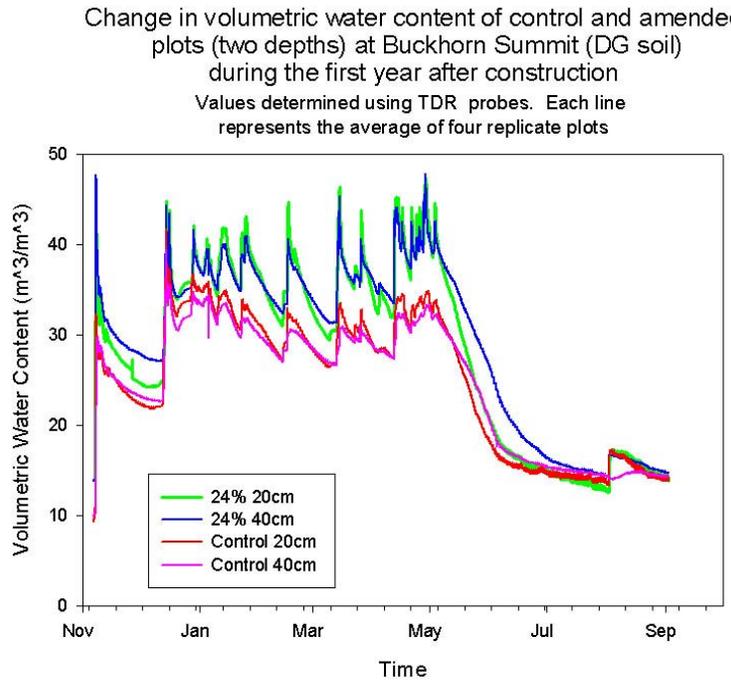
Figure 1. Volumetric water content of amended and unamended DG soils for the 01-02 water year.

9. During the rainy season, compost incorporation changes the threshold of runoff from a 2 year return frequency storm to nearly a 10 year storm (Table 2). Amounts of sediment loss for a given month or storm intensity were also reduced by over half by compost amendment. The time interval between storms also influences the capacity of the soil for greater infiltration capacity by allowing more complete profile drainage (Figure 1).

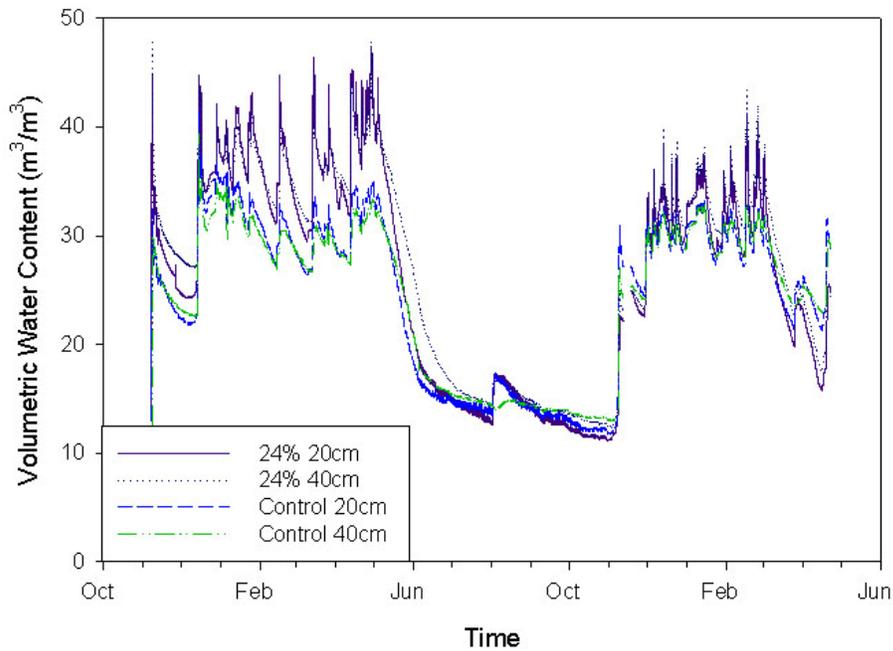
Figure 2. Volumetric soil water content for the 01-02 and 02-03 water years, Buckhorn Summit site, SHA 299 0.06 .

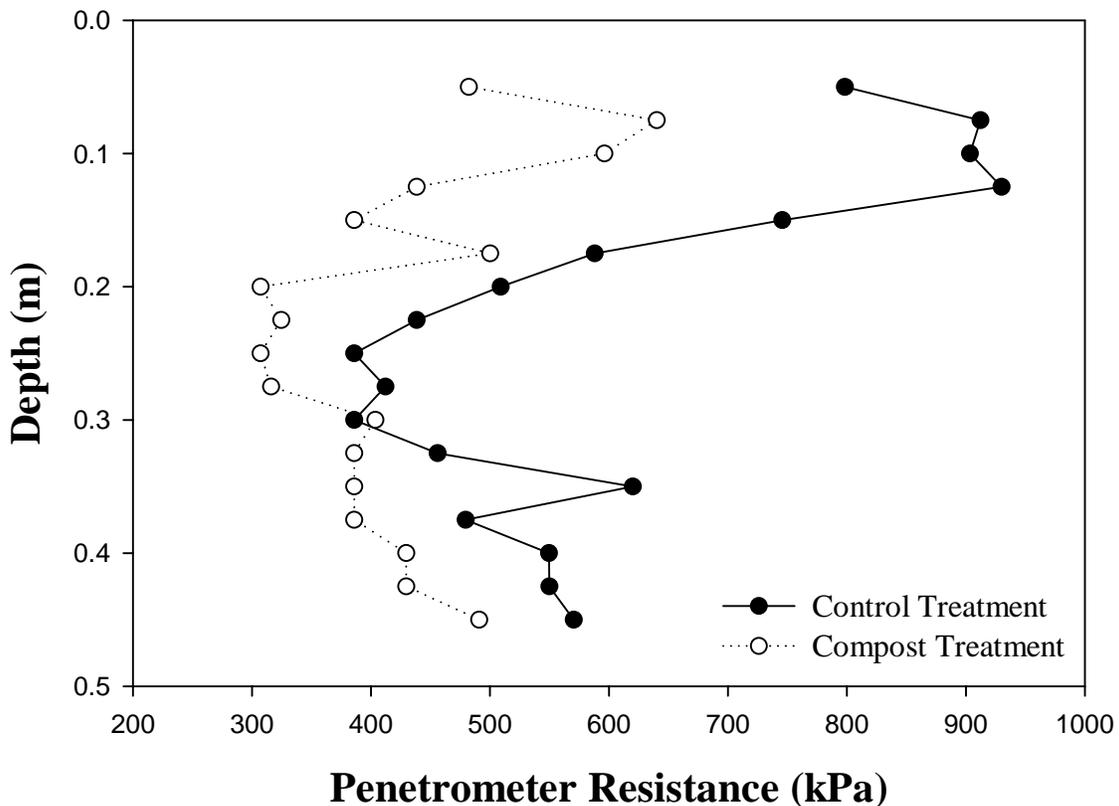
Figure 3. Penetration resistance at Buckhorn summit site (n = 4).

22. Within several seasons, a dense layer was observed to form in the soil at 10 to 20 cm depth, even without external compaction (Figure 3). We hypothesize that particles from compost or from DG minerals settled into pore spaces at this depth when they are carried by the average depth of the wetting front by rainfall from repeated storms. Penetration resistance peaked in this area on both composted and non-treated plots. Eventually, this layer may impact rooting or infiltration, but this was not observed during the first two years.

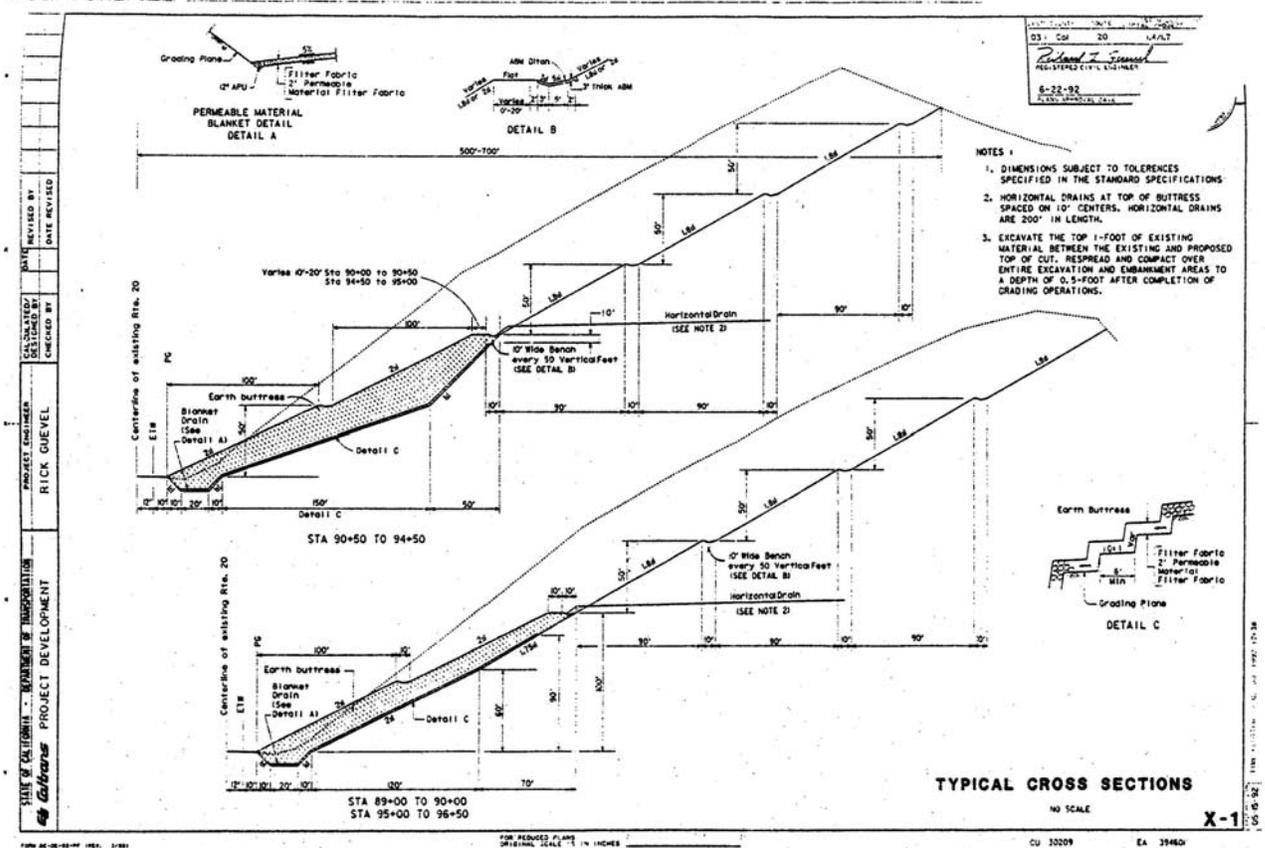
Figure 4. Cross sectional diagrams of COL 20 mile post 1.5 (from Caltrans job file).

This site has had a series of failures of the cut slope during the 1980's culminating in a large project in 1992 to stabilize the site by removing the material above the cutslope. Excavated material was trucked to a valley fill site half a mile to the south at the head of Lynch Creek. The bottom half of the remaining slope was cut back to a 2:1 (run:rise) slope constructed of compacted lifts, with a subdrain system underneath and concrete interceptor ditches constructed across the face of the slope. The upper half of the cut exposed the undisturbed country rock at the site and is at a 1.5:1 slope (run:rise) angle (Figure 4). The finished surface was amended with gypsum and fertilizer, and was seeded with native and introduced nonserpentine revegetation species. These plant materials died out within a few years, leaving the slope essentially barren. Parts of the top two benches received a thin overlay of topsoil that had been harvested from the native soil at the top of the cut before excavation. This layer amounted to only a centimeter or two of thickness, but resulted in a greater level of revegetation than with the fertilizer only treatments.
